Lower St. Johns River Basin

Thermal Imaging Summary Report

August 31, 2009

Fecal Coliform Source Identification Thermal Imaging Summary Report

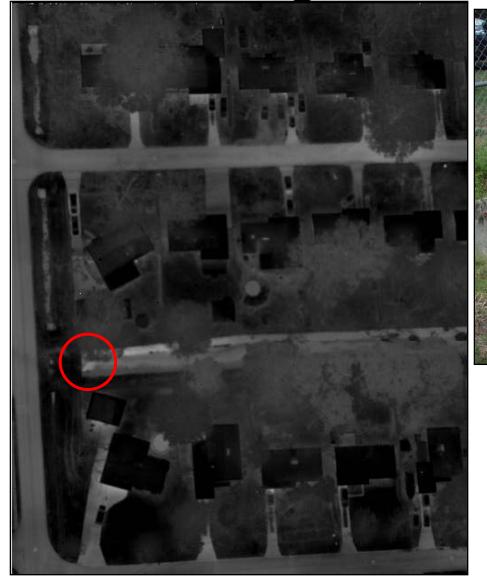
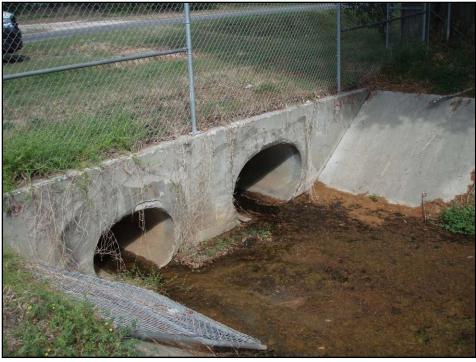
Thermal Anomaly 09_28-60_A

Thermal Imaging Anomaly	Field Description	Nearest Downstream Pre-/Post-Flight Station	Pre-flight Fecal Coliform Concentration (CFU/100mL)	Post-flight Fecal Coliform Concentration (CFU/100mL)	Approximate Location	Requested Follow-up and Conclusion	Responsible Agency				
	BIG FISHWEIR CREEK										
			Wester	n Fork							
09_28-60_A	Where Creek emerges from underground conveyance at Lake Shore Blvd. and Royce Ave.	BF3	2200	2245	Just north of Lake Shore Blvd. and Royce Ave. intersection						
10_28-72_A	MS4 culvert with flowing water (no odor)	BF3	2200	2245	550 feet downstream of the Lake Shore Blvd. and creek intersection						
11_29-38_A	MS4 culvert with flowing water (no odor)	BF3	2200	2245	250 feet upstream of the Quan Dr. and Creek intersection						
12_29-54_A	Multiple ground water seeps flowing into the artificial channel	BF3	2200	2245	Clarendon Rd.						
12_29-54_B	MS4 culvert from unnamed tributary/ditch	BF3	2200	2245	Approximately 50 feet upstream of the Clarendon Rd. and creek intersection

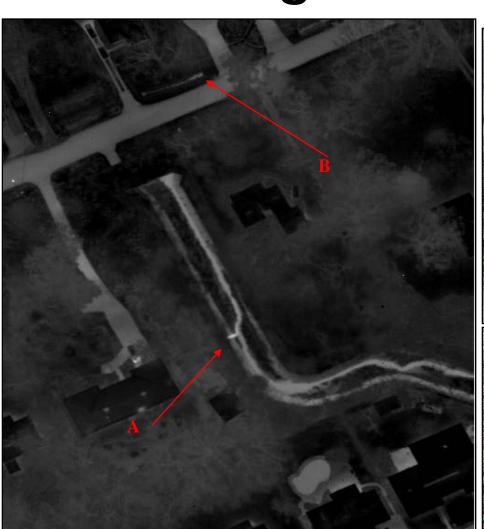
Thermal Anomaly 13_29-76_B

13_29-76_A	Blue 2-inch pipe dripping water (no odor) that originates at private residence	BF3	2200	2245	Approximately midway between Yerkes St. and Clarendon Rd.	COJ EQD investigation verified pipe as heat pump system drain (06/24/09)	COJ EQD				
13_29-76_B	Road side swale with culvert that extends under a driveway	BF3	2200	2245	Just south of Yerkes St.						
19_30-176_A	Outfall from an open ditch that flows in close proximity to a dog pen with 2 dogs present	BF3	2200	2245	Just north of Park St.						
			Easter	n Fork							
20_32-81_A	MS4 outfall draining neighborhood (mixed sewer and OSTDS use) from northeast; high organic matter indicated by foam	TBF3	1100	440	Just southeast of JEA lift station N427 on Plymouth St.	Designated as supplemental sampling station (TBF3B)	FDEP

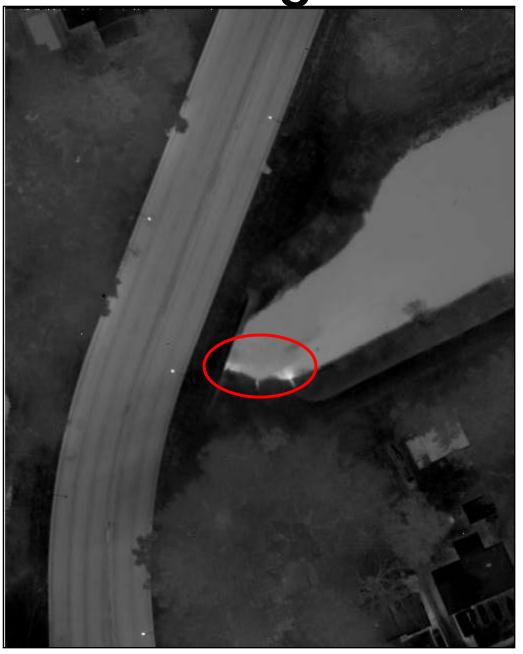
Thermal Anomaly 14_29-140_A

Thermal Imaging Anomaly	Field Description	Nearest Downstream Pre-/Post-Flight Station	Pre-flight Fecal Coliform Concentration (CFU/100mL)	Post-flight Fecal Coliform Concentration (CFU/100mL)	Approximate Location	Requested Follow-up and Conclusion	Responsible Agency
			Main C	hannel			
14_29-140_A	NA: pre- and post-flight fecal coliform samples ≤660 CFU/100mL	Fair	660	620	Blanding Blvd. and Glenwood Ave. intersection		
18_30-105_A	NA: on private property; unable to access site	Fair	660	620	1511 Hamilton Street	Investigated by the DCHD, COJ, and SJRWMD; ponding of surface waters in lowlying area (03/31/09)	DCHD, COJ, and SJRWMD
17_30-98_A	NA: pre- and post-flight fecal coliform samples ≤660 CFU/100mL	Fair	660	620	Roosevelt Blvd. and Park St. intersection	Adjacent to stormwater outfall on infrastructure map	
08_27-171_A	NA: pre- and post-flight fecal coliform samples ≤660 CFU/100mL	Fair	660	620	East side of Roosevelt Blvd. and north of Merrimac Ave.

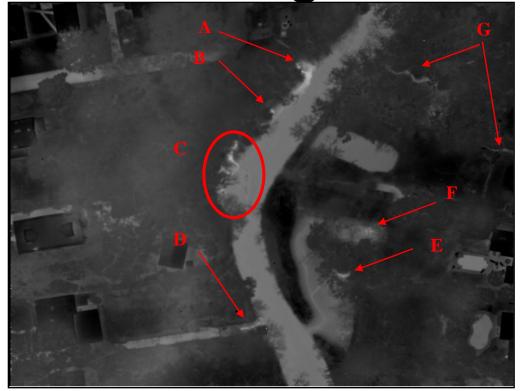
Thermal Anomaly 07_27-158_A

07_27-158_A	Flow from under rip rap at JEA lift station N116	BF2	1967	279	Merrimac Ave.; JEA lift station N116	COJ EQD sample collection (FC = 500 CFU/100mL; 03/31/09)	COJ EQD
07_27-158_B	Low-lying area; no pipes or odors observed	BF2	1967	279	Merrimac Ave.		
07_27-158_C	Multiple ground water inputs in low-lying area; no odors	BF2	1967	279	Merrimac Ave.		
07_27-158_D	NA: on private property; unable to access site	BF2	1967	279	Merrimac Ave.		
07_27-158_E	NA: on private property; unable to access site	BF2	1967	279	Merrimac Ave.		
07_27-158_F	NA: on private property; unable to access site	BF2	1967	279	Merrimac Ave.		
07_27-158_G	NA: on private property; unable to access site	BF2	1967	279	Merrimac Ave.		
06_30-71_A-C	NA: on private property; unable to access site	BF2	1967	279	Euclid St.		
05_27-146_A-B	NA: on private property; unable to access site	BF2	1967	279	East of Euclid St.		
04_30-45_A	Potential artesian well in main channel	BF2	1967	279	West of Herschel St. behind Harpoon Louie's	Requested follow-up 04/08/09	COJ EQD

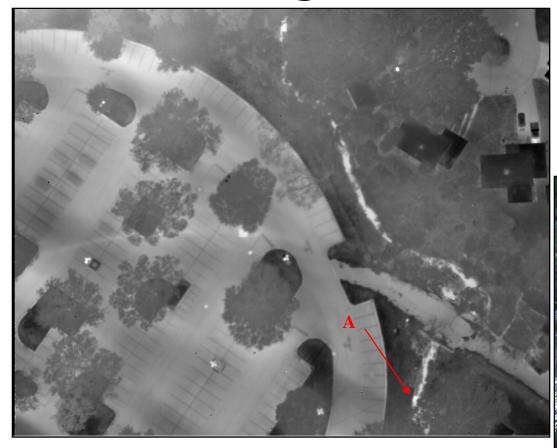
Thermal Anomaly 29_35-127_A

LITTLE FISH\	WEIR CREEK			
29_35-127_A	Slight flow from parking lot drain (matches picture not GPS coordinates)	Herschel	3500	3900	FCCJ parking lot at MacArthur St.		
28_35-69_B or 28_35-68_B	Standing water appears to have originated from irrigation system in bank of clay tennis courts in Boone Park	Herschel	3500	3900	Boone Park tennis courts		
28_35-69_A	Concrete culvert with 4- inch submerged metal pipe crossing conveyance system	Herschel	3500	3900	Upstream of Walsh St.	Requested that JEA provide identification of submerged metal pipe (06/29/09); pipe identified by JEA (08/21/09) as gravity sewer service connection to 3805 Walsh St.	JEA
27_35-57_A-B	Standing water in low area; no odor (not exact match for GPS coordinates)	Herschel	3500	3900	Between Valencia Rd. and Boone Park Ave.		
26_35-46_A	Stormwater culvert at end of Boone Park Ave. (not exact match for GPS coordinates)	Herschel	3500	3900	Intersection of Boone Park Ave. and creek

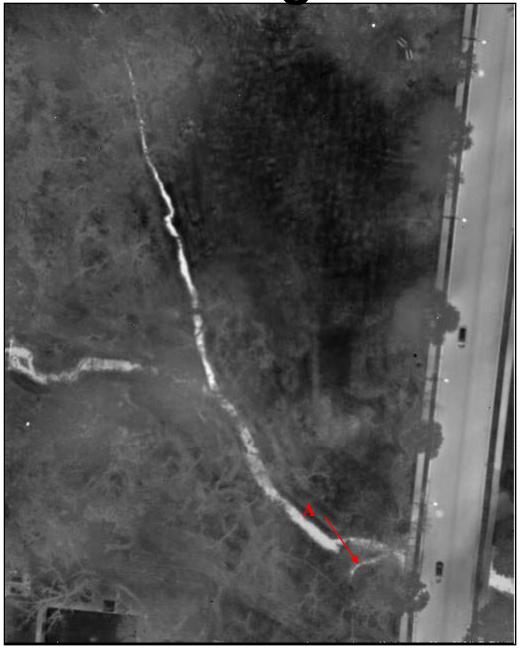
Thermal Anomaly 25_35-41_A

25_35-41_A	Stormwater outfall with sulfur odor	Herschel	3500	3900	Intersection of Herschel St. and creek

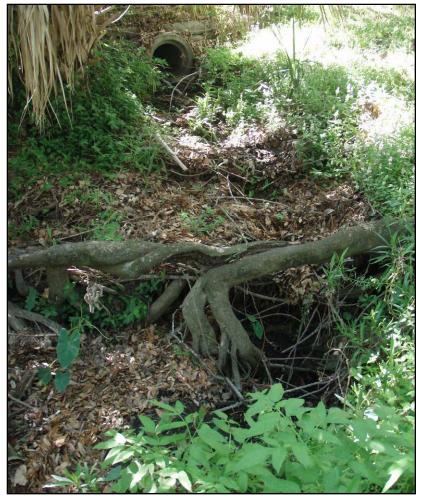
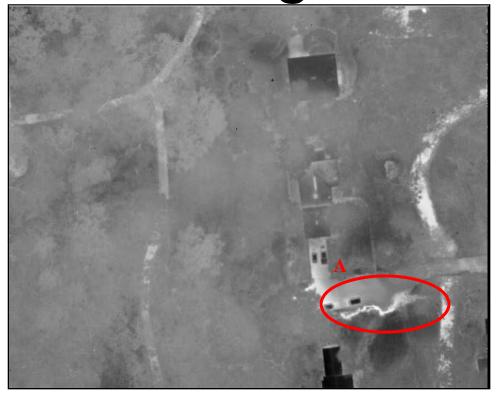
Thermal Anomaly 24_35-17_A

Thermal Imaging Anomaly	Field Description	Nearest Downstream Pre-/Post-Flight Station	Pre-flight Fecal Coliform Concentration (CFU/100mL)	Post-flight Fecal Coliform Concentration (CFU/100mL)	Approximate Location	Requested Follow-up and Conclusion	Responsible Agency
24_35-17_A	Blue drainage pipe	BF1	2164	1600	Intersection of Riverside Ave. and creek		
23_33-38_A	Stormwater inlet completely clogged, grey water and bubbles indicating denitrification in channel connecting drop inlet to creek; possible sewage odor; nearby JEA sewer manhole	BF1	2164	1600	Pine Grove Ave. just east of Riverside Ave.	COJ EQD sample collection (FC =1,279 CFU/100mL; 03/30/09); COJ EQD reported possible turbidity violation to Erosion Control Group; Designated as supplemental sampling station (TBF2B)	
22_36-175_C	Concrete stormwater outfall	BF1	2164	1600	South of intersection of St. Johns Ave. and Montgomery Pl.		
22_36-175_B	~1.5 inch PVC pipe; no flow	BF1	2164	1600	1808 Montgomery Pl.

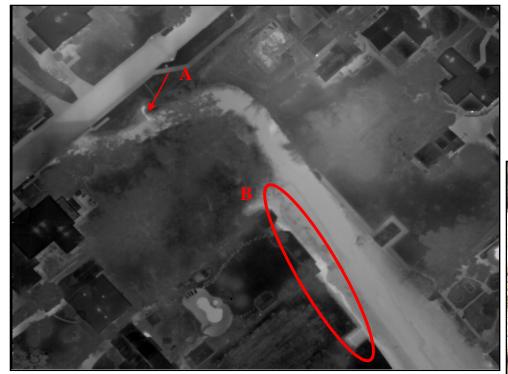
Thermal Anomaly 21_33-22_A

22_36-175_A	Stormwater outfall; ~20 feet upstream is submerged iron pipe with no apparent connection	BF1	2164	1600	Intersection of Greenwood Ave. and creek		
21_33-22_A	Stormwater outfall sampled as site TBF1	TBF1	520	344	Stormwater outfall on Greenwood Ave.		
21_33-22_B	NA: on private property; unable to access site; infrastructure map indicates likely coincides with stormwater outfall	NA	NA	NA	Downstream of Greenwood Ave.		
02-27-77_A	NA: on private property; unable to access site;	NA	NA	NA	Mouth of Big Fishweir Creek		
01-27-48_A	2 pipes extending out from seawall (drainage)	NA	NA	NA	Mouth of Big Fishweir Creek		
01-27-48_B	Flowing stormwater outfall	NA	NA	NA	Mouth of Big Fishweir Creek		
			MIRAMAF				
09_14-85_A	NA: outside of the revised WBID boundaries	NA	Main Cl	nannel NA	East of St. Augustine Rd., south of Thomas Ct.		
08_12-24_A	NA: outside of the revised WBID boundaries	NA	NA	NA	East of St. Augustine Rd., south of Emerson St.

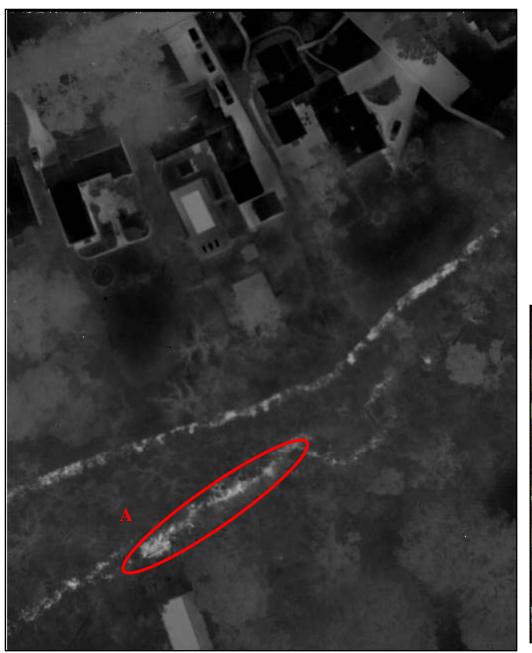
Thermal Anomaly 02_01-63_A

•		Main Cl	hannel			
02_01-63_A	Channel is dammed up by debris; almost stagnant upstream of dam with flow downstream; 2 groundwater seeps with white coloration enter creek from north bank downstream of signal	MR1	1229	2600	In wooded area behind ~ 1204 Morvenwood Rd.	Requested follow-up 04/24/09	COJ EQD
03_05-23_A	Rivulets of standing water in tidal area (thermal imaging picture labeled as 03_25-23_A)	NA	NA	NA	Mouth of Miramar Creek		
01_02-01_A	Rivulets of standing water in tidal area	NA	NA	NA	Mouth of Miramar Creek		
05_07-52_A	NA: outside of WBID boundary	NA	NA	NA	East bank of St. Johns River, north of Miramar Creek		
			CRAIG				
	NA. an universal		North	Fork	The end of Minter		
10_23-08_A	NA: on private property; unable to access site	CC3	840	2500	The end of Westmont St., adjacent to I-95

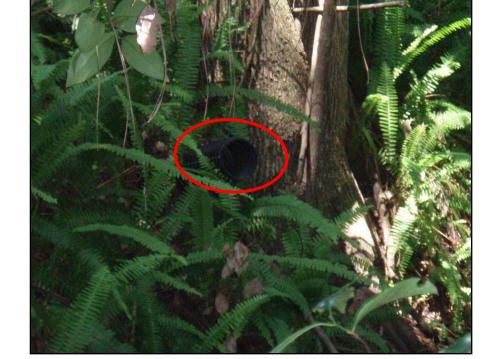
Northern Branch Pipe 9

NA	Northern Branch Pipe 9: black corrugated pipe possibly extending from property with white house	Greenridge	4000	4500	West bank of north branch between Colonial Manor Pond outfall and JEA lift station S505	Requested follow-up (04/24/09); Confirmed gutter drain as of 07/01/09	COJ EQD
NA	Northern Branch Pipe 8: black corrugated pipe with evidence of recent flow extending from property with brick house	Greenridge	4000	4500	West bank of north branch between Colonial Manor Pond outfall and JEA lift station S505	Requested follow-up (04/24/09); Confirmed gutter drain as of 07/01/09	COJ EQD
NA	Northern Branch Pipe 7: concrete pipe with no evidence of flow	Greenridge	4000	4500	East bank of north branch between Colonial Manor Pond outfall and JEA lift station S505	Requested follow-up (04/24/09)	COJ EQD
NA	Northern Branch Pipe 6: blue pipe with screen at end with no evidence of flow	Greenridge	4000	4500	East bank of north branch between Colonial Manor Pond outfall and JEA lift station S505	Requested follow-up (04/24/09)	COJ EQD

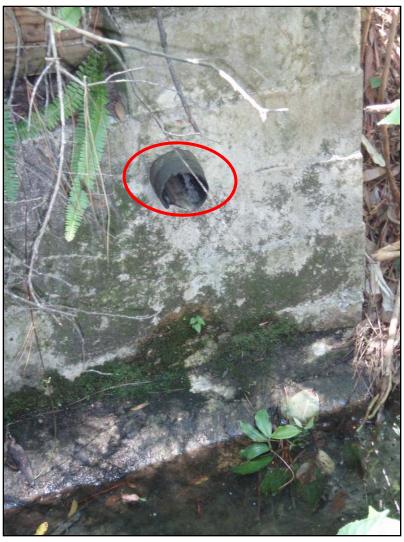
Northern Branch Pipe 5

NA	Northern Branch Pipe 5: black plastic pipe extending from concrete on property with tan house and wood fence (same property as Pipe 3)	Greenridge	4000	4500	West bank of north branch between Colonial Manor Pond outfall and JEA lift station S505	Requested follow-up (04/24/09)	COJ EQD
