# **Peace River and Withlacoochee River Threats Assessments and Fish Assemblage Monitoring**

**Final Report July 1, 2015 – June 30, 2019**

Submitted to Florida State Wildlife Grants Program  
August 1, 2019  
PID: 98462501284

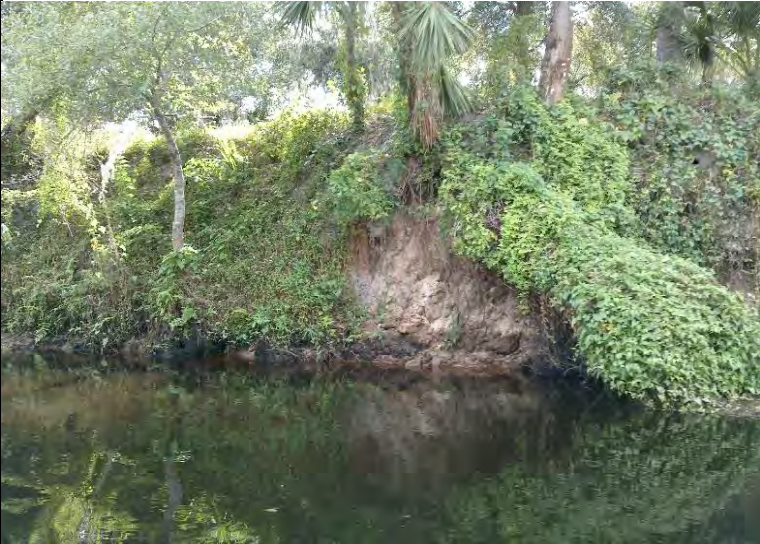
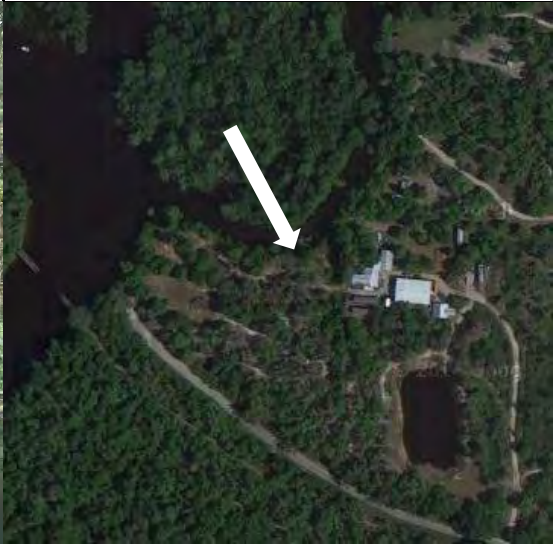
Peace River			Severity Scale: 2.0-Low
Watershed: Peace River Subwatershed: Lettuce Lake Latitude: 27.08989 Longitude: -81.97868			County: Desoto Site Number: PI002 Reach Length: 330 ft. Landowner: Kitty Gail Coleman

Risk Factor	Ranking	Score	<div> PI002 Bankfull Depth Profile

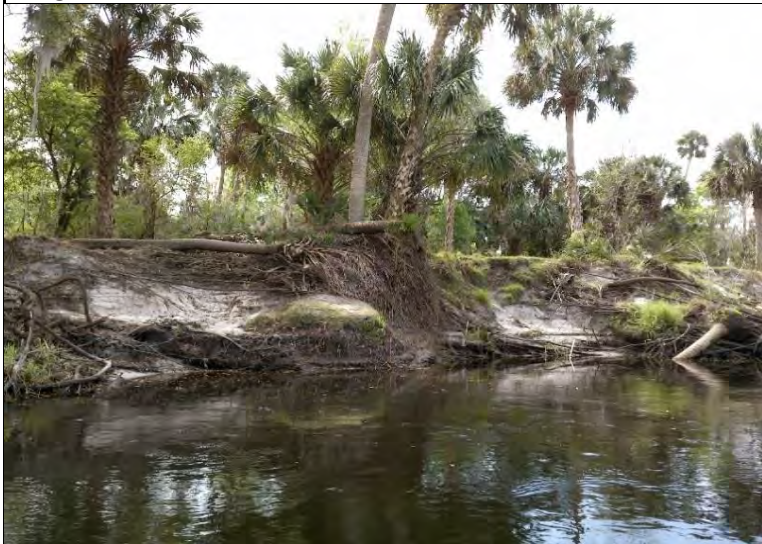
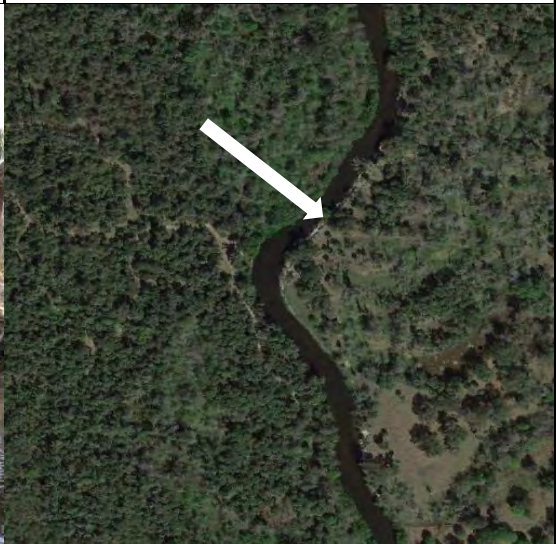
Peace River			Severity Scale: 3.75-Low	
Watershed: Peace River Subwatershed: Thompson Branch Latitude: 27.54599 Longitude: -81.79134			County: Hardee Site Number: PI122 Reach Length: 334 ft. Landowner: Burnett OMA

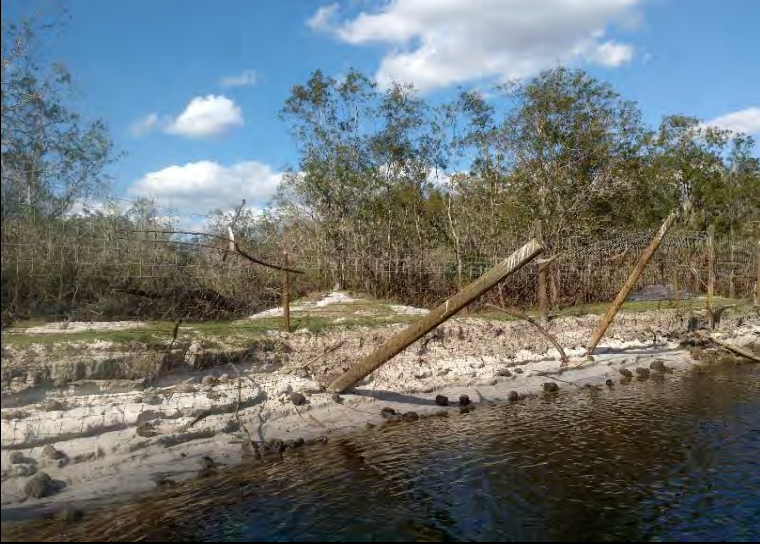
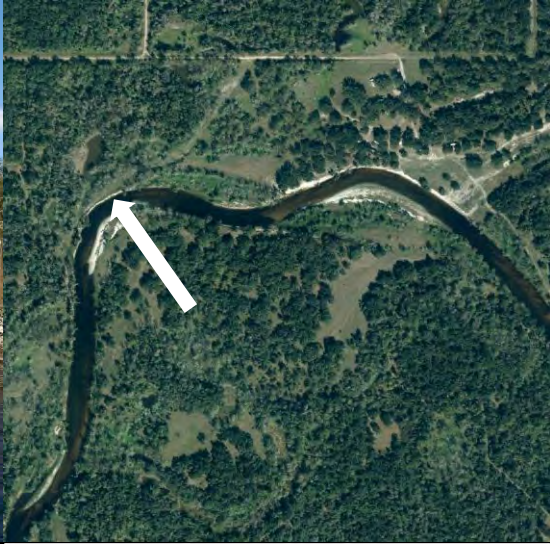
Peace River			Severity Scale: 6.75-Moderate
Watershed: Peace River Subwatershed: Johnson Lake Latitude: 27.17912 Longitude: -81.89562			County: Desoto Site Number: PI392 Reach Length: 320 ft. Landowner: GERACI D D TR

Risk Factor	Ranking	Score	
Pfankuch-Channel Stability:	Poor	1.5	
Channel Alteration:	None	0	
Bank Erosion:	Mass-wasting	1.5	
BEHI:	High (39.39)	1	
Local NPSP:	Obvious Sources	1.5	
Shoring Structures:	None	0	
Pipe Discharge:	None	0	<b>Additional Site Features</b> Stream Channel Woody Material: Infrequent Impoundments: None Substrate Composition: Medium Sand Bank Material: Sand Near Bank Stress: High RB Landuse: Natural Forest, Pasture LB Landuse: Natural Forest, Pasture
Water Odor:	Normal	0	
Fish Passage Barrier:	None	0	
RB: Riparian Buffer:	0 ft.	0.75	
LB: Riparian Buffer:	40 ft.	0.5	
RB: Floodplain Access:	Full	0	
LB: Floodplain Access:	Full	0	
<b>Severity Scale:</b>		<b>6.75</b>

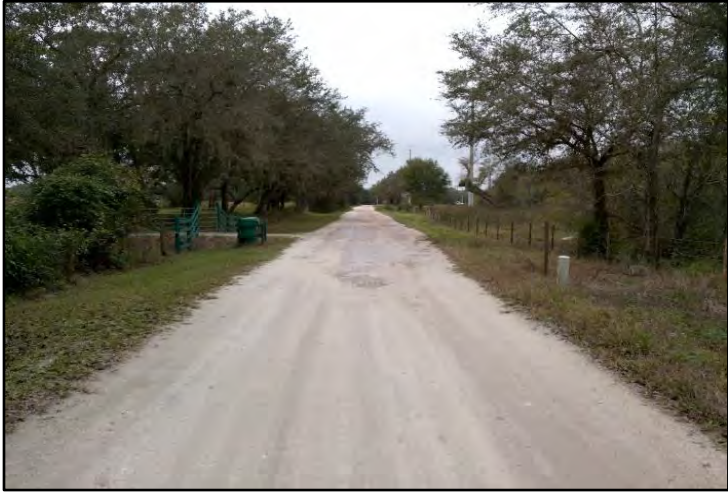
<p>Left Approach from Crossing Structure</p>

Unnamed Tributary			Sediment Risk Index: 54-Low	
Watershed: Peace River Subwatershed: McBride Branch Latitude: 27.314731 Longitude: -81.813592 Road Name: NE Bombay Rd.			County: Desoto Site Number: PU014 LULC: Low density residential, pastureland  Land Owner(s): Stewart Parker*

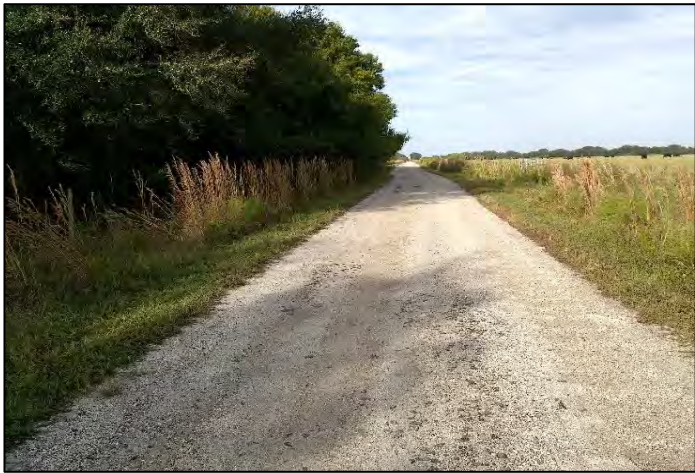
Unnamed Tributary			Sediment Risk Index: 46-Low	
Watershed: Peace River Subwatershed: Lower Prairie Creek Latitude: 27.00534 Longitude: -81.927457 Road Name: Live Oak Blvd			County: Charlotte Site Number: PU025 LULC: Pastureland, wetland  Land Owner(s): HUDSON HAMMOCKS & JMH-TR

Left Approach from Crossing Structure			Crossing Structure: DS	
Risk Factor	Ranking	Score		
US Channel Morph	Ponded	1		
DS Channel Morph	Ponded	1		
DS Bank Alteration	Minor	3		
Upstream Skew Angle	5° to 30°	3		
Crossing fill condition	Vegetated	5		
Inlet/Outlet Condition	Sediment/Scouring	3		
Potential Eroded Vol.	< 21 c.y.	5		
Soil K Factor	≤0.20	5		
Approach Slope Mean	≤2.0%	5		
Road Approach Material	All Aggregate	5		
Upstream Rt Outlet	Vegetated	1		
Upstream Lt Outlet	Vegetated	1		
Upstream Rt Ditch	Vegetated	1		
Upstream Lt Ditch	Vegetated	1		
Downstream Rt Outlet	Vegetated	1		
Downstream Lt Outlet	Vegetated	1

Downstream Rt Ditch	Vegetated	1		
Downstream Lt Ditch	Vegetated	1		
Improved Outlet Total	4	1		
Improved Ditches Total	4	1		
<b>SRI Total:</b>		<b>46</b>

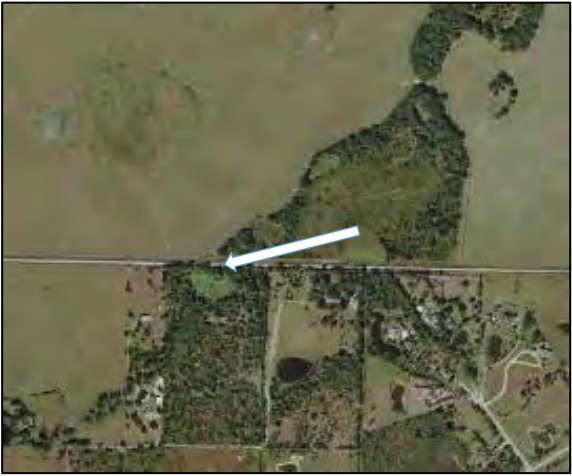
<b>Additonal Site Features</b> Crossing Type and Quantity: Culvert (1) Crossing Material: Corrugated Metal Culvert Outfall Drop: 1 in. Fish Passage Barrier: Present Notes: Pasture upstream and downstream

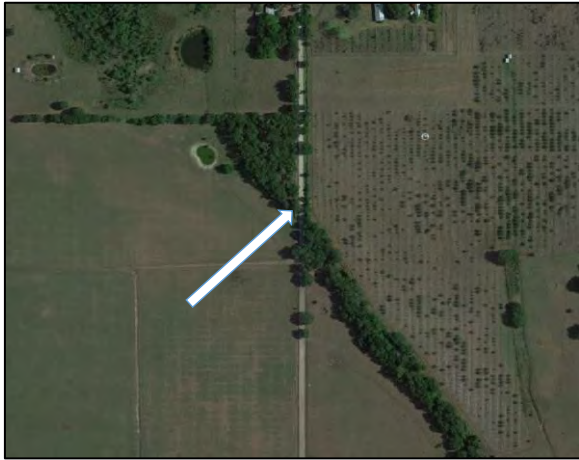
<b>Additonal Site Features</b> Crossing Type and Quantity: Culvert (2) Crossing Material: Corrugated Metal Culvert Outfall Drop: 0 in. Fish Passage Barrier: Not Present Notes: Stream possibly channelized; Stream not flowing at survey, *Additional land owners: BURNETT ROBERT W & RENE GAIL
