Tampa Shoreline Restoration Initiative

[*Shoreline Restoration Masterplan*]

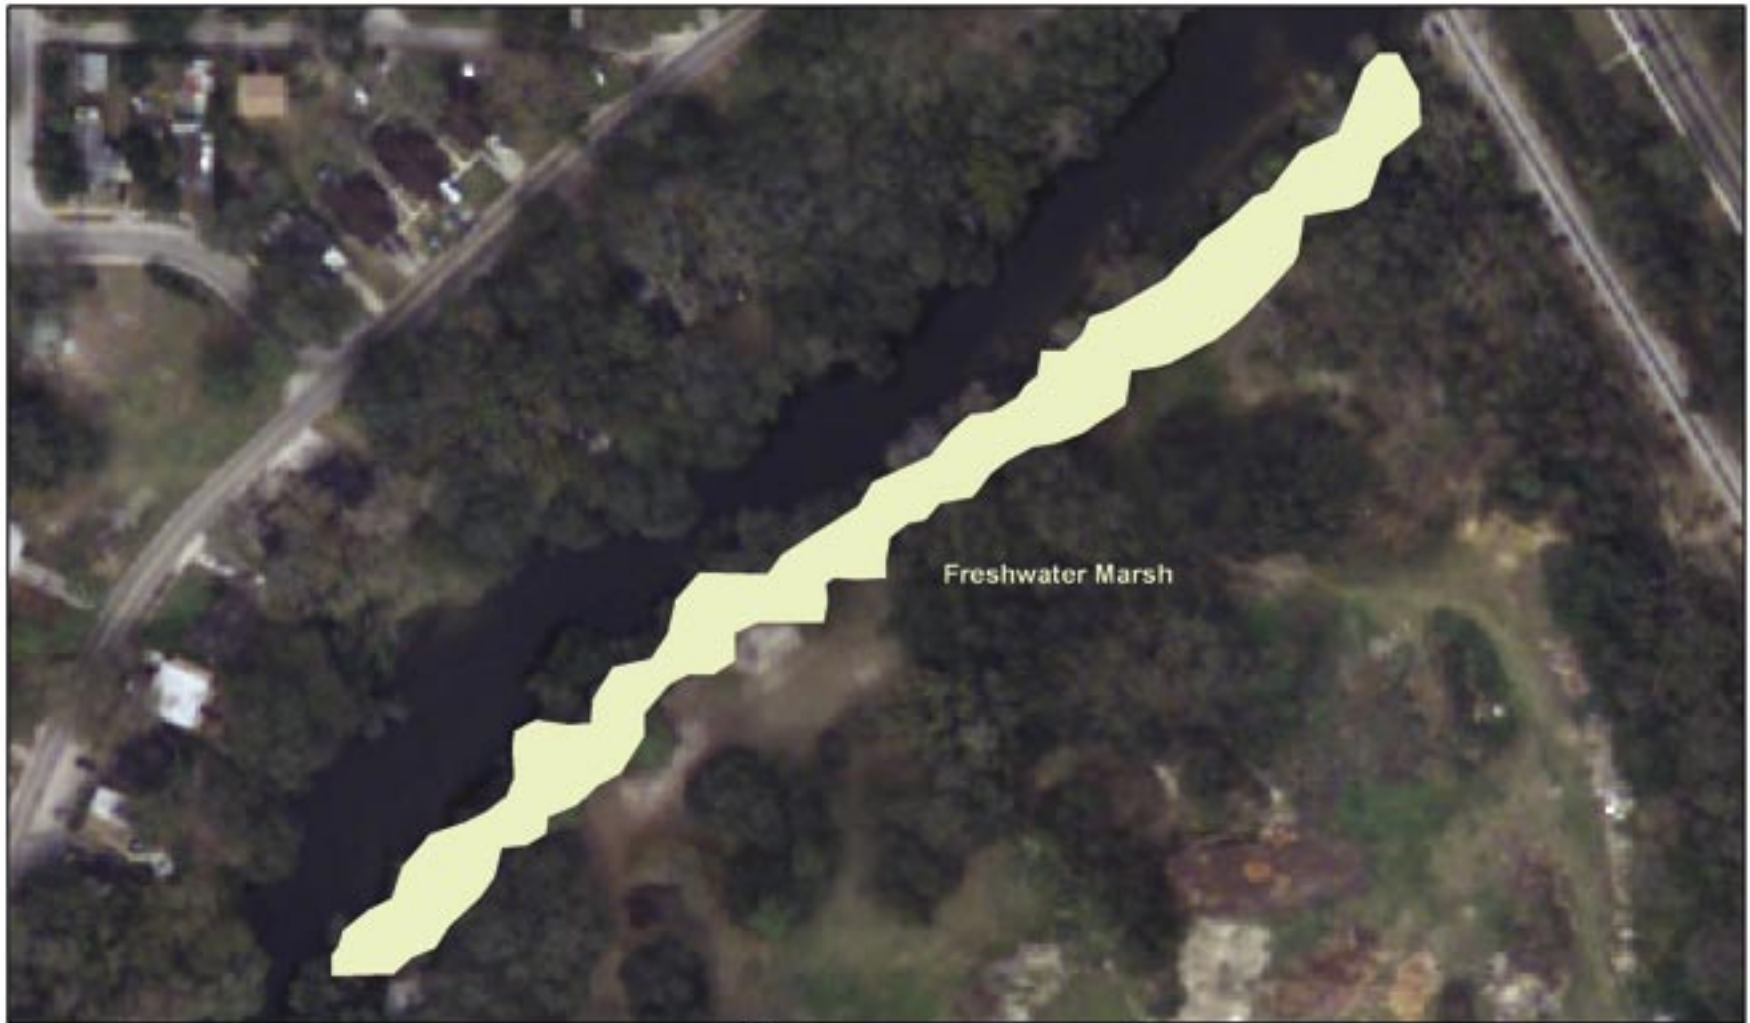
The 22nd Street Park shoreline consists primarily of a freshwater marsh buffer. Several large laurel oaks (*Quercus laurifolia*) and cabbage palms (*Sabal palmetto*) provide canopy along the shoreline, but the cover is not dense enough to classify the entire shoreline as a riparian forest. This system contains approximately 35% cover of nuisance species including: air potato (*Dioscorea bulbifera*), Brazilian pepper (*Schinus terebinthifolius*) and creeping ox-eye (*Vedelia trilobata*). Leather fern (*Acrostichum sp.*) was observed along the waterward edge of this system and, due to the steep slope, is isolated from the surrounding nuisance species. The water level is appropriate, but the shoreline has severely eroded. Due to the steep slope, the extent of the wetland species is limited to the base of the slope, and upland species have colonized the top of the bank. The shoreline provides some habitat for wading birds, amphibians and fish.

Figure 3: Existing shoreline condition of 22nd Street Park.

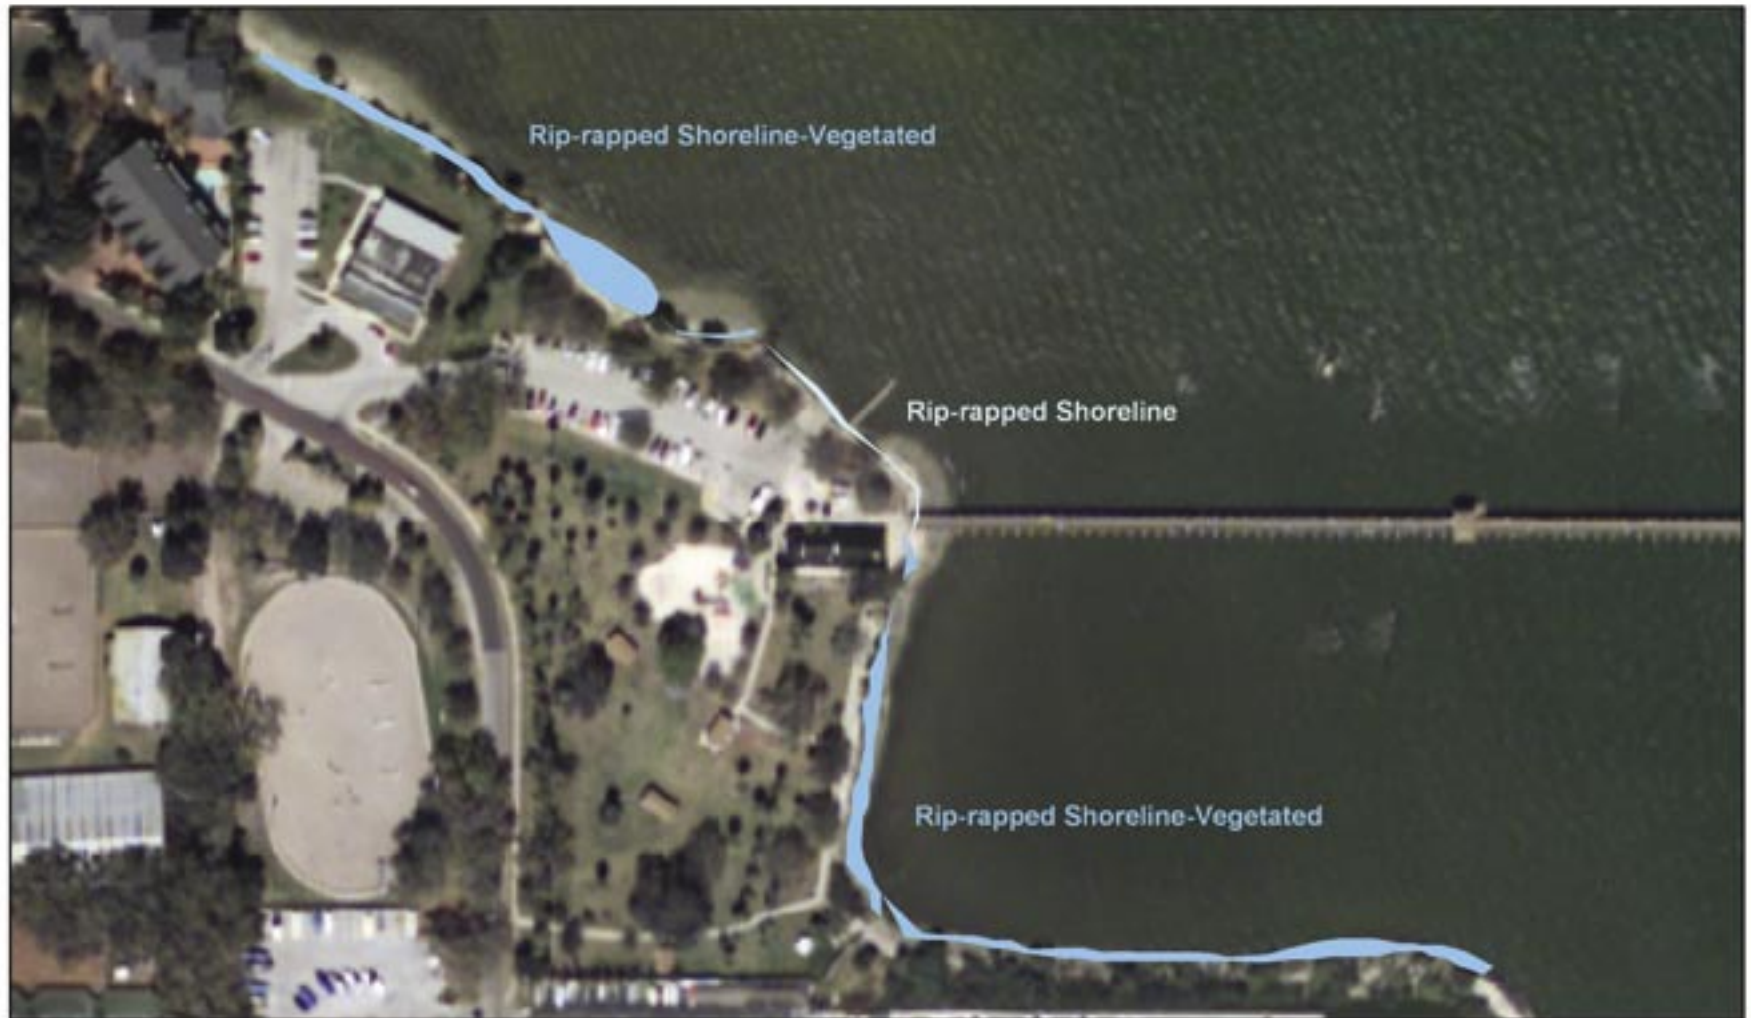
Ballast Point Park

It is evident that a majority of the Ballast Point shoreline has successfully been restored. The entire shoreline has been faced with rip-rap, and vegetation has been planted or colonized in all areas; with the exception of the wall adjacent to the boat ramp and dock (figure 4). A lagoon area has been created through the installation of rip-rap approximately 20 feet waterward of the seawall. This area includes several native species including: smooth cordgrass (*Spartina alterniflora*) and red mangroves (*Rhizophora mangle*). The remaining shoreline has been colonized by red, black and white mangroves (*Avicennia germinans* and *Languncularia racemosa*), and saltbush (*Baccharis halimifolia*). The southern point was not part of the original restoration and contains approximately 10% cover by Brazilian pepper (*Schinus terebinthifolius*). It is anticipated that the overall shoreline provides habitat for wading birds, fish, amphibians and invertebrates.

Figure 5: Existing shoreline condition of Ballast Point Park.

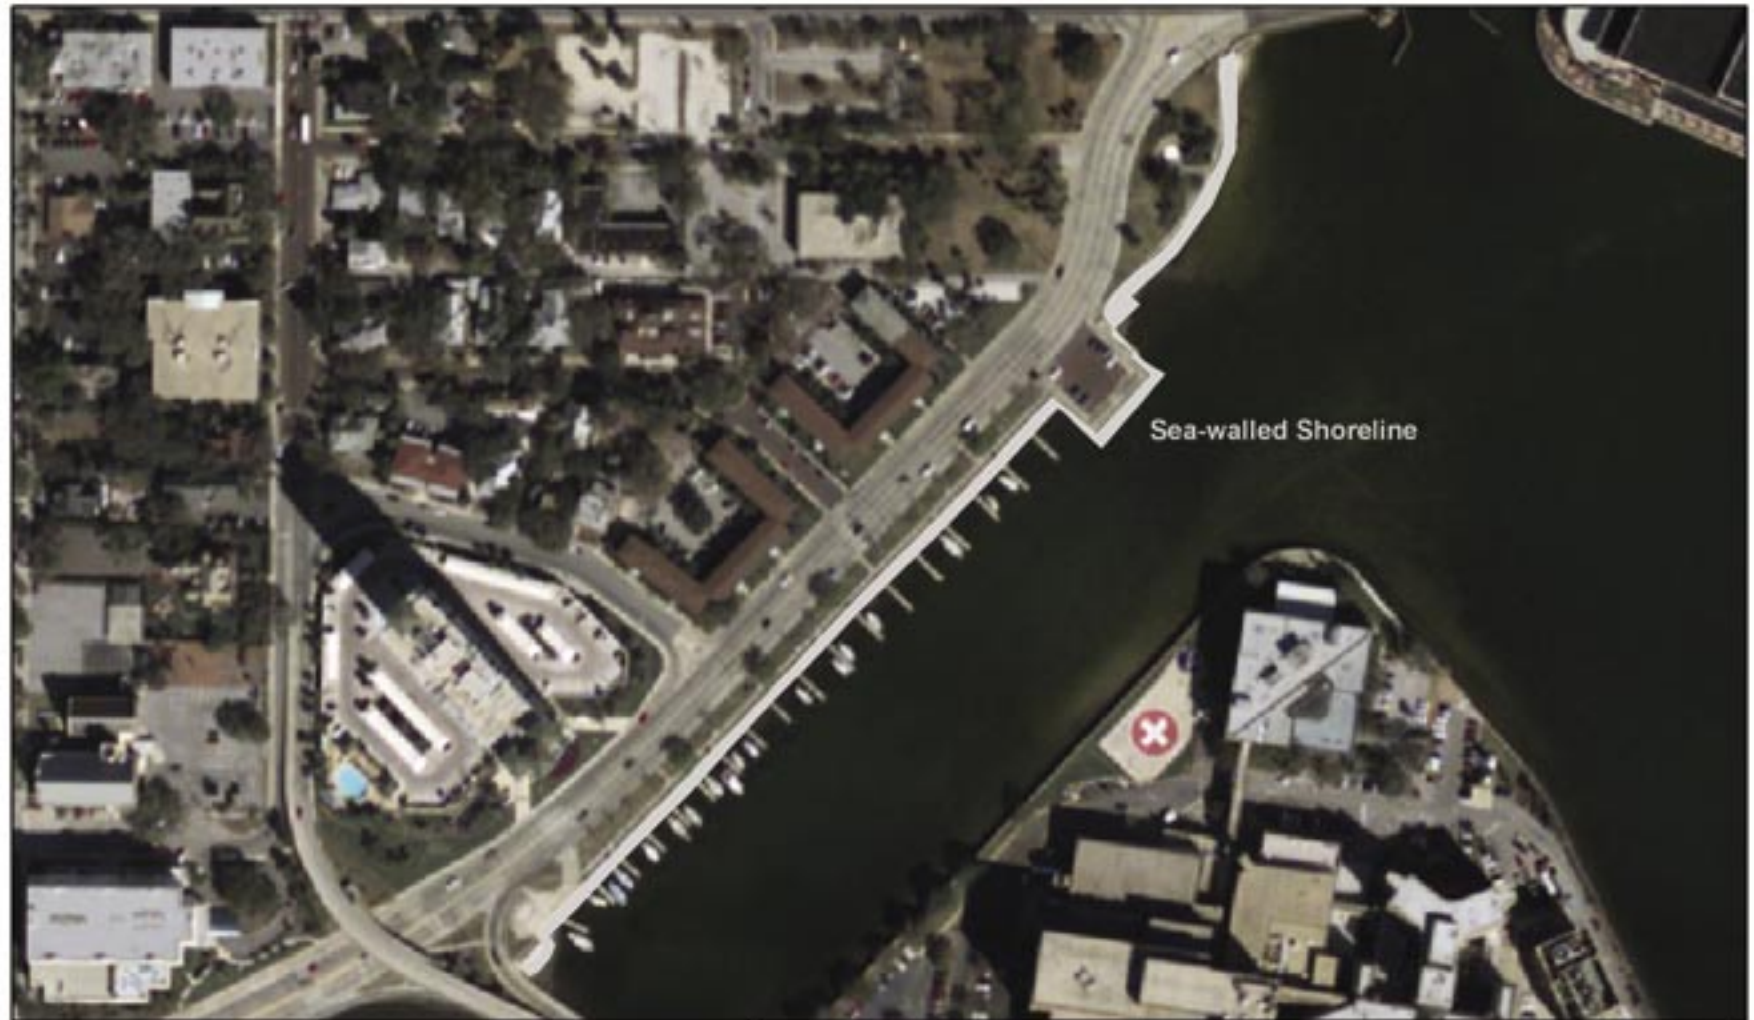
Seawall makes up the entire Bayshore Blvd. Linear Park shoreline (figure 7). The adjoining upland area consists of a concrete footpath and a narrow vegetated buffer that separates the footpath from a busy roadway. This park does not contain any natural area and provides no obvious wildlife support. Finger piers are adjacent to a majority of the shoreline and may preclude the placement of rip-rap along the wall. Litter observed within this park was found floating in the water and therefore would be difficult to retrieve. This park has a low exotic removal rating due to the absence of vegetation, but could benefit from enhancing the shoreline through the placement of rip-rap or reef material waterward of the existing seawall to create habitat for wading birds and fish. Further enhancement would be difficult due to the limited park area. Overall, the habitat quality for the seawall is minimal.

Figure 8: Existing shoreline condition of Bayshore Blvd. Linear Park.

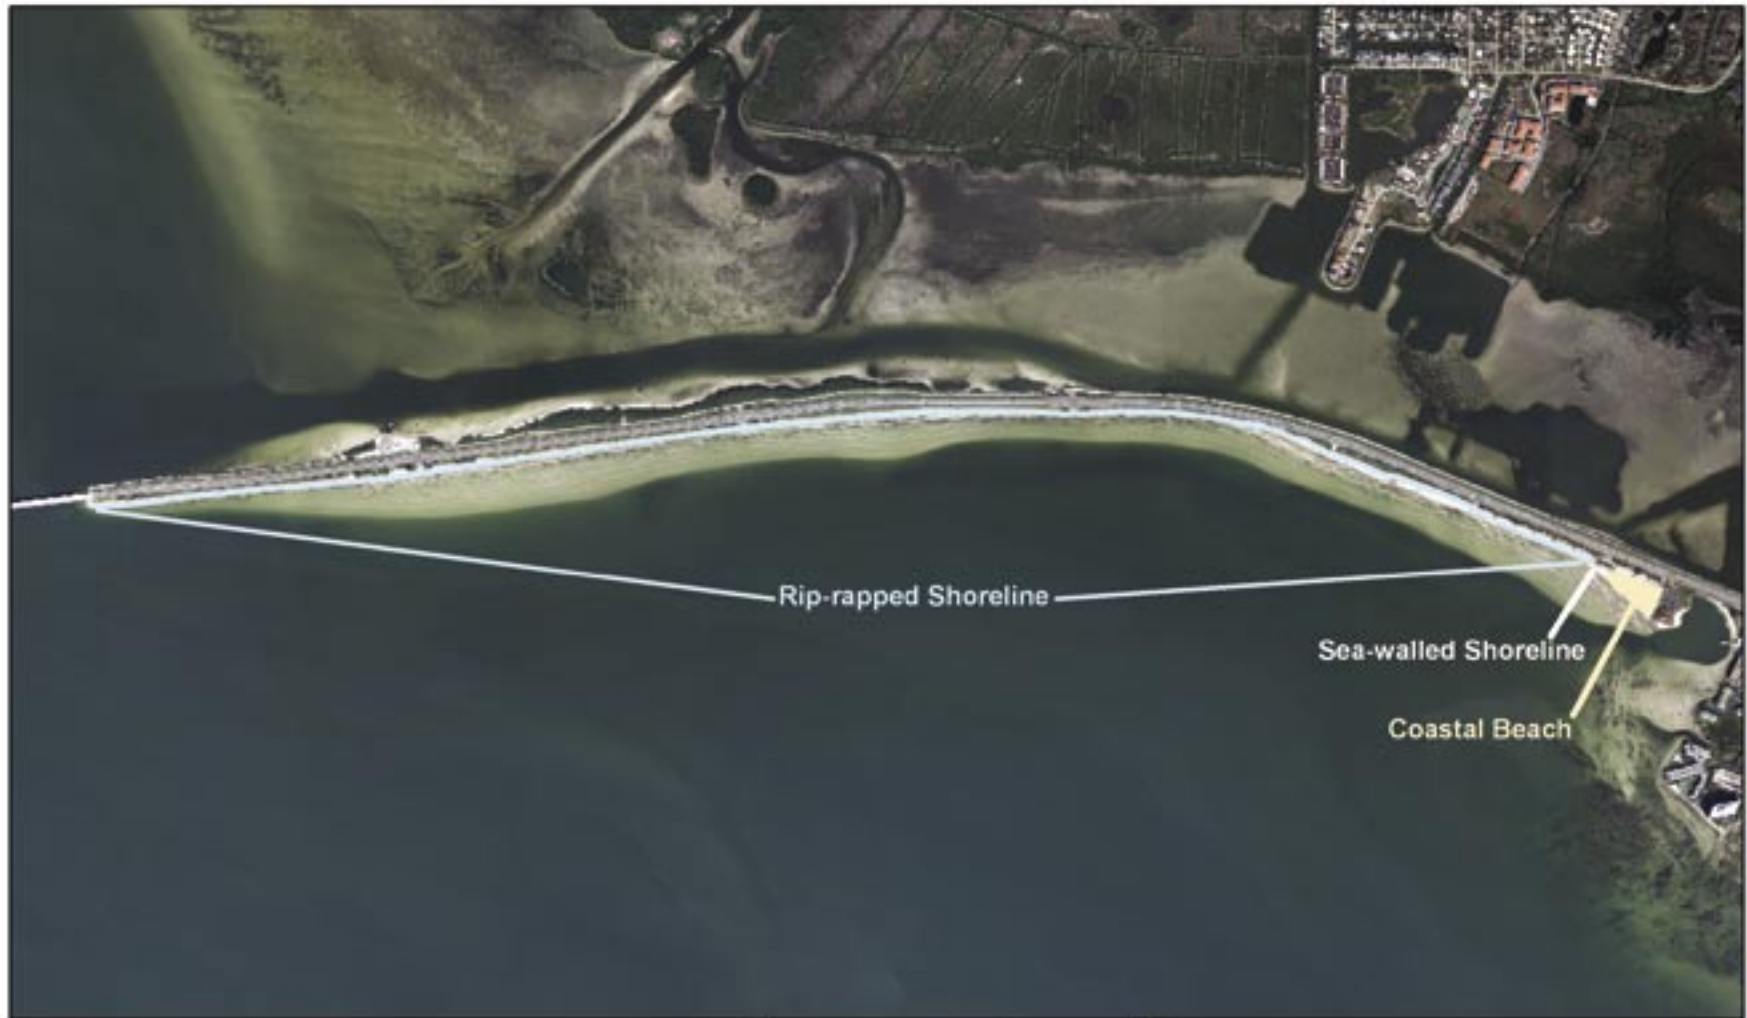
The Ben T. Davis Park shoreline consists primarily of a hardened shoreline with both rip-rap and seawall. The park area includes a public beach, concession stand, parking area and a long access roadway, which is used for recreational fishing along the waterward side of the road. The beach area is isolated but contains a small, vegetated area including both sea oats (*Uniola paniculata*) and railroad vine (*Ipomoea brasiliensis*) (figure 9). The beach area is immediately adjacent to a large commercial building and the park's parking area.

Figure 10: Existing shoreline condition of Ben T. Davis Park.

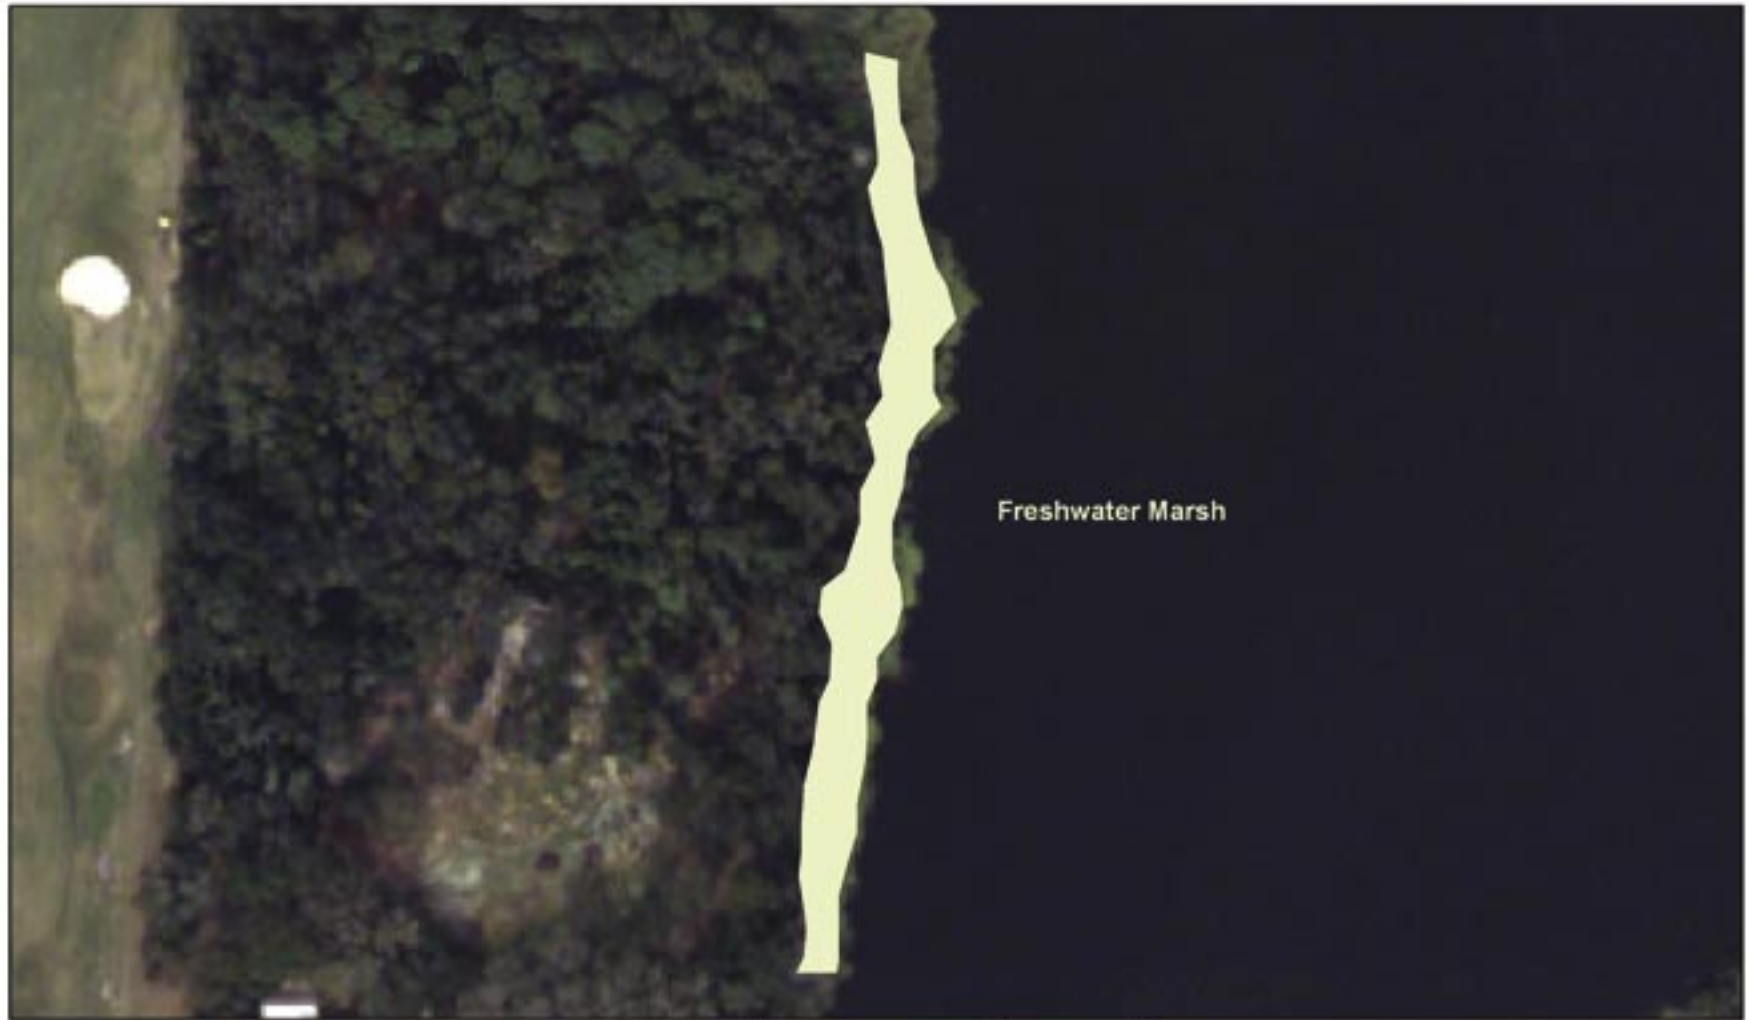
Blackwater Hammock Park was purchased through the Florida Communities Trust in 1997 in conjunction with Hillsborough County's Environmental Land Acquisition and Protection Program (ELAPP). The Blackwater Hammock shoreline consists primarily of a freshwater marsh bordered by a riparian forest. The freshwater marsh consists of a large percentage of exotics including: wild taro (*Colocasia esculenta*), water hyacinth (*Eichhornia crassipes*), and cattails (*Typha sp.*). The marsh also contained less dominant exotics such as: paragrass (*Brachiaria mutica*) and water lettuce (*Pistia stratiotes*) (figure 11). This system transitions into a more forested system that includes: cypress (*Taxodium distichum*), Carolina willow (*Salix caroliniana*), cinnamon fern (*Osmunda cinnamomea*) and laurel oak (*Quercus laurifolia*). Overall approximately 50% of the shoreline consisted of nuisance species. The slope of the shoreline is gradual and it appears that the vegetation is providing habitat for fish, wading birds and amphibians.

Figure 12: Existing shoreline condition of Blackwater Hammock Park.

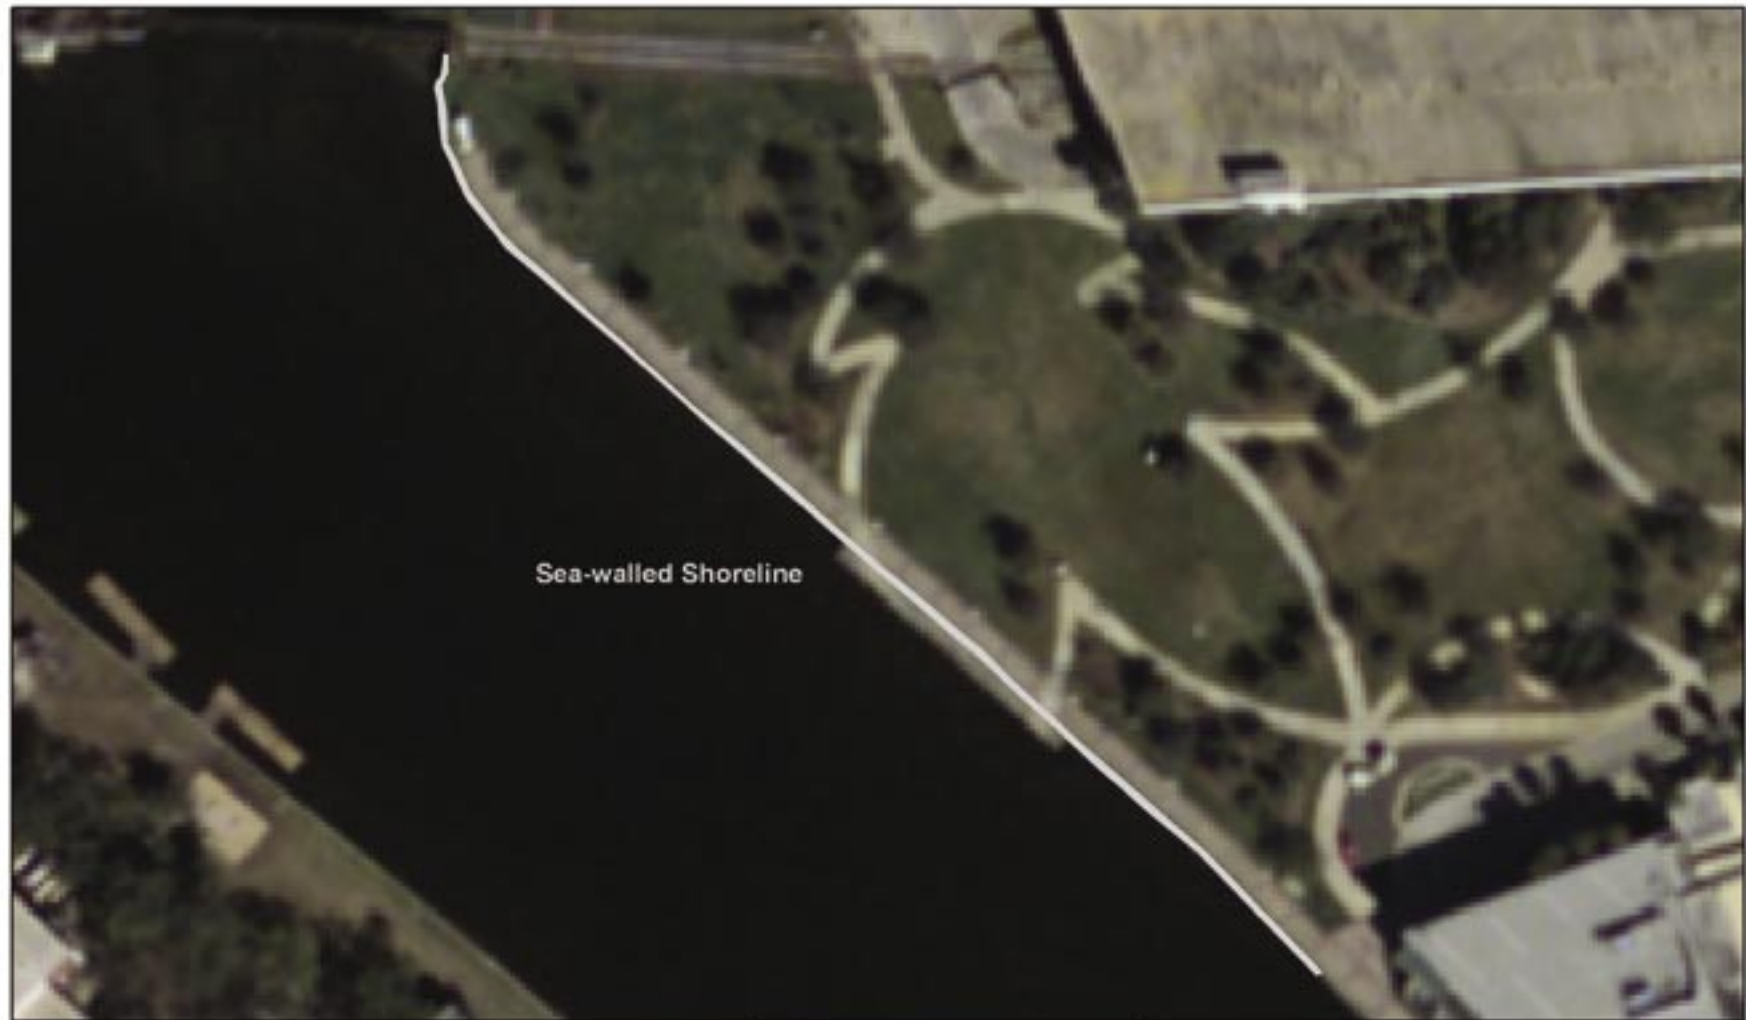
The entire Curtis Hixon Park shoreline is sea-walled (figure 14). In addition, the area will be undergoing major reconstruction which, at this time, plans indicate that the shoreline will remain the same. The park is located adjacent to the Hillsborough River as an upland urban park. This shoreline provides no significant habitat value for wildlife that would be found utilizing the adjacent river. The assessment area immediately upland of the seawall is a wide concrete pedestrian path. In addition, the park and river are located in a highly urbanized area. The adjacent upland park is maintained as a grassed area with scattered oaks. The park is highly visible and in an urban area with high usage. Therefore, it would be highly beneficial to restore the shoreline by installing rip-rap or reef material along the seawall. Similar plans have been considered by the City of Seattle in the Terminal 46 Area (Landscape Northwest 2004).

Figure 15: Existing shoreline condition of Curtis Hixon Park.

- Short Term:** Determine if existing plans for reconstruction could incorporate unique shoreline features such as habitat shelves.
- Long Term:** Pursue funding in conjunction with the City of Tampa, SWFMWD, and or Tampa Bay Watch to install rip-rap, habitat shelves, or reef balls adjacent to the wall to serve as a demonstration project.

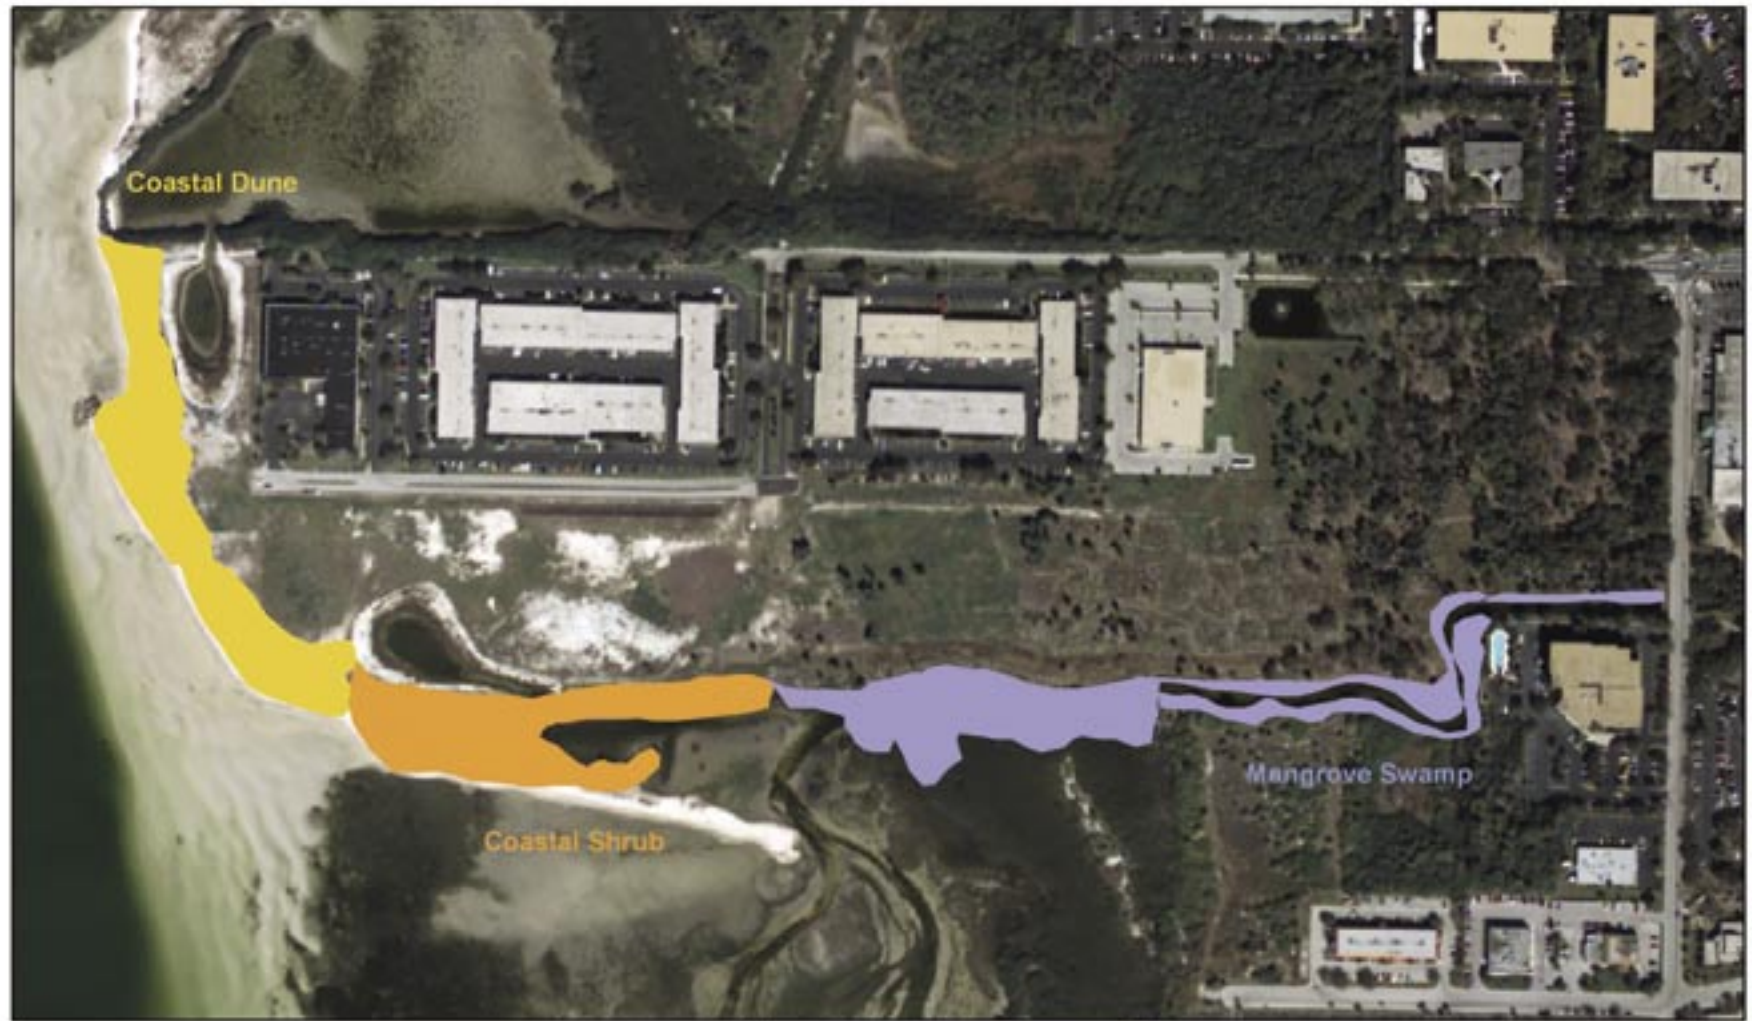
The Cypress Point Park shoreline is a diverse mixture of habitats including: mangrove fringe, coastal dunes and coastal shrub. Although this park is narrow, the shoreline provides a significant amount of natural habitat and wildlife support. The coastal dune system contains several native species including: sea-oats (*Uniola paniculata*), cucumber leaved sunflower (*Helianthus angustifolius*), sand cord grass (*Spartina bakeri*), love grass (*Eragrostis sp.*), railroad vine (*Ipomea brasiliensis*) and fingergrass (*Eustachys petraea*) (figure 16). The dune system experienced some erosion during the 2004 hurricane season, creating several steep ledges. The coastal shrub system also contains a variety of native species including: finger grass, buttonwood (*Conocarpus erectus*), seashore elder (*Iva imbricata*), and black and white mangroves (*Languncularia racemosa* and *Avicennia germinans*). The coastal shrub blends into and becomes a pure mangrove fringe on the western edge of the park. This mangrove fringe contains a healthy stand of red (*Rhizophora mangle*), black and white mangrove fringe, which are diverse in both species and size distribution. Saltgrass (*Distichlis spicata*) forms a dense cover waterward of the fringe within the shallow areas. This combination of habitats provides wildlife support for fish, wading and shore birds, amphibians and invertebrates. The hydrology is normal for this type of system and is supporting appropriate vegetation.

Figure 17: Existing shoreline condition of Cypress Point Park.

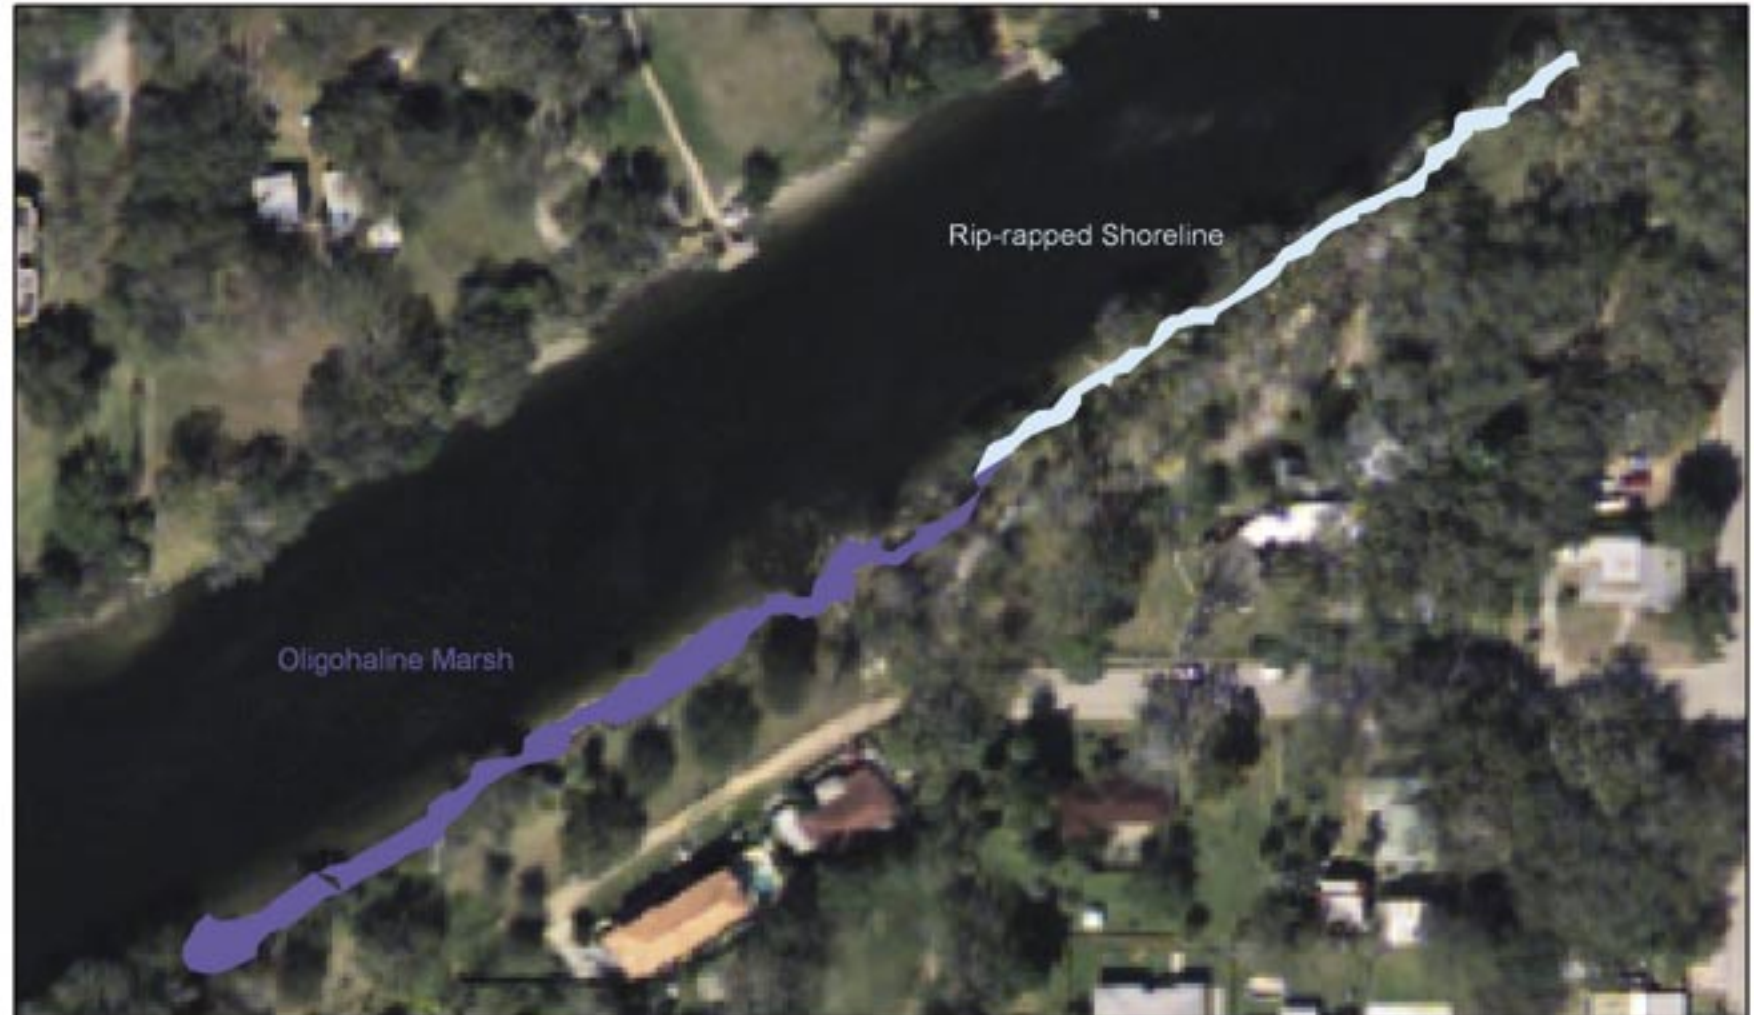
The Epps Park shoreline consists primarily of an oligohaline riparian buffer with scattered lengths of rip-rap (figure 23). This system consists of a variety of native species including: cypress (*Taxodium distichum*), laurel oak (*Quercus laurifolia*), leather fern (*Acrostichum sp.*), sand cord grass (*Spartina bakeri*), maidencane (*Panicum hemitomon*), wax myrtle (*Myrica cerifera*), needle rush (*Juncus roemerianus*) and arrowhead (*Sagittaria sp.*). Nuisance species along the shoreline include: torpedo grass (*Panicum repens*), creeping ox-eye (*Wedelia trilobata*) and cattails (*Typha sp.*). The entire shoreline is rip-rapped but the vegetation is covering all but the most waterward rocks.

Figure 24: Existing shoreline condition of Epps Park.

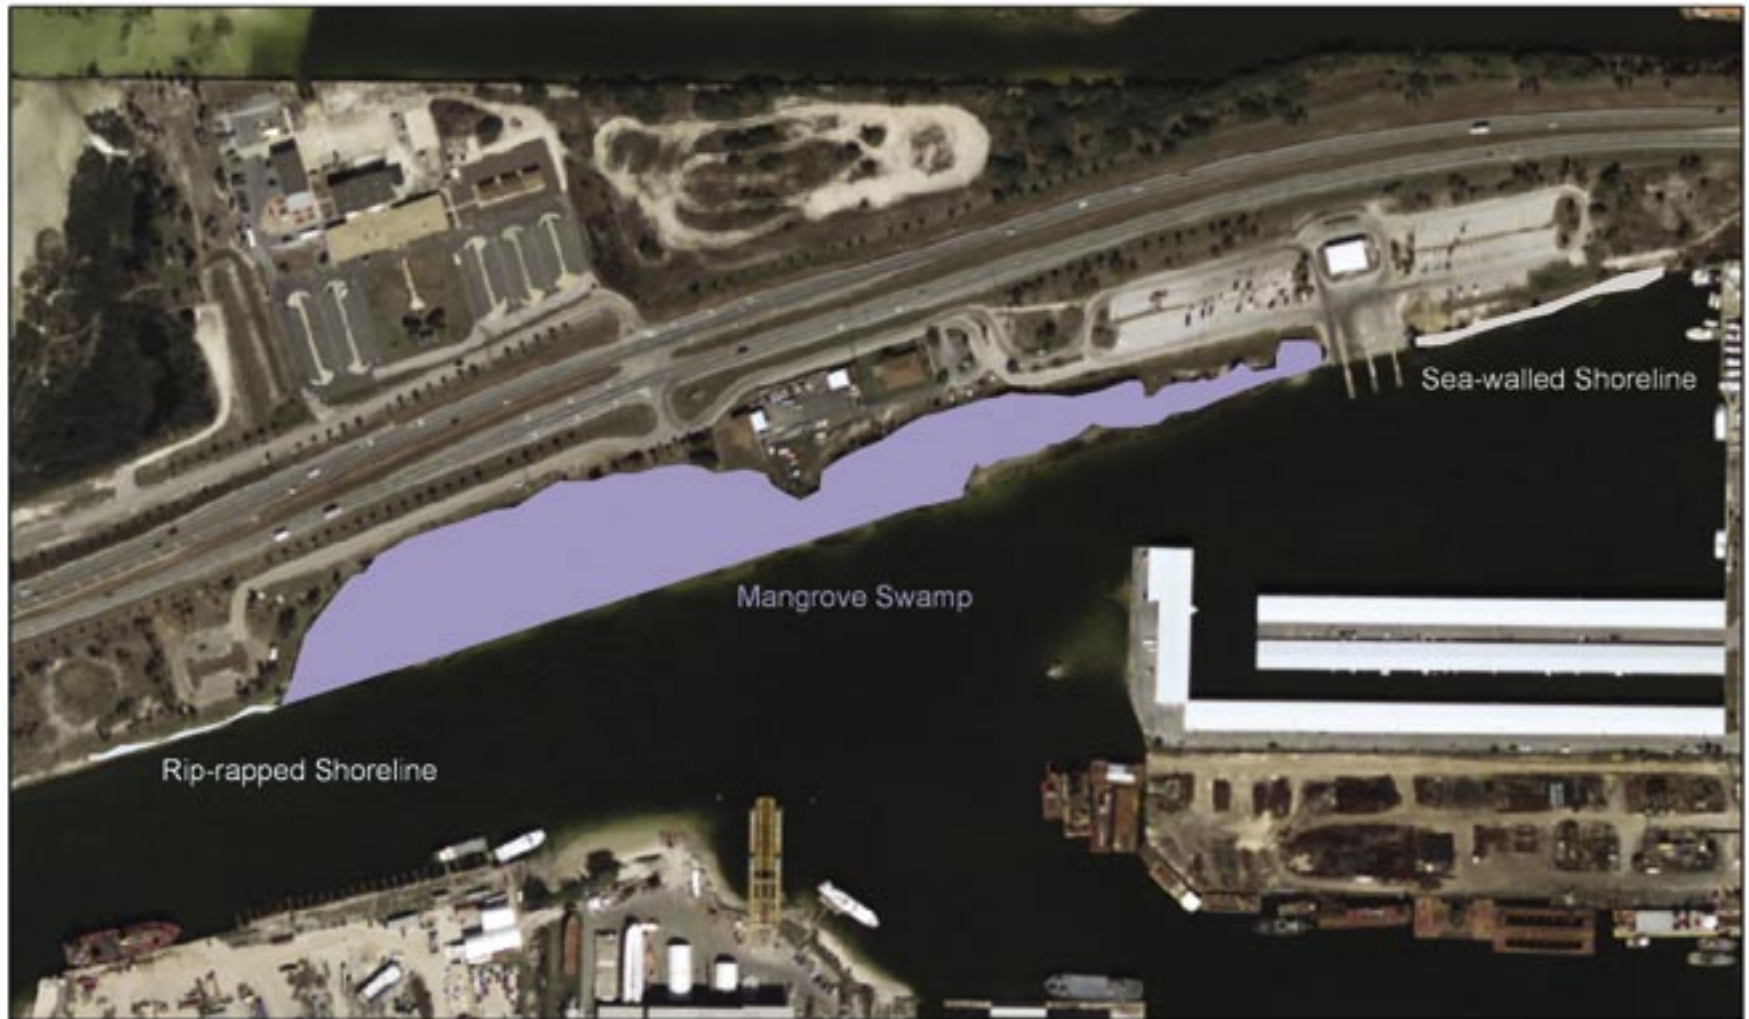
Portions of the Gandy Park shoreline were previously restored through a cooperative project with the SWIM program and the City of Tampa. The majority of the shoreline was historically sea-walled, but now consists primarily of a mangrove fringe. The western end of the park consists of a steep rip-rap and "mac block" shoreline for shoreline protection of the Gandy Bridge approach (figure 28). This area has very little vegetative cover due to the hardened shoreline and higher wave energy due to boat wakes and wave exposure from the open bay. Vegetation along the shoreline includes: black mangroves (*Avicennia germinans*), saltbush (*Baccharis halimifolia*) and morning-glory (*Ipomea brasiliensis*). The majority of the shoreline is a dense, healthy mangrove fringe. Remnant portions of the seawall, which were cut or breached, still exist in several areas—the breaches allow for tidal exchange with the bay. The mangrove fringe contains a variety of native species including: red, white, and black mangroves, saltbush and flat-topped goldenrod (*Euthamia minor*). On the landward edge of the fringe, scattered cabbage palms (*Sabal palmetto*) and laurel oaks (*Quercus laurifolia*) occur. Approximately 20% of the fringe has been recolonized by exotic/nuisance vegetation including mimosa (*Acacia sp.*) and Brazilian pepper (*Schinus terebinthifolius*). Within the mangrove fringe is a small, tidally influenced, open water area. The mangrove fringe is healthy and diverse in size and species. The exotics appear to be limited primarily to the landward edge of the fringe.

Figure 29: Existing shoreline condition of Gandy Park.

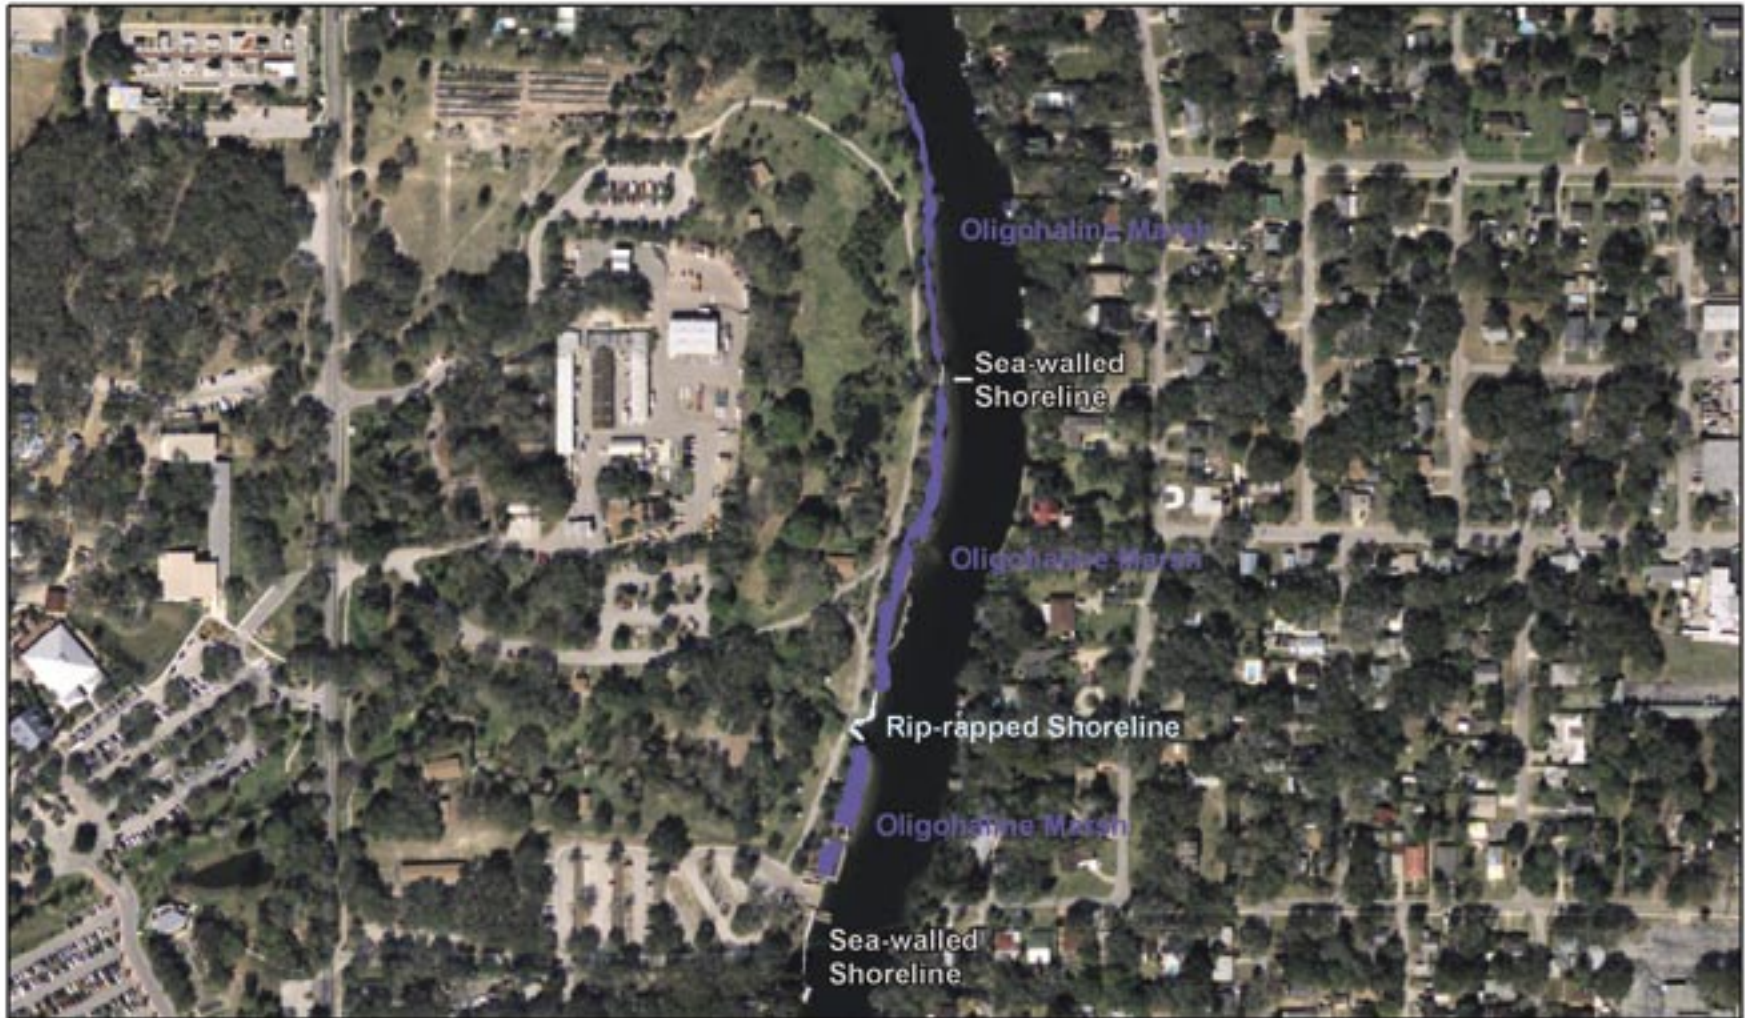
The Lowry Park shoreline consists primarily of a restored oligohaline riparian buffer (figure 33). This system consists of a variety of native species including: leather fern (*Acrostichum sp.*), wax myrtle (*Myrica cerifera*), bulrush (*Scirpus sp.*), saltbush (*Baccharis halimifolia*), sand cord grass (*Spartina bakeri*), cypress (*Taxodium distichum*), red maple (*Acer rubrum*) and several other beneficial species. Within the marsh habitat, approximately 20% of the cover consisted of exotic or invasive species including torpedo grass (*Panicum repens*) and cattails (*Typha sp.*). Adjacent to the seawall and rip-rap, the percent cover of cattails (*Typha sp.*) was approximately 15%. Overall, the native species are large and dominant and it does not appear that the exotic species are becoming a nuisance. The slope of the shoreline is shallow and there is no evidence of litter.

Figure 34: Existing shoreline condition of Lowry Park.

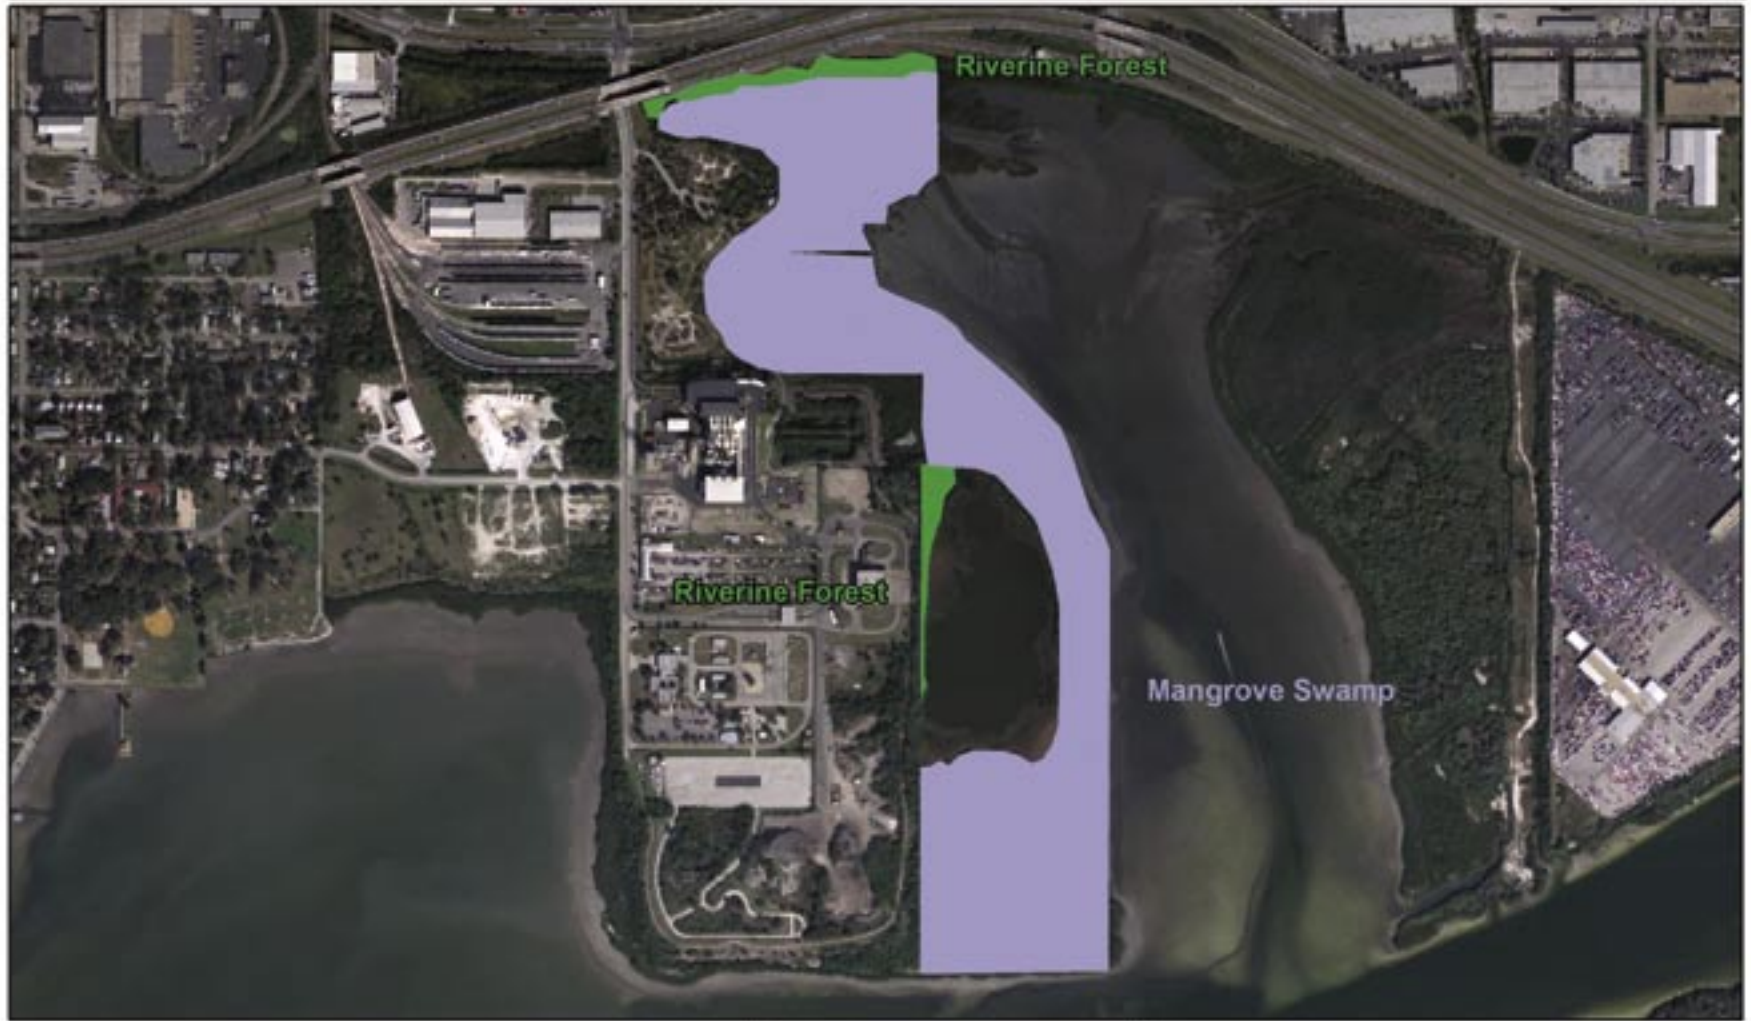
The McKay Bay Nature Park shoreline can be broken into two polygons. A large portion of the shoreline is a healthy, wide mangrove fringe (figure 36). The remaining shoreline is riverine forest that contains 40% nuisance species. The shoreline is narrow and adjacent to a narrow access road that runs between the park and a recycling plant. The shoreline is very steep and the vegetation is stratified. *Mimosa* (*Albizia julibrissin*) occurs on the landward edge of the fringe. Within the fringe is a mixture of mimosa and Brazilian pepper (*Schinus terebinthifolius*), and red and white mangroves (*Rhizophora mangle* and *Languncularia racemosa*) occur on the waterward edge. This habitat is adjacent to the bay, which allows for movement in and out of the system. It is anticipated that this shoreline supports wading birds, fish, and invertebrate species. Due to the close proximity of the recycling plant, there is little supporting habitat landward of the fringe. Overall, due to the low level of nuisance species cover (2%) within this system, it has a low exotic removal priority rating.

Figure 37: Existing shoreline condition of McKay Bay Nature Park.
