Tampa Shoreline Restoration Initiative

[*Shoreline Restoration Masterplan*]

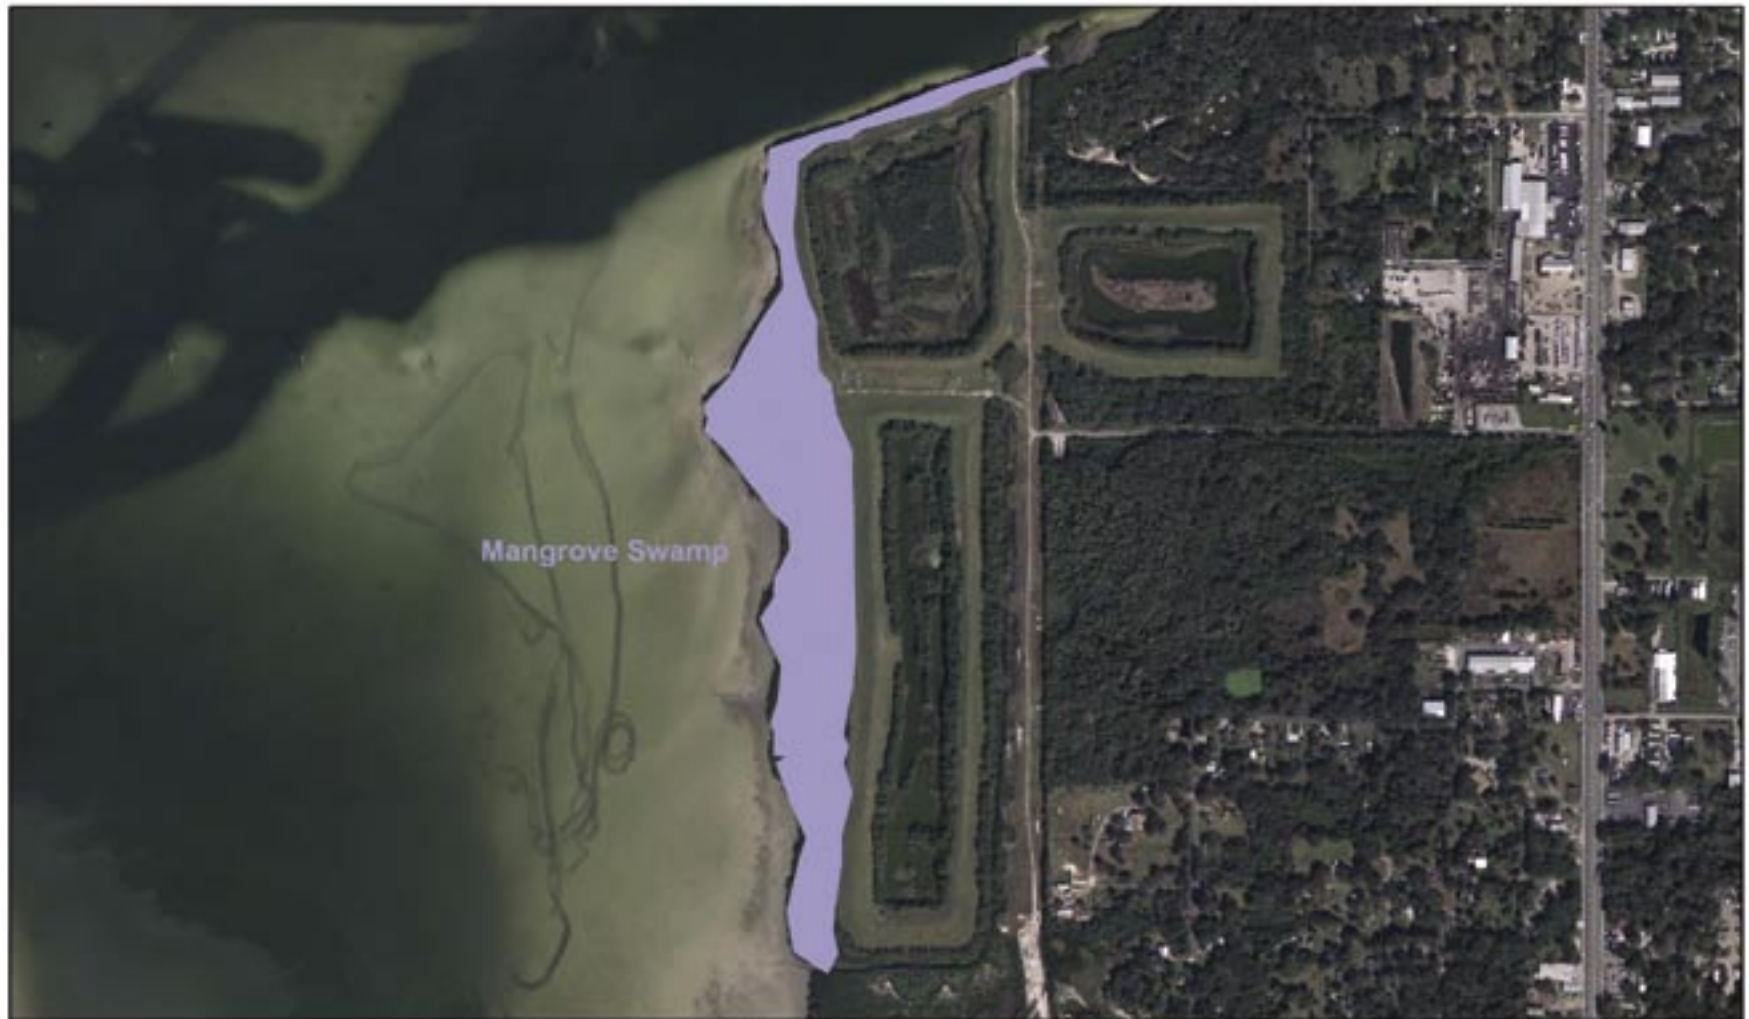
Palm River Park (McKay Bay Bike Trail)

The McKay Bay Bike Trail Park was assessed as a substitution for Palm River Park, which is not located on the river. McKay Bay Bike Trail is located on McKay Bay directly outside the mouth of the Palm River (figure 39). The entire shoreline is a mangrove fringe containing both red and white mangroves (*Rhizophora mangle* and *Languncularia racemosa*) along the waterward edge of the fringe. The fringe contains approximately 50% exotic species, 40% of which is mimosa (*Albizia julibrissin*). The mimosa is limited to the landward edge of the fringe. The shoreline is steep and there are signs of erosion.

Figure 40: Existing shoreline condition of Palm River Park (McKay Bay Bike Trail).

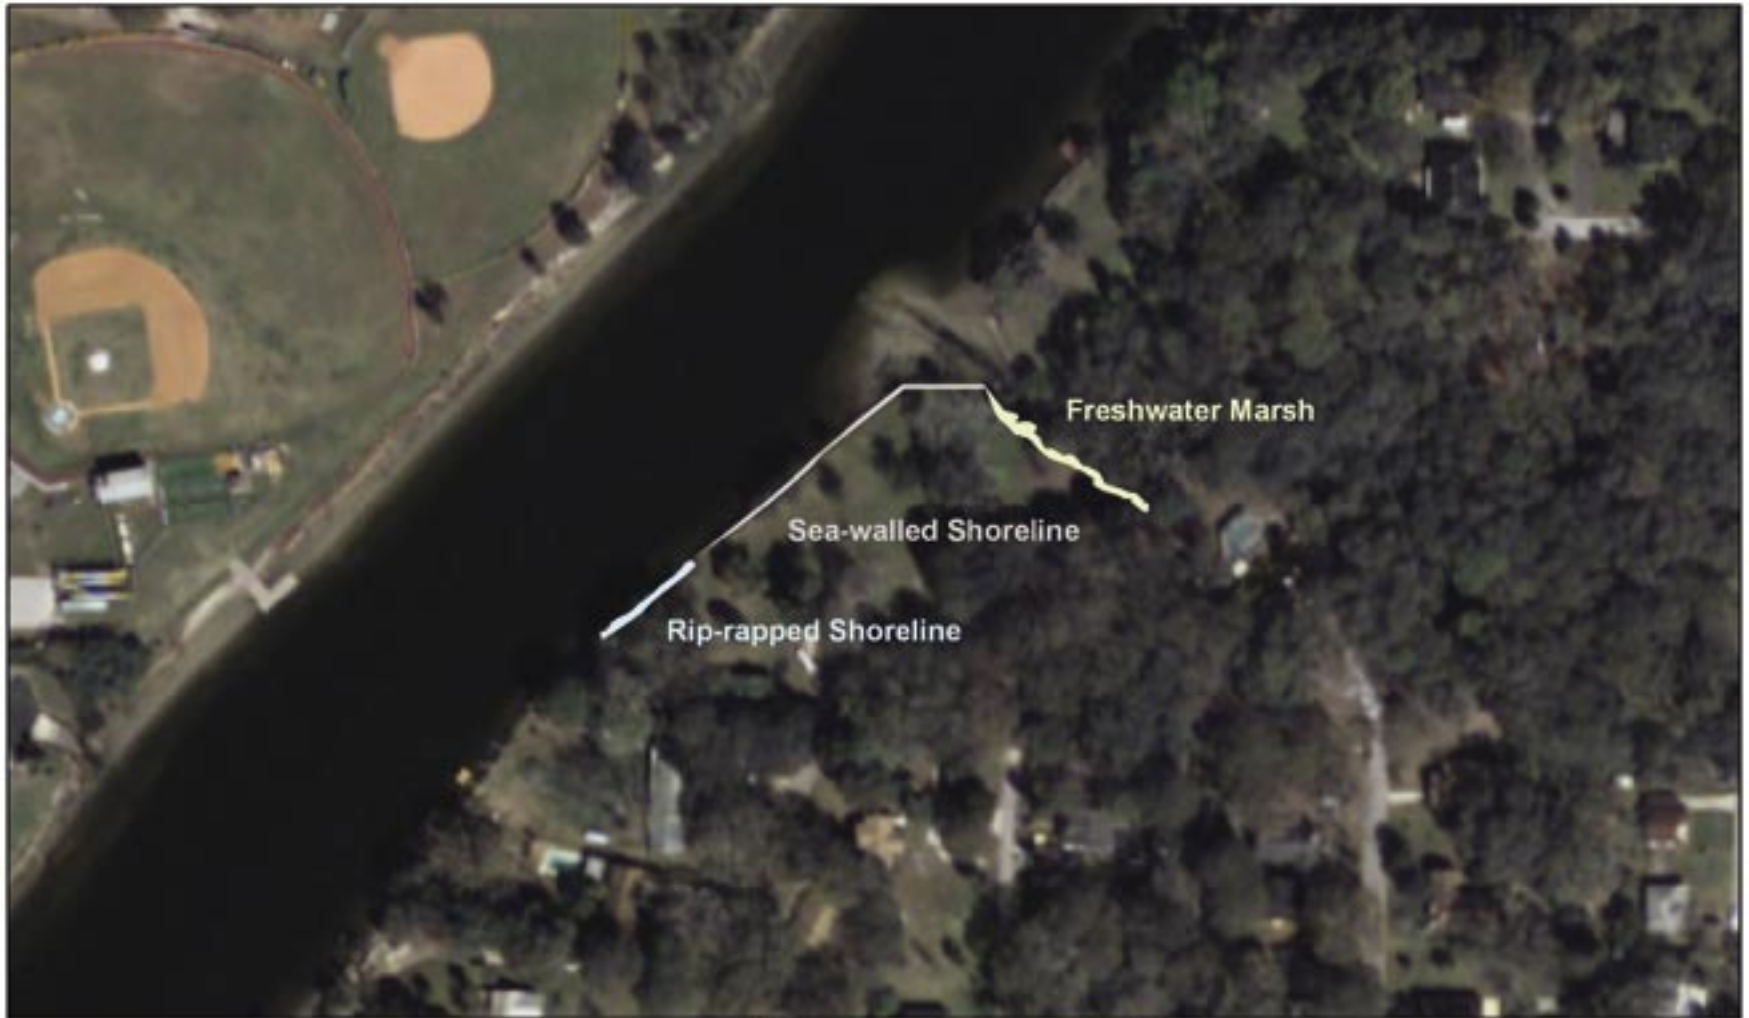
The Reed Property shoreline consists of a mixture of freshwater marsh, seawall and rip-rapped shoreline (figure 44). The seawall has been compromised in several areas and has caused erosion to occur landward of the wall. Due to recent heavy rain events, water has pooled landward of the wall. Vegetation within this area is limited to the uplands landward of the wall and includes: laurel oaks (*Quercus laurifolia*), bahia and St. Augustine grass (*Paspalum notatum* and *Stenotaphrum secundatum*). A portion of the seawall is rip-rapped, and some cattails (*Typha sp.*) are growing waterward of the rocks. The freshwater marsh is primarily covered by nuisance and/or exotic species including: cattails (*Typha sp.*), Brazilian pepper (*Schinus terebinthifolius*) and the less dominant creeping ox-eye (*Wedelia trilobata*). It is anticipated that the shoreline provides some habitat for fish, amphibians and wading birds. The river level was normal for this time of the year, and is supporting the plant species within this habitat. However, the seawall is precluding the water from influencing the entire shoreline. The shoreline is eroding behind the seawall and along a portion of the freshwater marsh.

Figure 45: Existing shoreline condition of Reed Property.

Long Term: 1) Use volunteers to remove exotic species and ongoing maintenance once construction is complete. 2) Monitoring of shoreline condition once restoration is complete.

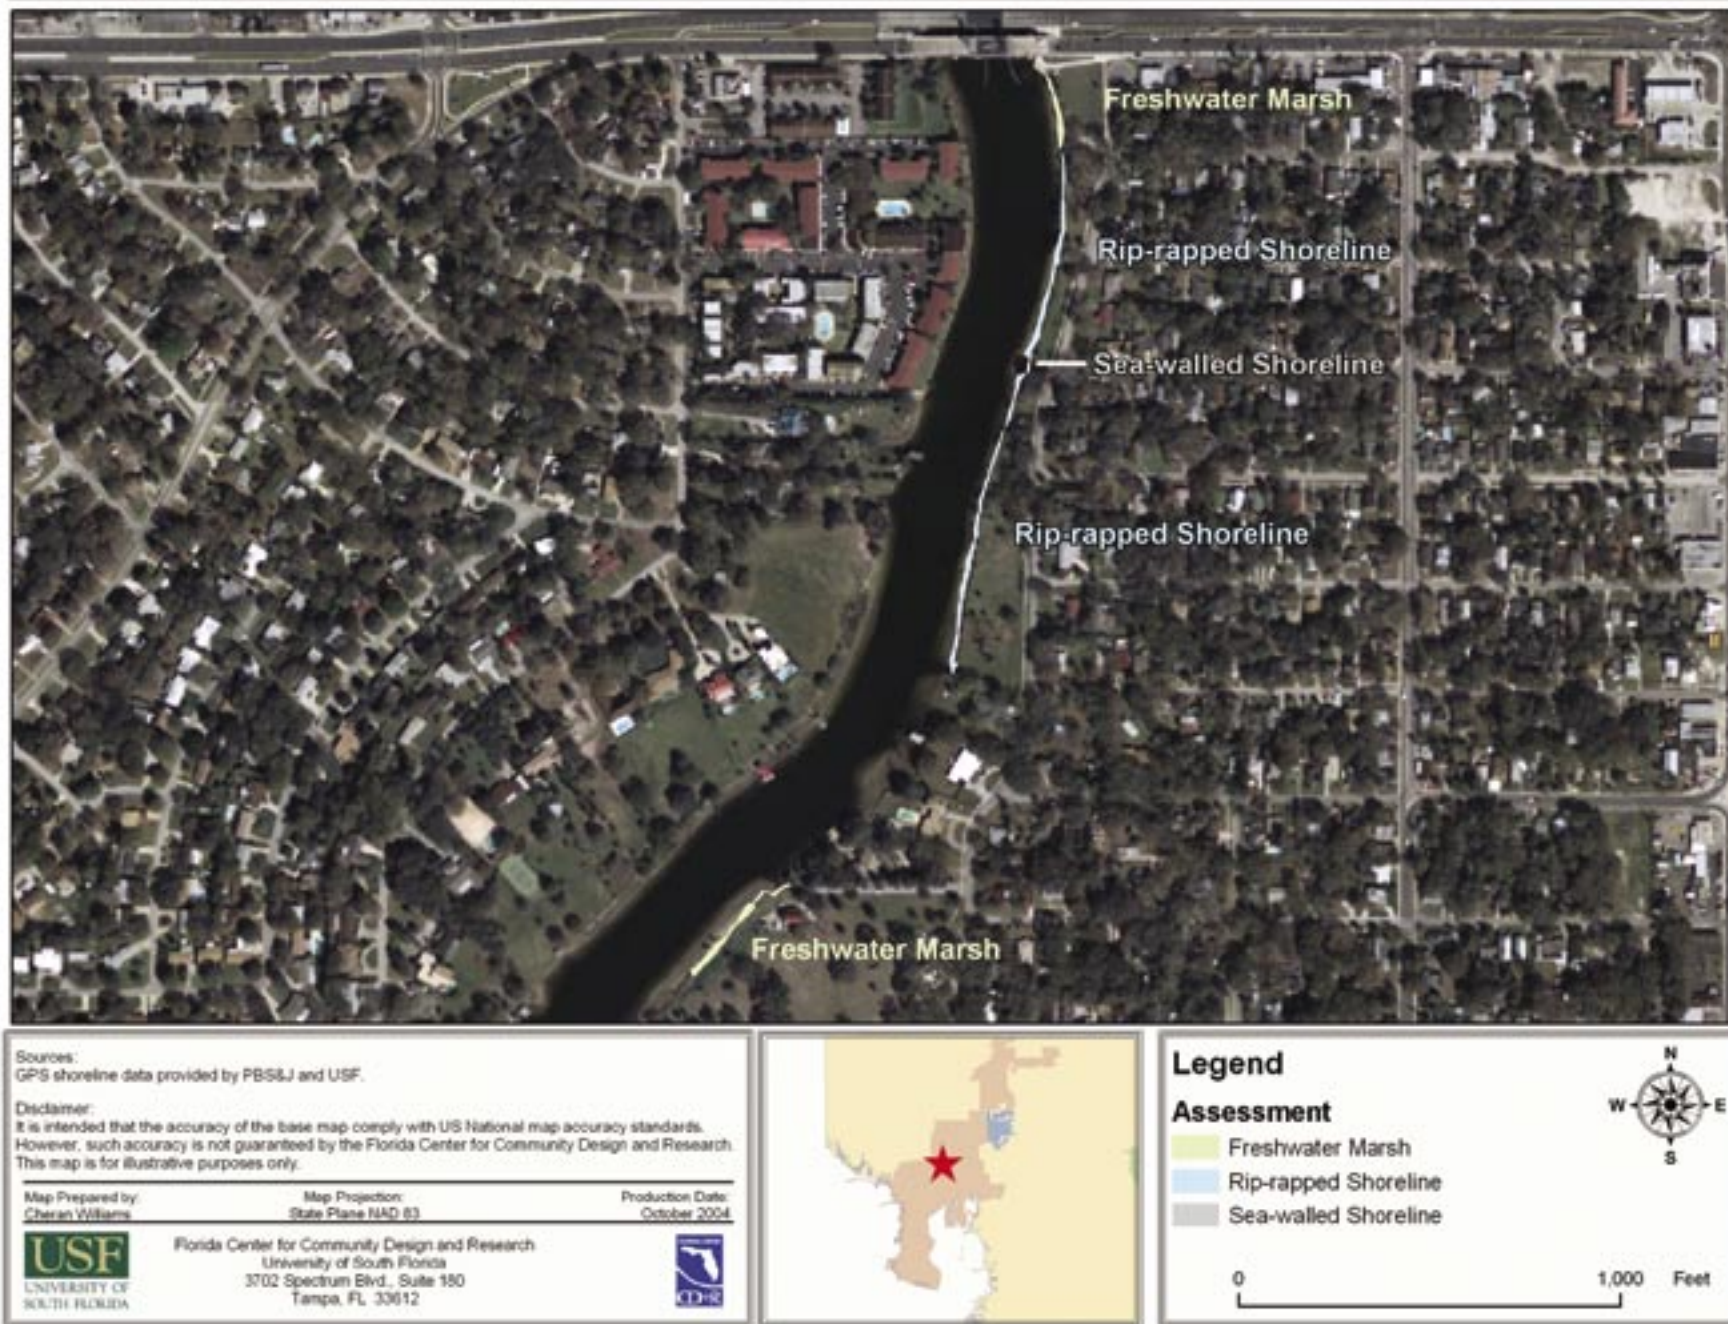
Rivercrest Park

Although a portion of this park has been restored, it has a high exotic removal priority rating due to the large percentage of nuisance species encroaching from the landward edge. It is recommended that the exotics species be cleared from this area and the landward edge be replanted to avoid further encroachment.

Figure 53: Existing shoreline condition of Rivercrest Park.

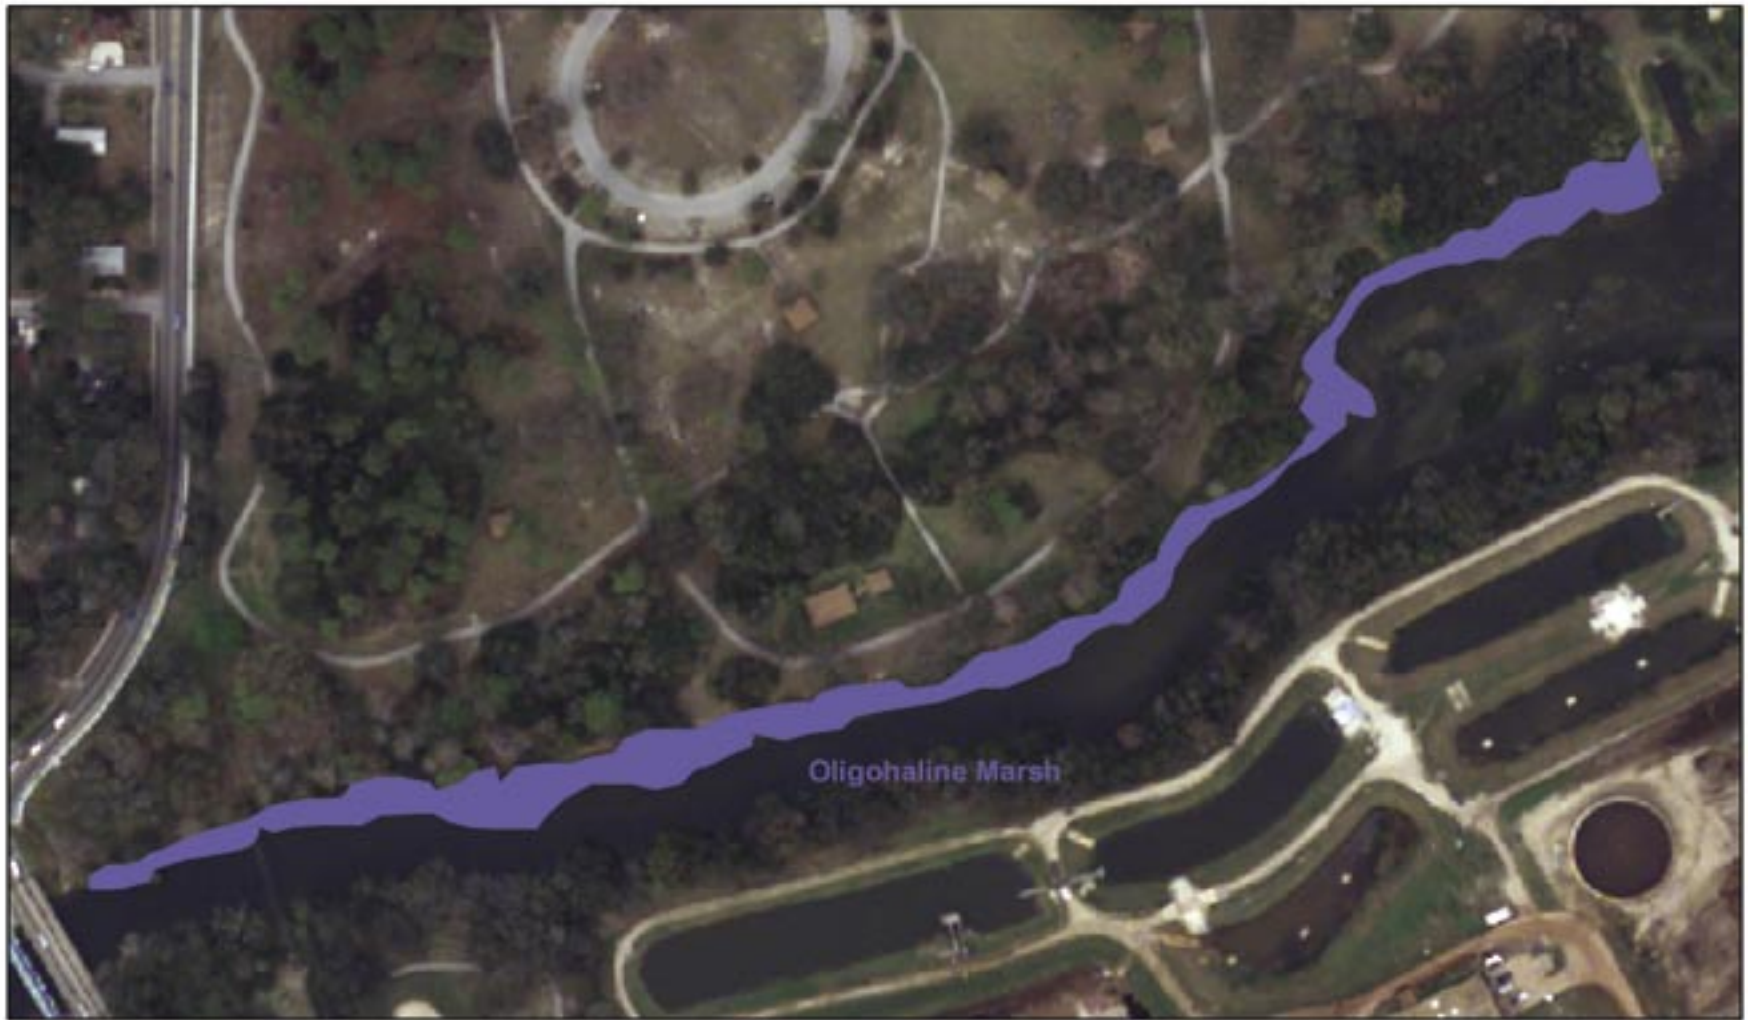
The Rowlett Park shoreline consists primarily of an oligohaline marsh and riparian buffer with some scattered tree cover (figure 61). This shoreline consists of a variety of native species including: Carolina willow (*Salix caroliniana*), laurel oak (*Quercus laurifolia*), cabbage palm (*Sabal palmetto*), leather fern (*Acrostichum* sp) and elderberry (*Sambucus canadensis*). Approximately 45% of this site consists of nuisance species including air potato (*Dioscorea bulbifera*), cattails (*Typha* sp.) and creeping ox-eye (*Wedelia trilobata*). In addition, there is some encroachment of less dominant nuisance species including Caesar weed (*Urena lobata*) and white beggar-ticks (*Bidens pilosa*). The shoreline width varies between 20 to 100 feet wide and has a shallow slope.

Figure 62: Existing shoreline condition of Rowlett Park.
