# Hollin Creek

Anclore Watershed

WBID 1475

February 1, 2011

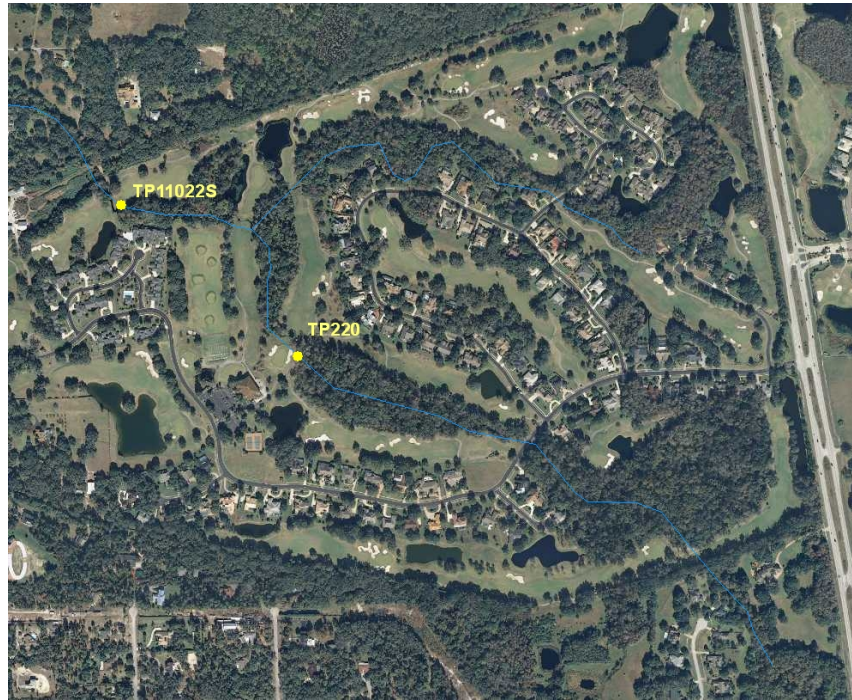
Figure 2. Location of sites in Hollin Creek

Two sites in Hollin Creek were sampled on 2/01/11 (Figure 2). At the downstream site (TP11022S, Figure 3), the creek is a second order, sandy bottom stream with a water velocity of 0.33 m/sec. The in-stream habitat in Hollin Creek at this location was predominantly sandy bottom with 8% substrate available for invertebrate and fish use (snags, roots, and leaves). The Habitat Assessment (HA) score was 117, which is on the high end of the suboptimal habitat category. Despite the adjacent residential development, the Creek has not been channelized and exhibited natural morphology. The wooded riparian zone was fairly thick on the right bank but sparse on the left bank, where the golf course came within 10 meters of the stream. The riparian zone provides a buffer from storm water runoff inputs, and serves as a source of food and physical substrates for fish and invertebrates. The SCI score at site TP11022S was 41 (out of 100 possible points), meeting the minimum criteria for a healthy, and well balanced macroinvertebrate community.

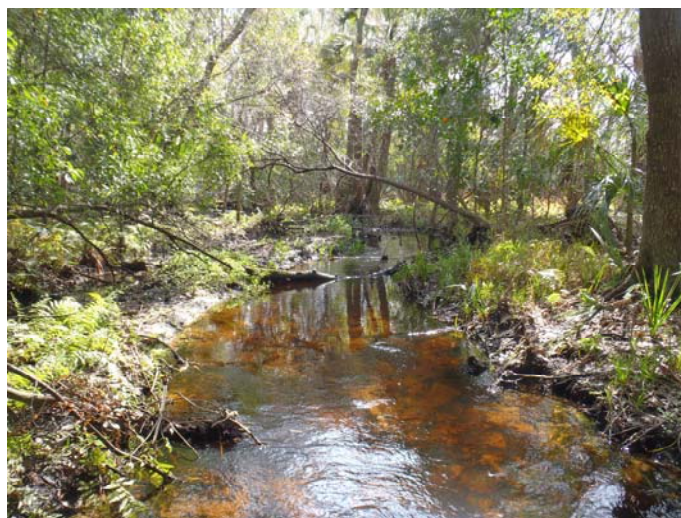
**Figure 4. TP 220**

The Creek at site TP220, further upstream, is a first order stream flowing through a cypress flood plain (Figure 4). This site was also predominately sandy bottomed with 10% available habitat (snags, roots and leaves). The HA score was 126, which falls in the low end of optimal conditions. Water velocity was 0.3 m/sec. The riparian zone was natural and wide enough on both sides to provide adequate protection from storm water runoff. At TP220, the SCI score was only 26, indicating disturbance to the macroinvertebrate community. However, at this location the creek is a first order headwater stream that is likely to go dry seasonally. We could not be sure that the creek had been flowing for a minimum of three months prior to sampling, allowing for adequate colonization by macroinvertebrates (and as specified in our Standard Operating Procedures (SOP) and the resulting low SCI score may not be accurately assessing the macroinvertebrate community.

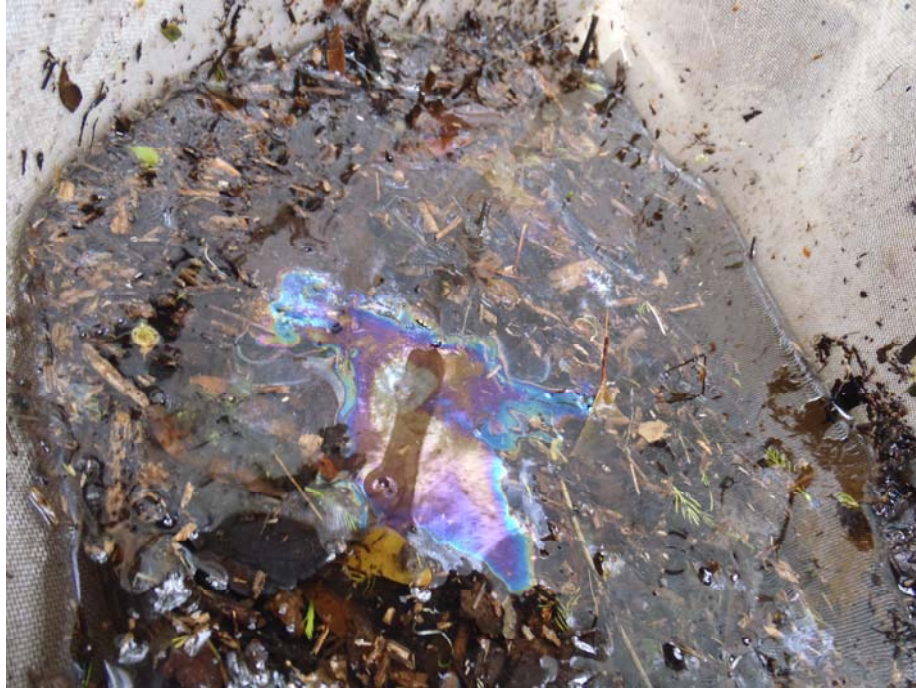
There were only two sensitive species at TP11022S and one at TP220. Neither site had any long lived species, although mussels were observed at TP220, but not present in the analysis. TP11022S was dominated by the midge, *Rheotanytarsus* sp. and TP220 was dominated by *Hyaella azteca*, an amphipod grazer. During the course of rinsing leaves out of the sample at TP11022S, an unusual oil slick was observed (Figure 5), accompanied by the odor of gasoline.

Figure 5. Oil slick at TP11022S

Biological sampling in Hollins Creek was inconclusive. While the SCI score at TP11022S exceeded the minimum criteria for a health macroinvertebrate community, the petroleum product observed suggests that some undesirable practices in the watershed need to be addressed. At TP220, in the headwater tributary, the macroinvertebrate community may have been stressed by periods of desiccation prior to the sampling event. Consequently, the stream will be sampled again in the fall of 2011, after the rainy season, to ensure that over three months of continuous flow has occurred prior to sampling. This should eliminate natural desiccation as a stressor, and allow conclusions to be drawn concerning the effects of water quality on the stream biota.

It was evident that the golf course had several Best Management Practices (BMPs) in place, including minimum use of fertilizers and maintenance of stream riparian zone. However, the stream may be receiving contaminated runoff from residential development, particularly in view of the oil slick observed in TP11022S. Rain and household water mixed with urban pollutants may result in storm water with undesirable quality entering the stream. These potential pollutants may include: oil, and other automobile fluids, paint and construction debris, yard and pet wastes, pesticides and litter. Untreated urban runoff may contaminate streams, rivers and bays, and also may harm aquatic life. Pinellas County, the golf course and local municipalities have BMPs in place in some areas, but practices on private property could be improved. Home owners can reduce storm water runoff pollution by limiting lawn fertilization and removing yard and automotive waste and so that it does not enter the stream with the storm water runoff.
