LAKE ASSESSMENT REPORT FOR LAKE ALLEN IN HILLSBOROUGH COUNTY, FLORIDA

Date Assessed: August 5, 2008
Assessed by: Monetta Wilson and David Eilers
Reviewed by: Jim Griffin, Ph.D.

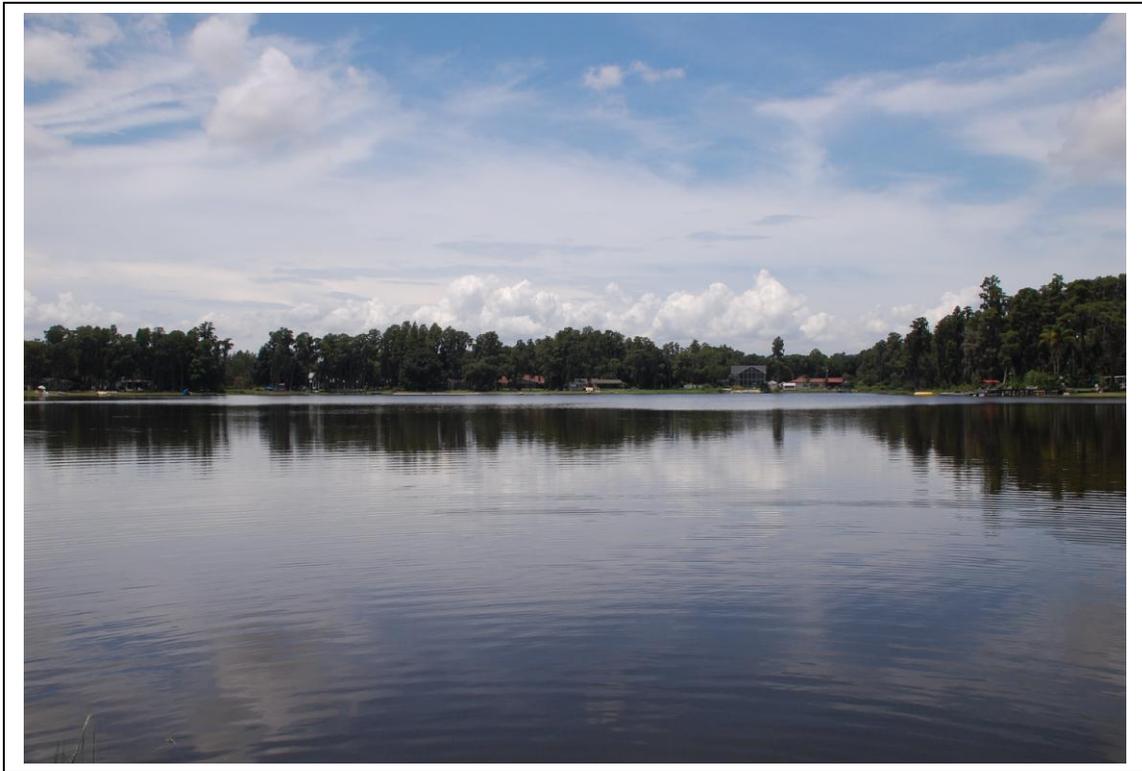
Figure 1. Photo of Lake Allen, taken August 5, 2008.

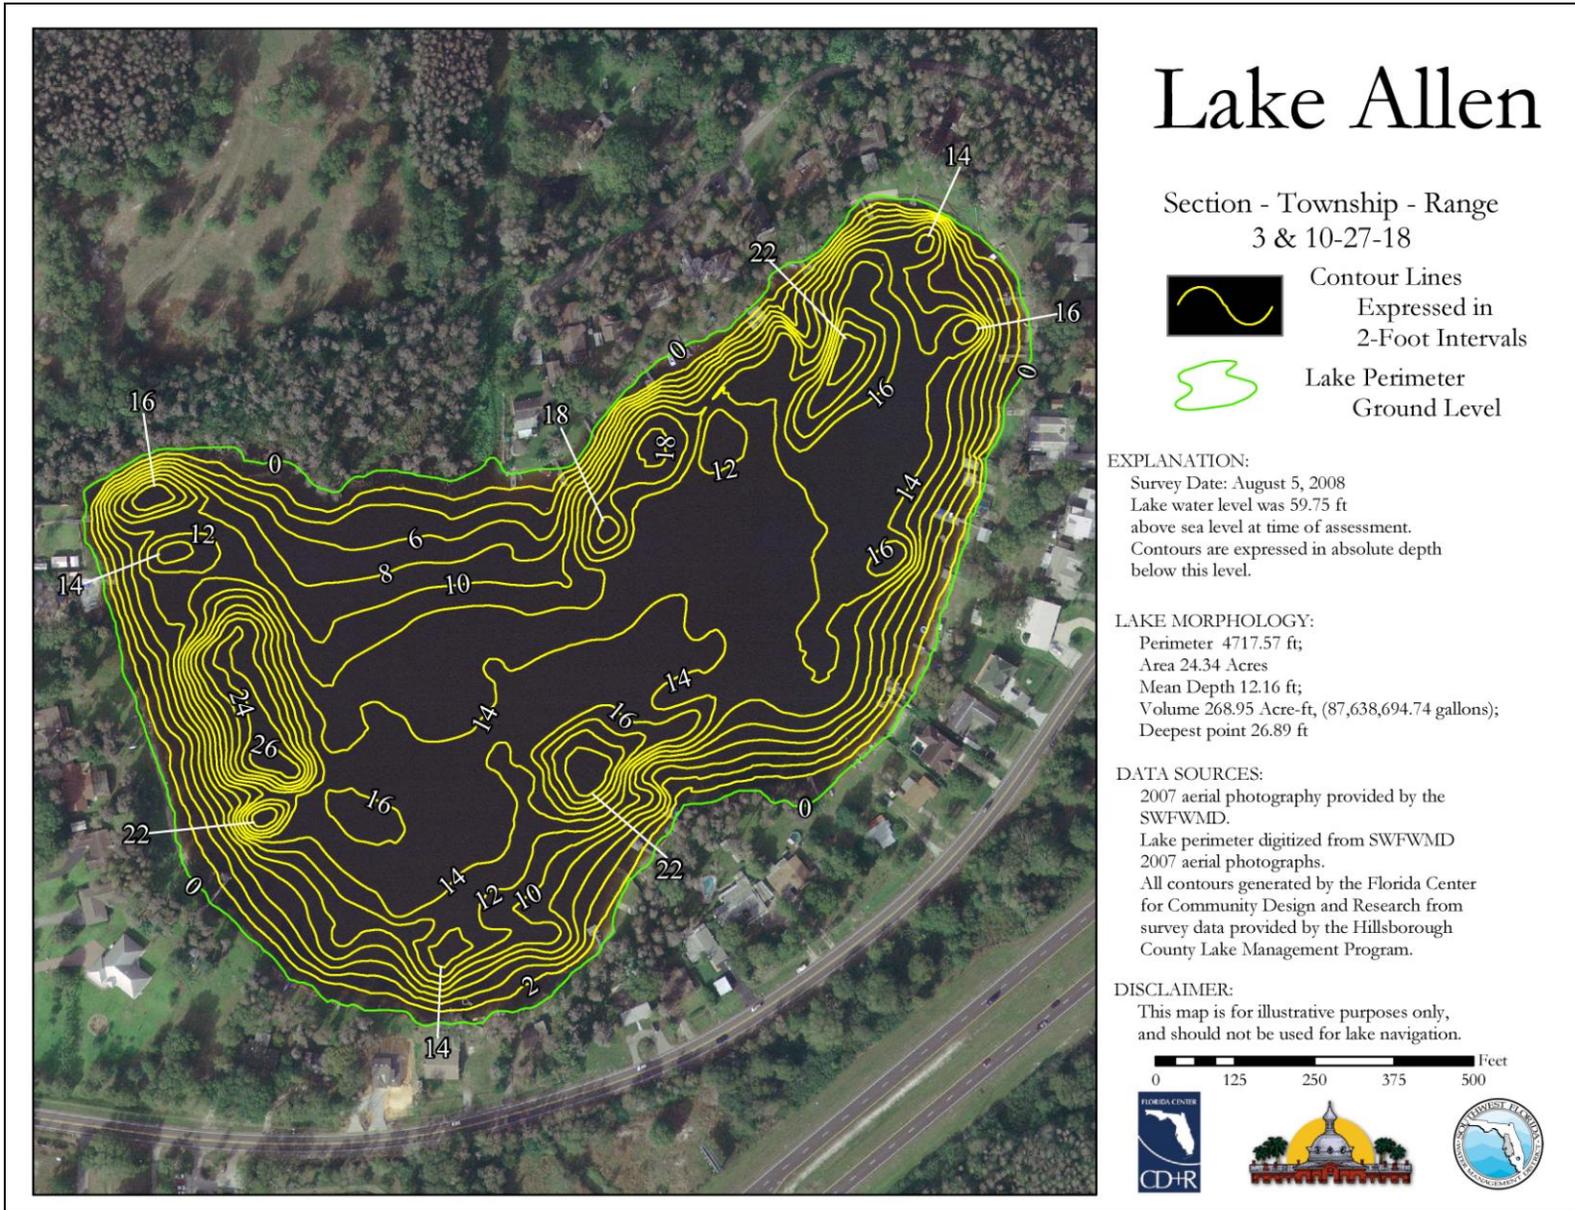
Figure 1. Contour map for Lake Allen. The mapping technique used in 2008 employs a standard DGPS for horizontal position and a fathometer for depth.

Bathymetric Mapⁱⁱ. Table 1 provides the lake's morphologic parameters in various units. The bottom of the lake was mapped using a Lowrance LCX 28C HD Wide Area Augmentation System (WAAS)ⁱⁱⁱ enabled Global Positioning System (GPS) with fathometer (bottom sounder) to determine the boat's position, and bottom depth in a single measurement. The result is an estimate of the lake's area, mean and maximum depths, and volume and the creation of a bottom contour map (Figure 2). Besides pointing out the deeper fishing holes in the lake, the morphologic data derived from this part of the assessment can be valuable to overall management of the lake vegetation as well as providing flood storage data for flood models.

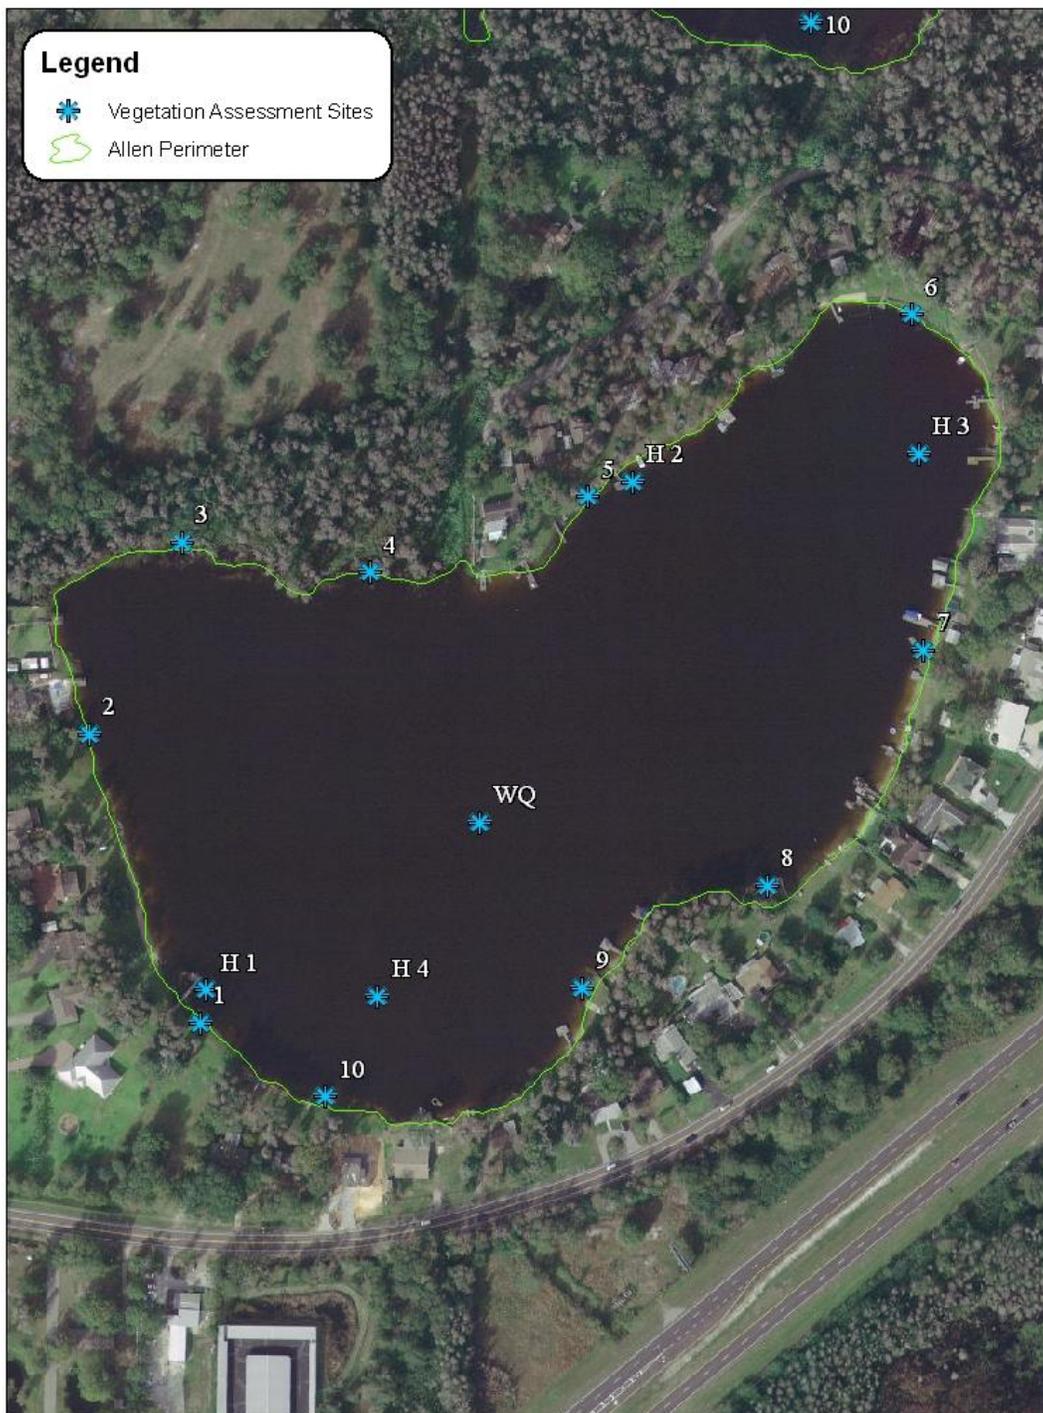
Figure 3. 2007 six-inch resolution aerial photograph showing location of vegetation assessment sites on Lake Allen. Major emergent and floating vegetation zones as well as structures are also observable in this aerial.

The lake's apparent vegetative cover and shoreline detail are evaluated using the latest lake aerial photograph as shown in Figure 3 and by use of WAAS enabled GPS. Submerged vegetation is determined from the analysis of bottom returns from the Lowrance 28c HD combined GPS/fathometer described earlier. As depicted in Figure 3, ten vegetation assessment sites were chosen for intensive sampling based on the *Lake Assessment Protocol* (copy available on request) for a lake of this size. The site positions are set using GPS and then loaded into a GIS mapping program (ArcGIS) for display. Each site is sampled in the three primary vegetative zones (emergent, submerged and floating).^{iv} The latest high resolution aerial photos are used to provide shore details (docks, structures, vegetation zones) and to calculate the extent of surface vegetation coverage. The primary indices of submerged vegetation cover and biomass for the lake, percent area coverage (PAC) and percent volume infestation (PVI), are determined by transiting the lake by boat and employing a fathometer to collect "hard and soft return" data. These data are later analyzed for presence and absence of vegetation and to determine the height of vegetation if present. The PAC is determined from the presence and absence analysis of 100 sites in the lake and the PVI is determined by measuring the difference between hard returns (lake bottom) and soft returns (top of vegetation) for sites (within the 100 analyzed sites) where plants are determined present (Figure 6).

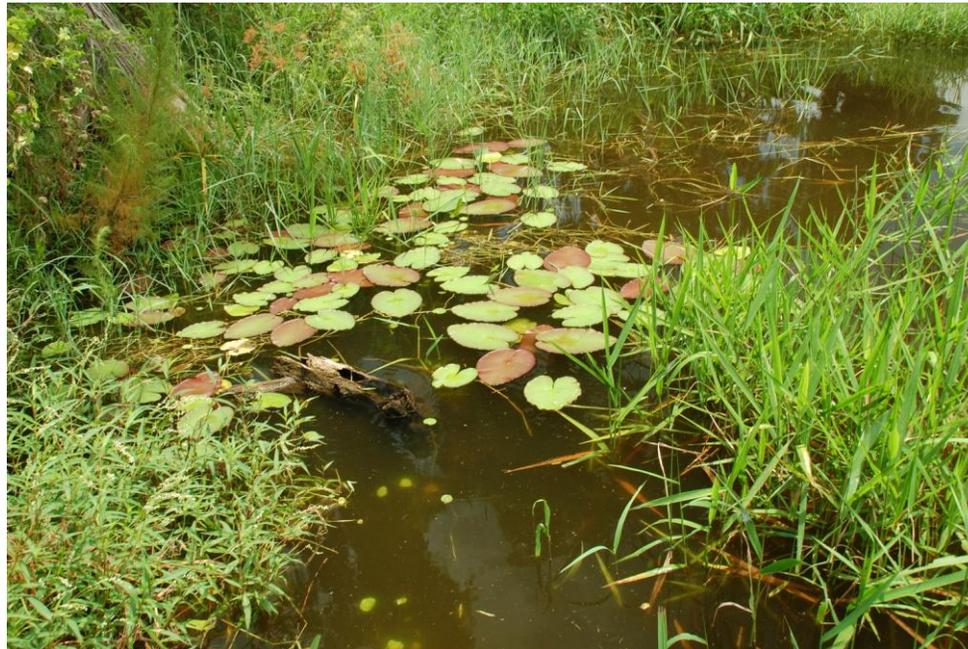
Figure 4. Photograph of Spatterdock, *Nuphar lutea var. advena*, on Lake Allen. Native species such as Spatterdock provide vital habitat for endemic species of invertebrates and fish.

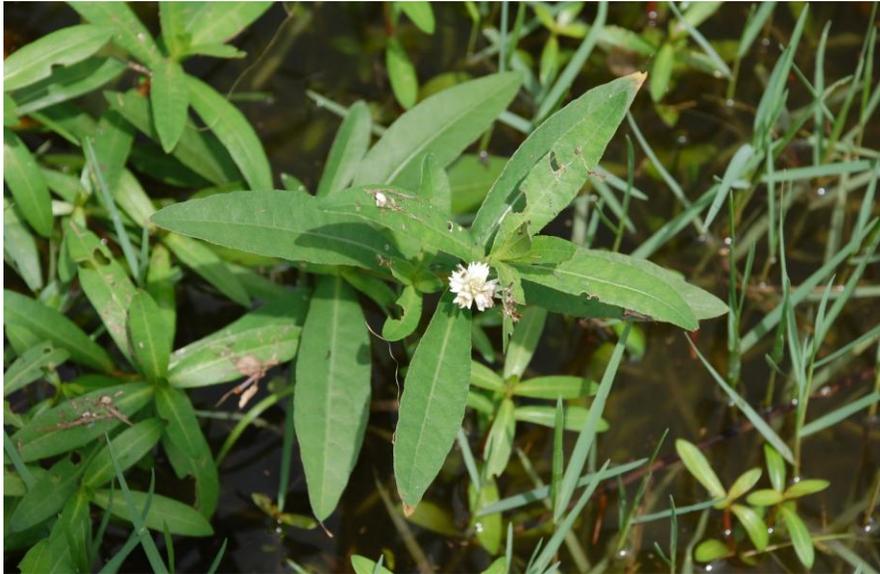
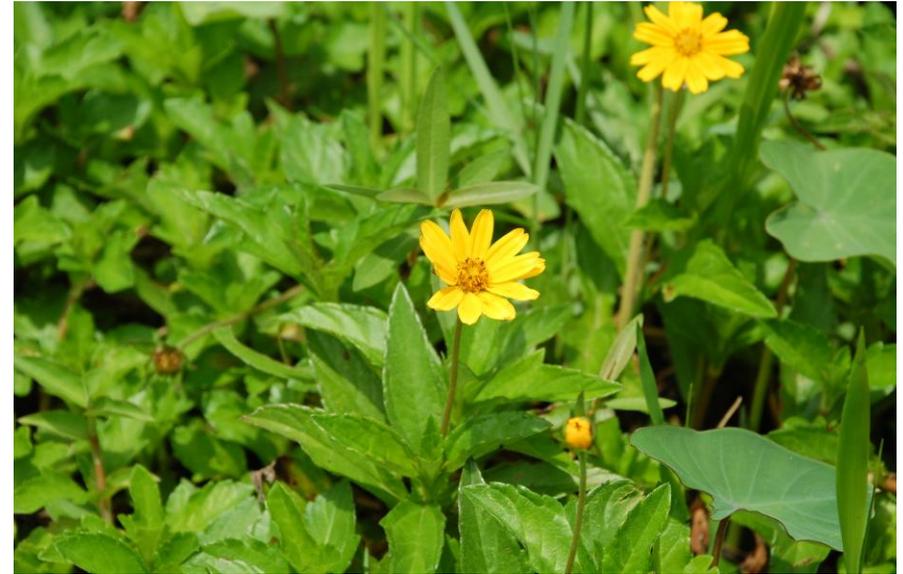
Figure 5. Photograph of (left) Alligator Weed, *Alternanthera philoxeroides*, and (right) Creeping Oxeye, *Sphagneticola trilobata*, on Lake Allen are common non-native invasive species which disrupt natural vegetation communities along the shorelines of lakes in Florida.

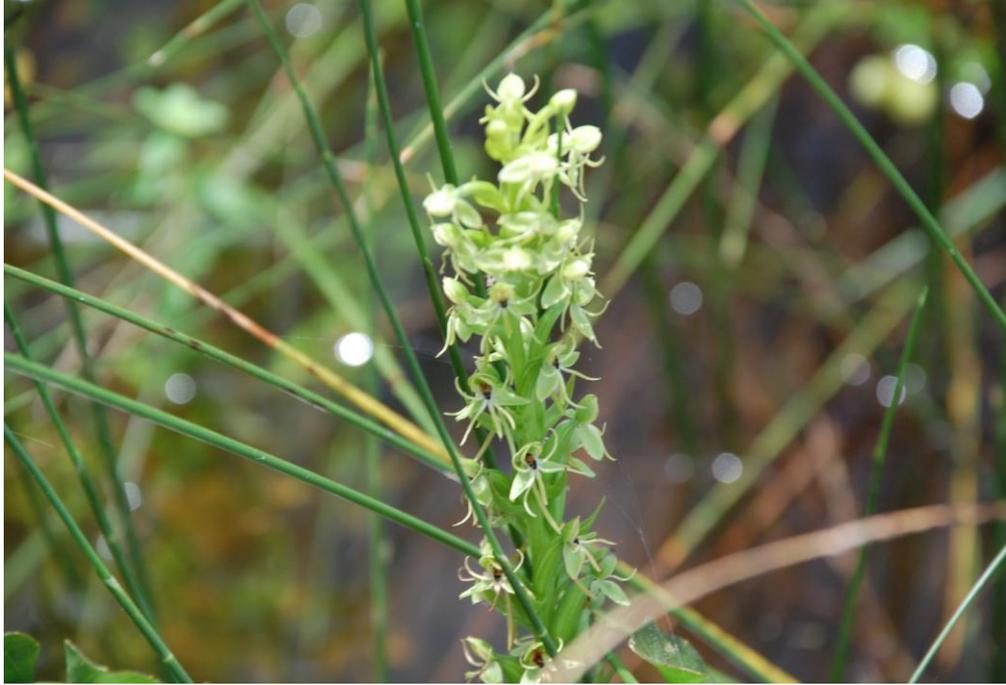
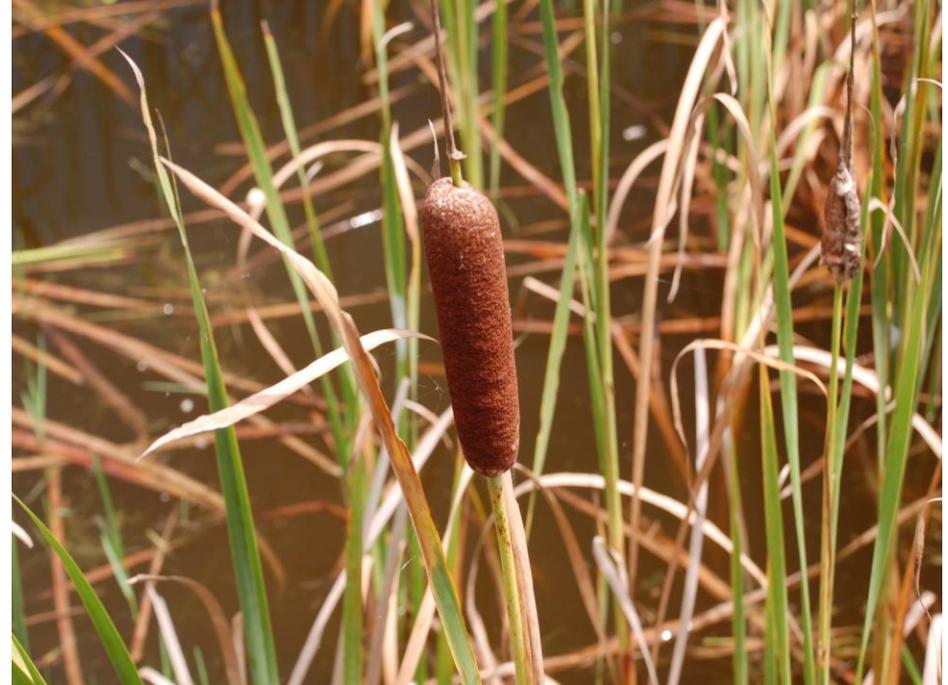
Figure 6. Photograph of (left) Waterspider False Reinorchid, *Habenaria repens*, and (right) Cattails, *Typha spp.* Are both native emergent plants commonly occurring along lake margins in Florida.

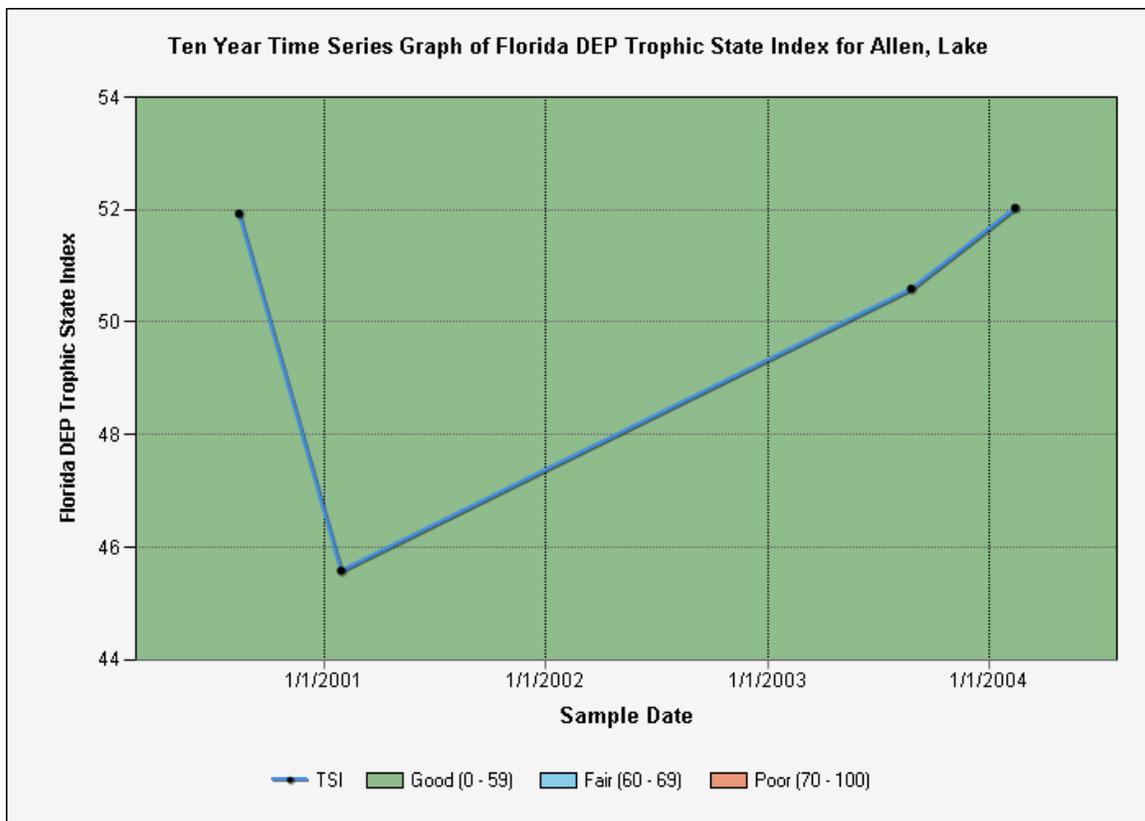
Figure 7. Recent Trophic State Index (TSI) graph from Hillsborough Watershed Atlas. For the latest data go to: <http://www.hillsborough.wateratlas.usf.edu/lake/waterquality.asp?wbodyid=5046&wbodyatlas=lake>

Note: The graph above includes benchmarks for using verbal descriptors of "good", "fair" and "poor". The verbal descriptors for these benchmarks are based on an early determination by stakeholders of the generally acceptable and understood terms for describing the state of lakes. The same benchmarks are used for nutrient graphs (Nitrogen and Phosphorus), chlorophyll graphs and trophic state index (TSI) graphs. The TSI is a calculated index of lake condition based on nutrient and chlorophyll (a) concentrations (please see "Learn more about Trophic State Index"). The benchmarks are established based on the TSI range that relates to a specific descriptor. The source for the TSI concentration relationships is the Florida Water

Lake Allen is a (small) area (24.34 acre) lake that would be considered in the high eutrophic (fair to poor) category of lakes based on water chemistry. It has virtually no submerged aquatic vegetation and is dominated by microscopic algae. About 1% of the open water areas contain submerged vegetation. Vegetation helps to maintain the nutrient balance in the lake as well as provide good fish habitat. The lake has many open water areas that support various types of recreation and has a poor diversity of plant species. The primary Pest plants in the lake include *Panicum repens*, *Schinus terebinthifolius* and *Ludwigia peruviana*. For more information and recent updates please see the Hillsborough Watershed Atlas (water atlas) website at: <http://www.hillsborough.wateratlas.usf.edu> .

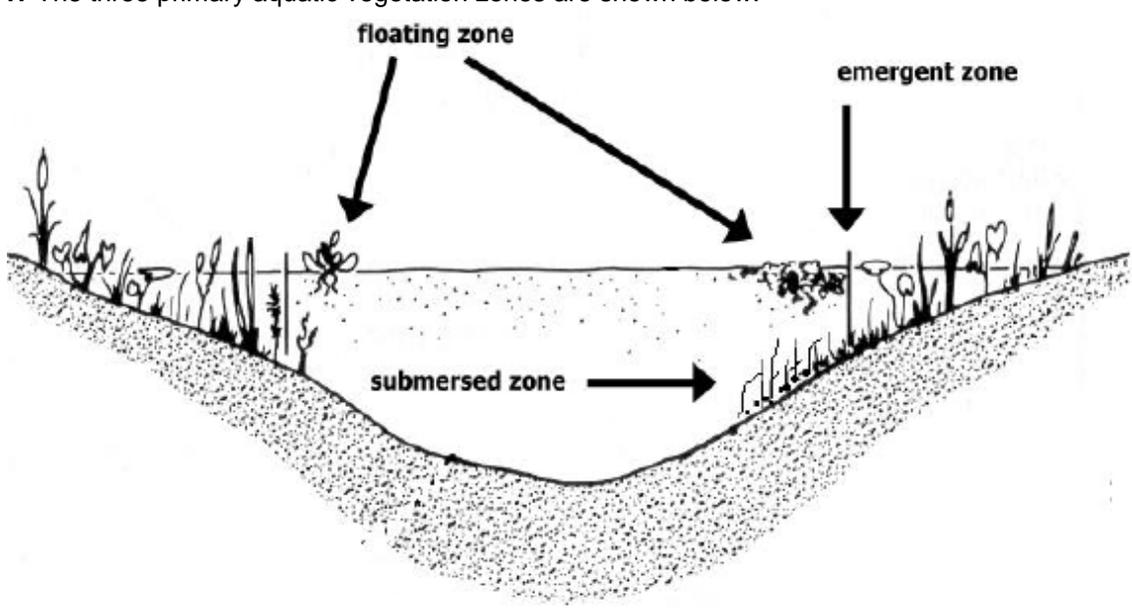
iv The three primary aquatic vegetation zones are shown below:
