Halls Branch Creek

Study Area

Halls Branch Creek is a small stream with its headwaters located southeast of Virgil Hall Road and outfalls to the South Prong Alafia River in Hillsborough County Florida. The sample site selected for the study was located immediately upstream of the Virgil Hall Road and was assessed on May 4, 2017. Halls Branch Creek is located in FDEP WBID 1684 which contains 1,049 acres of land. The watershed surrounding Halls Branch Creek is dominated by Natural Land/Open Water (15.9%), Residential (15.0%) and Agricultural (11.7%) land uses. The Landscape Development Intensity Index of the watershed is 5.63. The 100 meter buffer immediately surrounding the stream had a Landscape Development Intensity Index of 3.76 with Reclaimed Lands (32.9%) being the dominant land use.

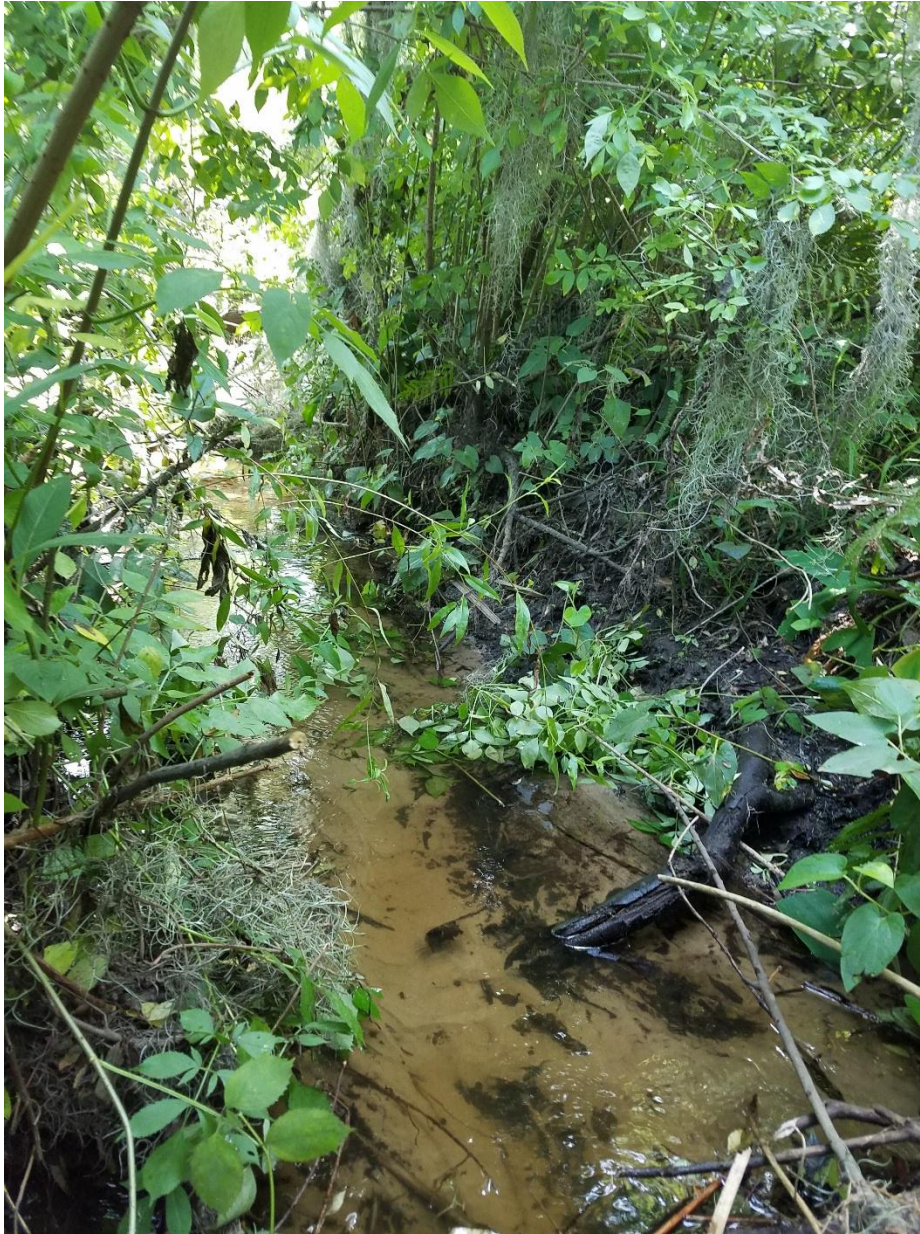
Figure 2 Overview photograph of the Halls Branch Creek sample site

Halls Branch Creek at Virgil Hall Road received a Habitat Assessment score of 101 due to Optimal scores for Artificial Channelization and Bank Stability. Suboptimal scores were recorded for Water Velocity, Riparian Buffer Zone Width and Riparian Zone Vegetation Quality. Marginal scores were achieved for Substrate Diversity, Substrate Availability and Habitat Smothering.

The major productive habitats found at the sample site were Snags (4.1%) and Roots/Undercut Banks (7.0%). The water velocity was measured at the 20 meter mark and averaged 0.18m/s. Sand Smothering was observed on the snags and root habitats.

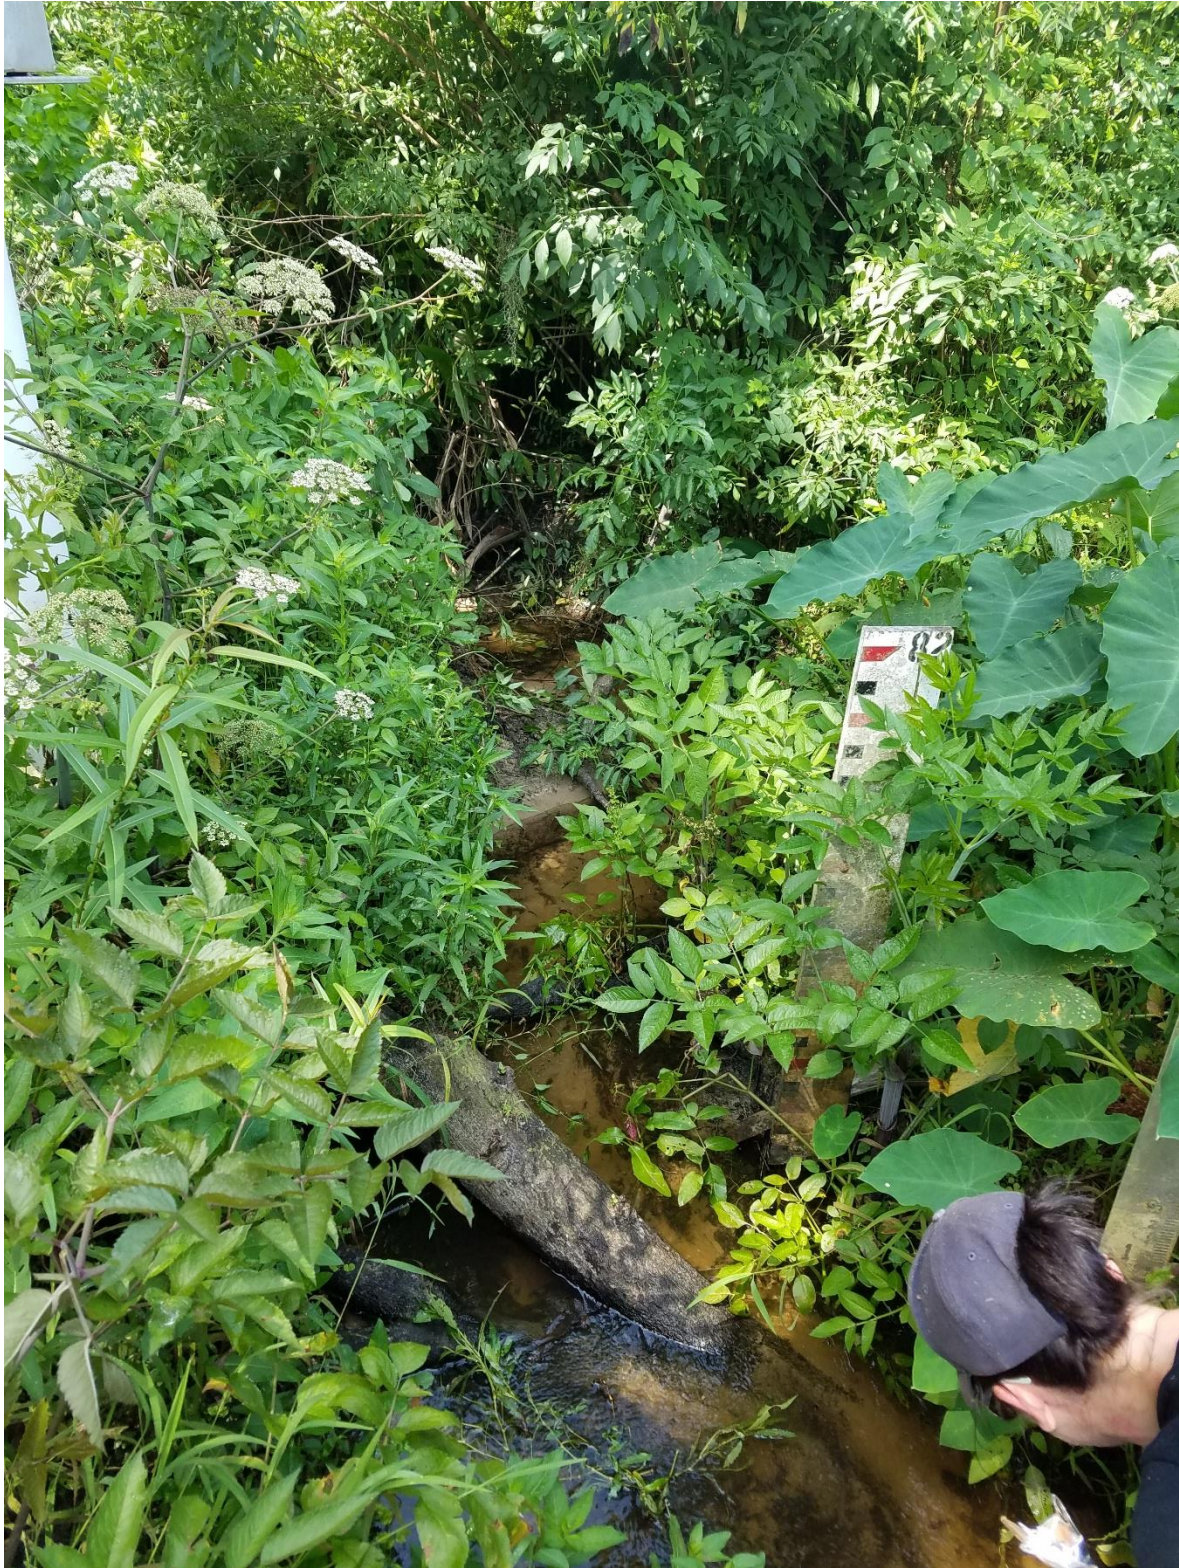
The Linear Vegetation Survey identified 8 species rooted in the water at the time of the assessment. One of these species are classified as non-native, invasive species. The remaining 6 species are native to this region. The vegetation community along this sample location showed little evidence of frequent disturbance. There were a total of 31 species observations in the 100 meter study area. The mean Coefficient of Conservatism (CoC) metric for the study area was 2.99 and the % FLEPPC metric for the study area was 32%.

Figure 3. The Halls Branch Creek sampling site was difficult to access due to dense growth of vegetation along its banks
