Howell Branch

Study Area

Howell Branch located in the town of Bealsville, Hillsborough County Florida was sampled on 4/13/17. The sampling site is located in Bealsville Park off of Nesmith Road and lies within the FDEP WBID 1568, which contains 5,843 acres of land. The watershed surrounding Howell Branch is dominated by Residential (29.60%), Field Pasture (22.90%), Forest/Natural (20.40%), and Agricultural (9.90%) land uses. The Landscape Development Intensity Index of the watershed is 4.49. The LDI was also calculated for the 100m buffer around the stream in the WBID to capture the land use that has the largest potential to alter the stream. The buffer LDI value was 3.07.

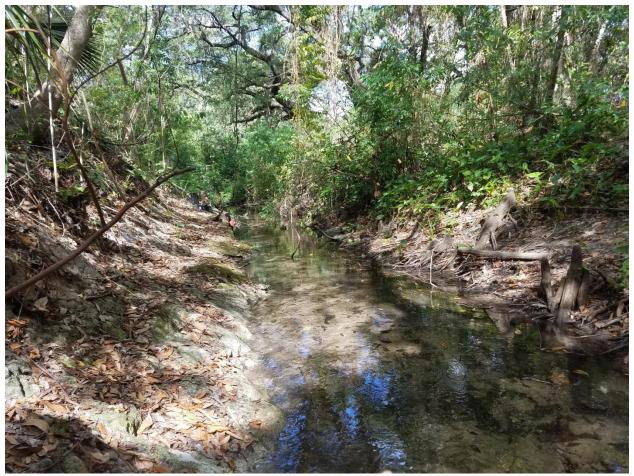
Figure 2 Overview photograph of Howell Branch at Bealsville Park sample site

Howell Branch at Bealsville Park received an optimal Habitat Assessment score of 123. Primary habitat components received suboptimal scores for Substrate Diversity, Water Velocity, and Habitat Smothering, and a marginal score Substrate Availability (2.9% Snags, 3.75% Roots/undercut banks, 2.6% Leaf Packs/mats). Secondary habitat components received optimal scores for Artificial Channelization, Bank Stability, Riparian Buffer Zone Width, and Riparian Zone Vegetation Quality.

During the Rapid Periphyton Survey, periphyton was not observed in the 99 individual grab samples performed. The average canopy cover in the 100 meter region was 94.36%. The Secchi Disk Depth was measured as 0.6 meters visible on bottom at the 50 meter mark. The average water depth at the time of the assessment was 0.15 meters.

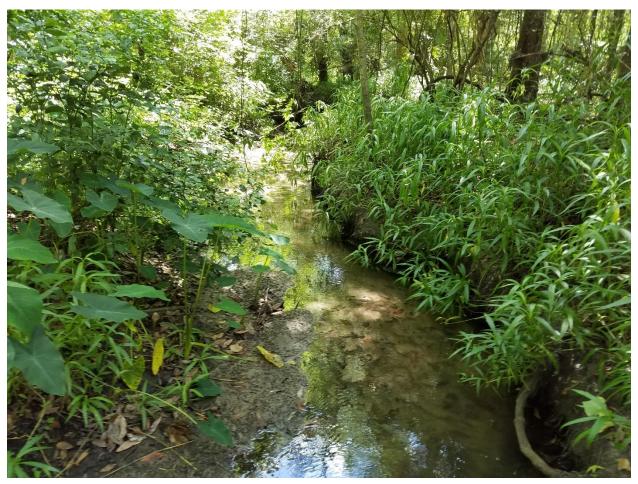
The Linear Vegetation Survey identified 3 species rooted in the water at the time of the assessment. Two of these species are non-native, invasive species (*Colocasia esculenta* and *Ruellia simplex*). The vegetation community along this sample location did not show evidence of frequent

disturbance resulting in the dominance by pioneering species. There were a total of 19 species observations in the 100 meter study area. The mean Coefficient of Conservatism (CoC) metric for the study area was 0.24 and the % FLEPPC metric for the study area was 94.7%.

Figure 3. Colocasia esculenta and Ruellia simplex along the banks of Howell Branch
