# Lake Ellen

## Study Area

## Lake Bathymetry and Morphological Characterization

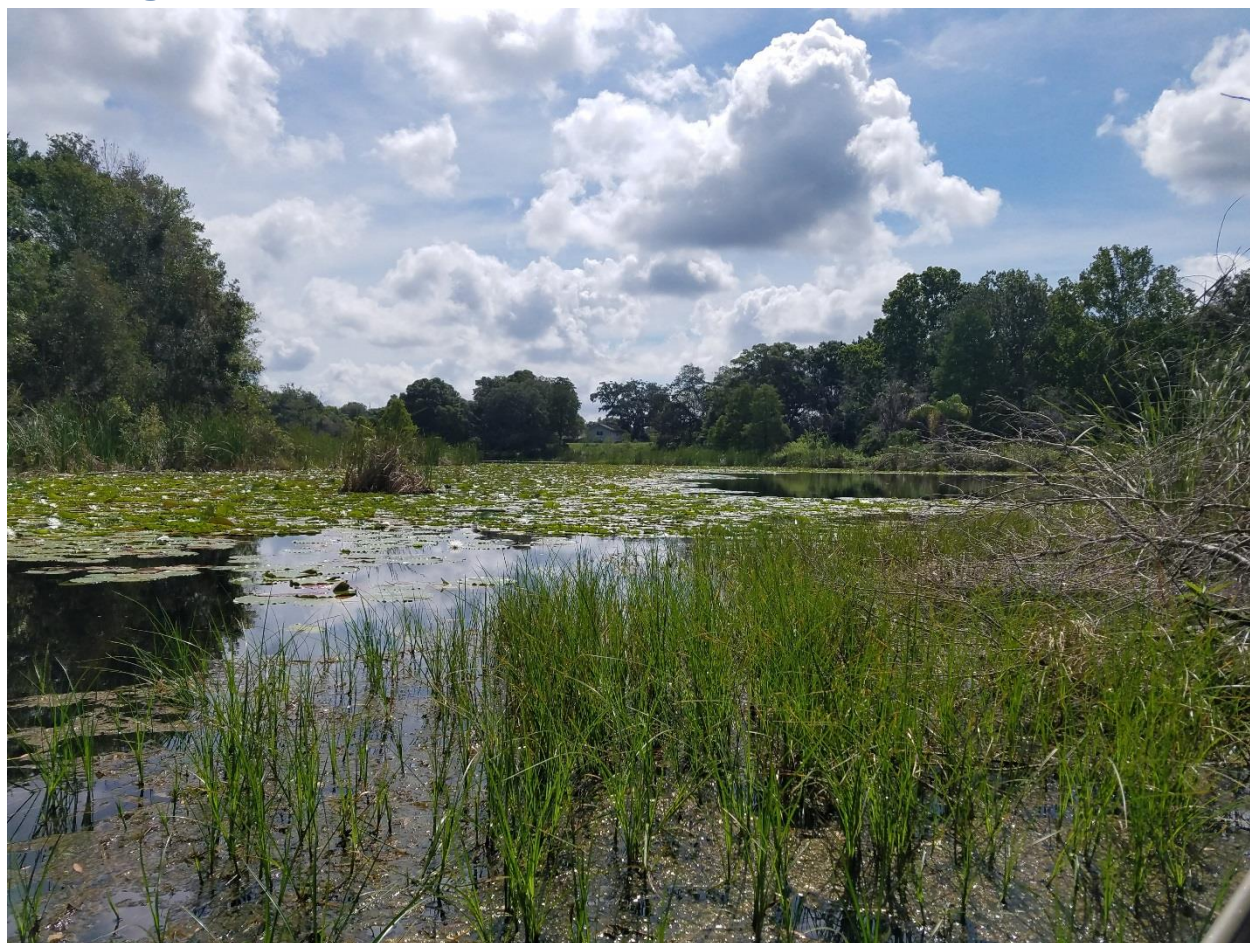
**Figure 3 Overview photograph of Ellen Lake**

The lake assessment for Ellen Lake was conducted on June 29, 2017. At the time of the assessment, Lake Ellen had dense growth of emergent and floating leaved vegetation throughout the lake, restricting access in the northeast lobe. Ellen Lake received a lake habitat assessment (FEDP form FD 9000-6) score of 76 due to suboptimal scores for Secchi, Lakeside Adverse Human Alterations, Upland Buffer Zone and Adverse Watershed Land Use. Vegetation Quality, Stormwater Inputs and Bottom Substrate Quality achieved Marginal scores.

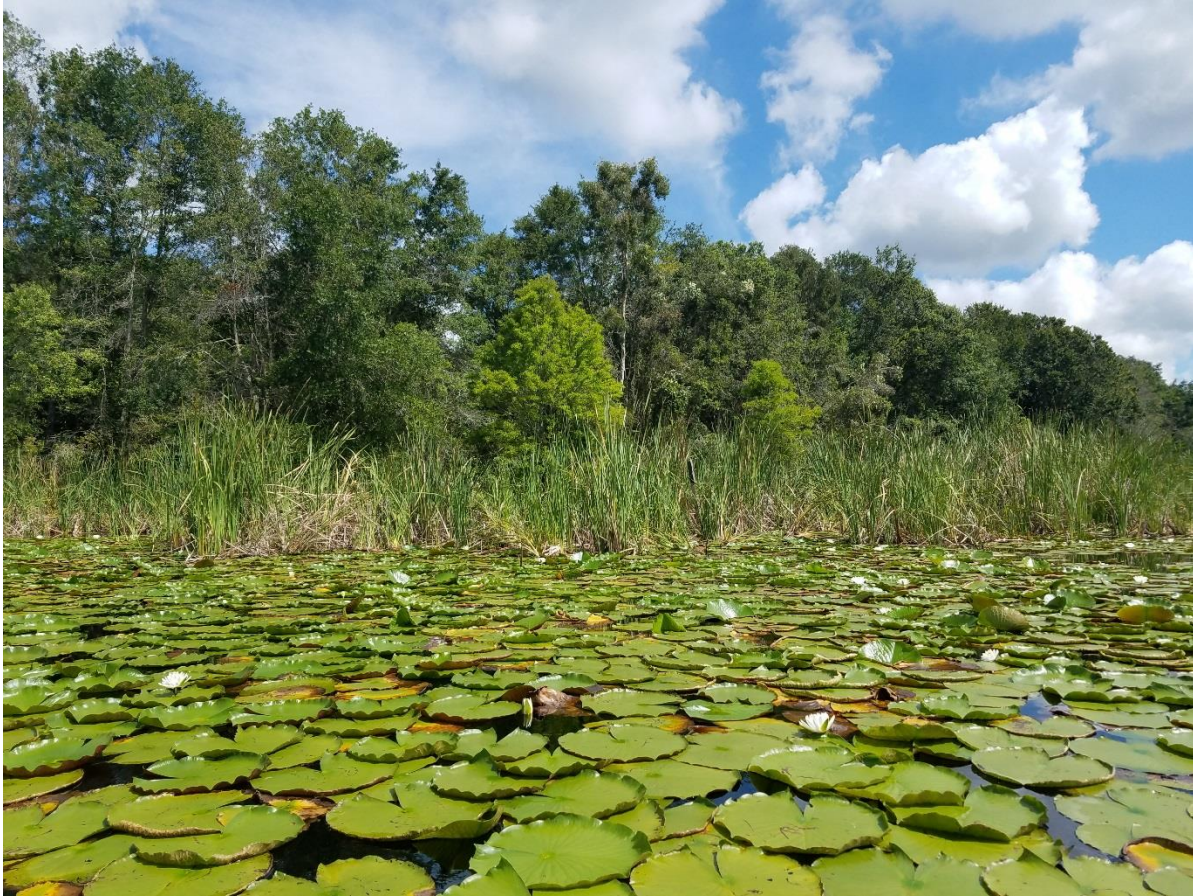
Figure 4 Ellen Lake had a buffering zone of emergent and floating leaved vegetation surrounding the lake containing a mixture of native and invasive species.

The Lake Vegetation Index identified 27 species of wetland vegetation growing in the four selected sections along Ellen Lake. The majority of these species (19) are native species. The remaining 8 species (*Alternanthera philoxeroides*, *Melaleuca quinquenervia*, *Oxycaryum cubense*, *Salvinia minima*, *Colocasia esculenta*, *Schinus terebinthifolius*, *Sphagneticola trilobata* and *Ludwigia peruviana*) are non-native and invasive to this region. The vegetation community along Ellen Lake is dominated by a variety of emergent species including *Typha*, *Oxycaryum cubense*, and *Melaleuca quinquenervia*. The water's surface in Ellen Lake was dominated by *Nymphaea odorata* (Figure 5). No species of submerged aquatic vegetation was observed by visual or frodus sampling at the time of the assessment. By analyzing the collected sonar chart, submerged aquatic vegetation potentially covered approximately 6.3% of the surface area Ellen Lake. This submerged vegetation inhabits an estimated 0.1% of the water volume in Ellen Lake.

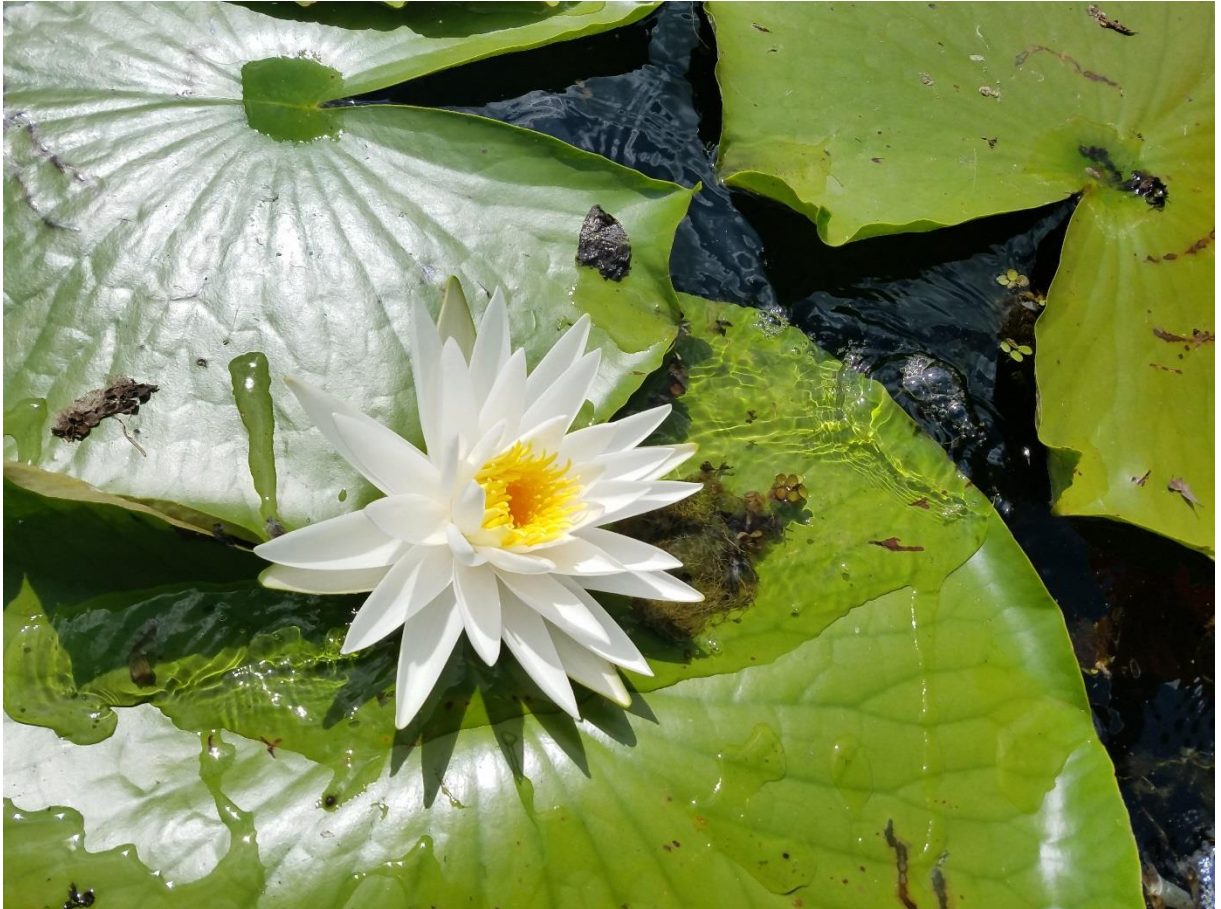
Figure 5 *Nymphaea odorata* dominated the water surface in Ellen Lake

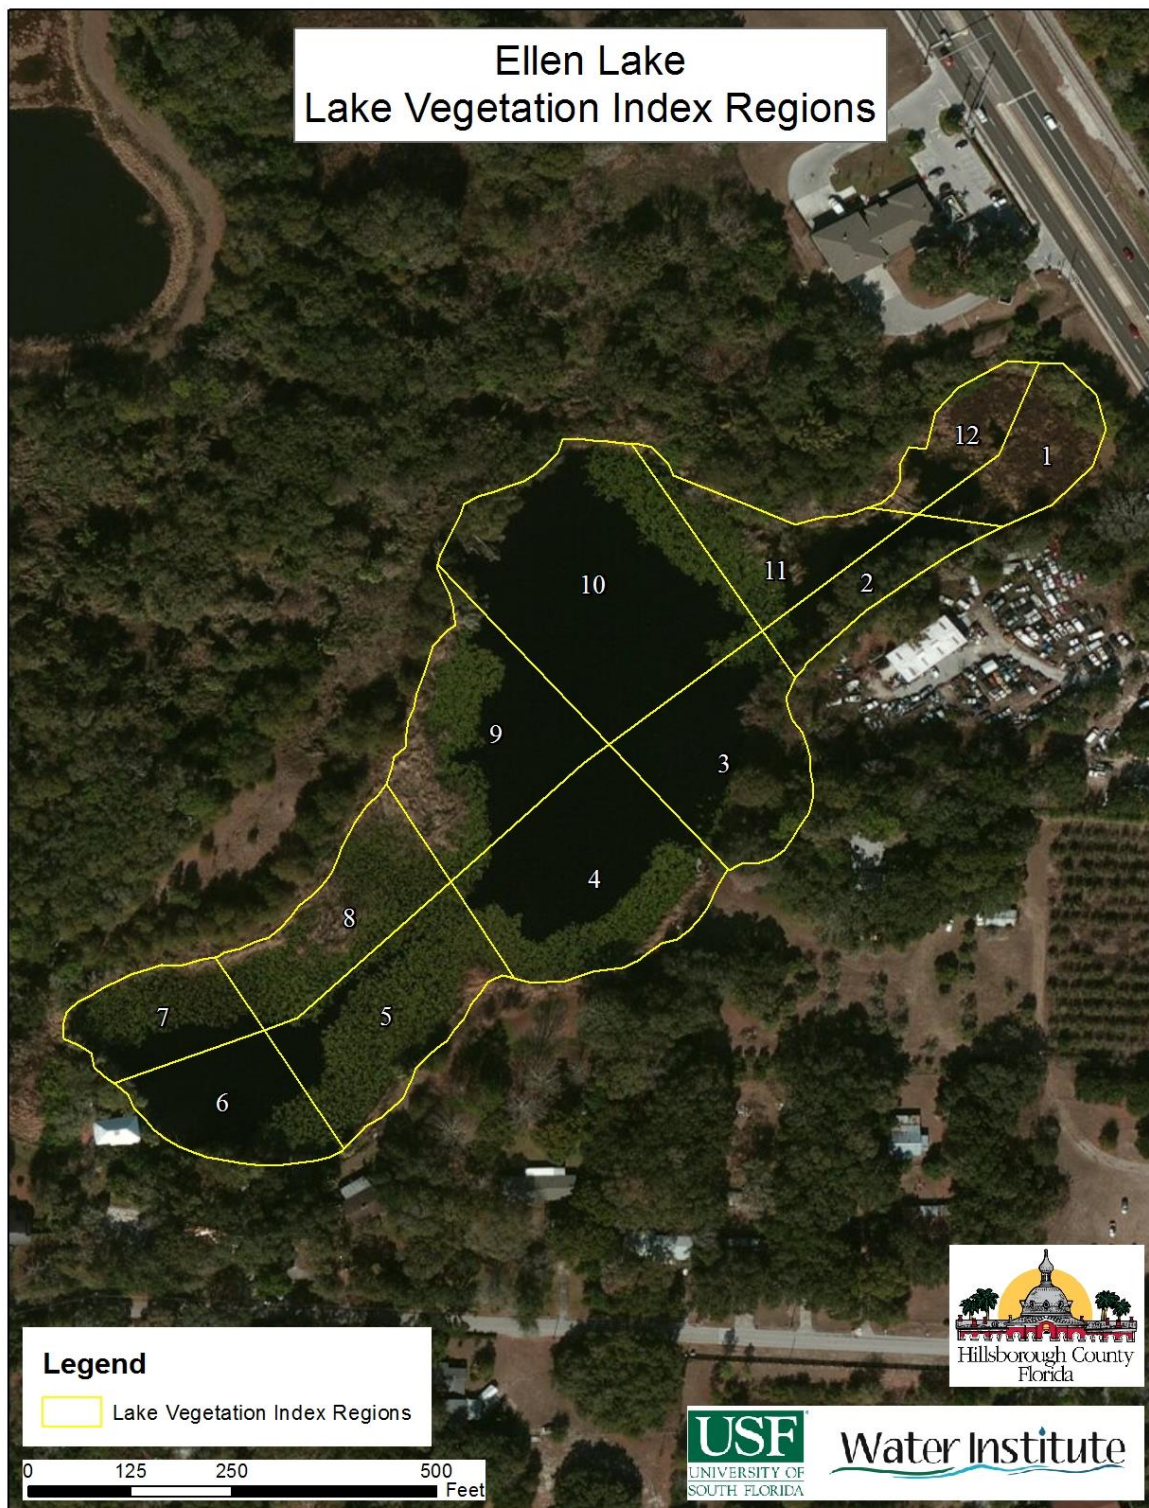
Figure 6: Lake Vegetation Index region map for Ellen Lake

The calculated LVI score for Ellen Lake was 20, below the impairment threshold of 37. Figure 6 shows the map of Ellen Lake detailing the LVI regions used for the assessment. Table 2 details the species list results of the Lake Vegetation Index. Table 3 details the scoring result for the Lake Vegetation Index.
