Lake Maurine

Study Area

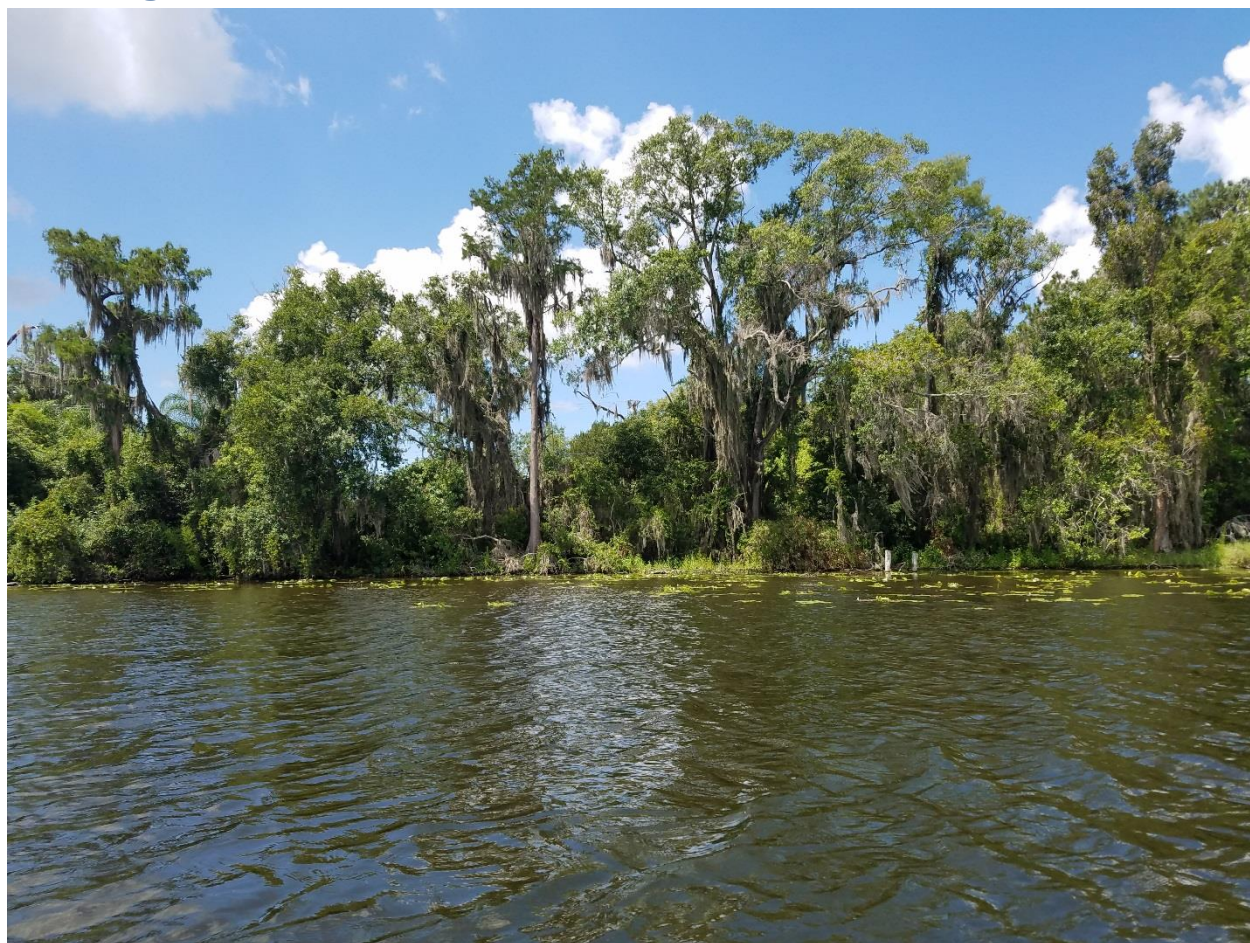
Figure 3 Overview photograph of Lake Maurine showing the less developed south shore

The lake assessment for Lake Maurine was conducted on July 10, 2017. Lake Maurine received a lake habitat assessment (FEDP form FD 9000-6) score of 63 due to suboptimal scores for Secchi, Vegetation Quality, Bottom Substrate Quality and Adverse Watershed Land Use. Marginal scores were achieved for Lakeside Adverse Human Alterations and Upland Buffer Zone. Stormwater Inputs received poor scores.

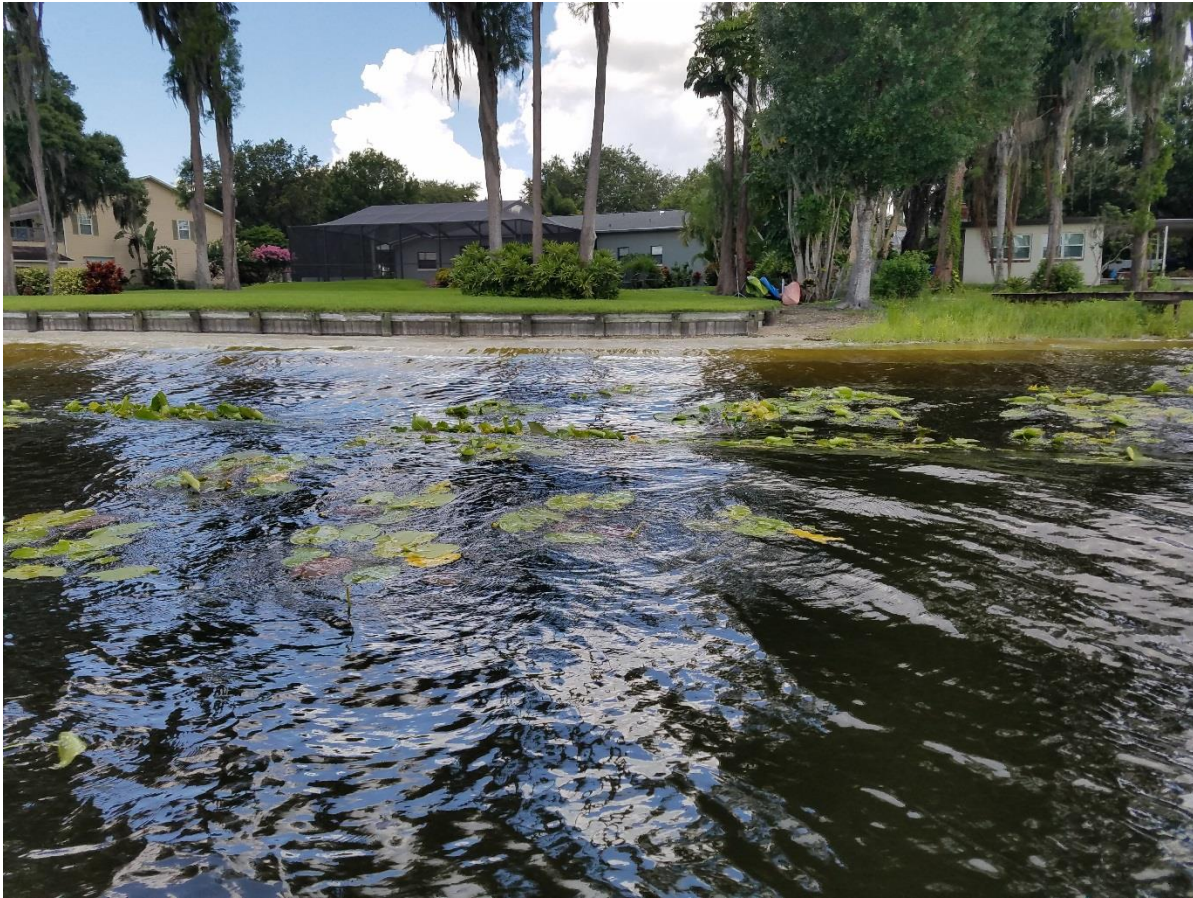
Figure 4 Lake Maurine was dominated by cultivated vegetation and seawalls with few areas of natural buffer.

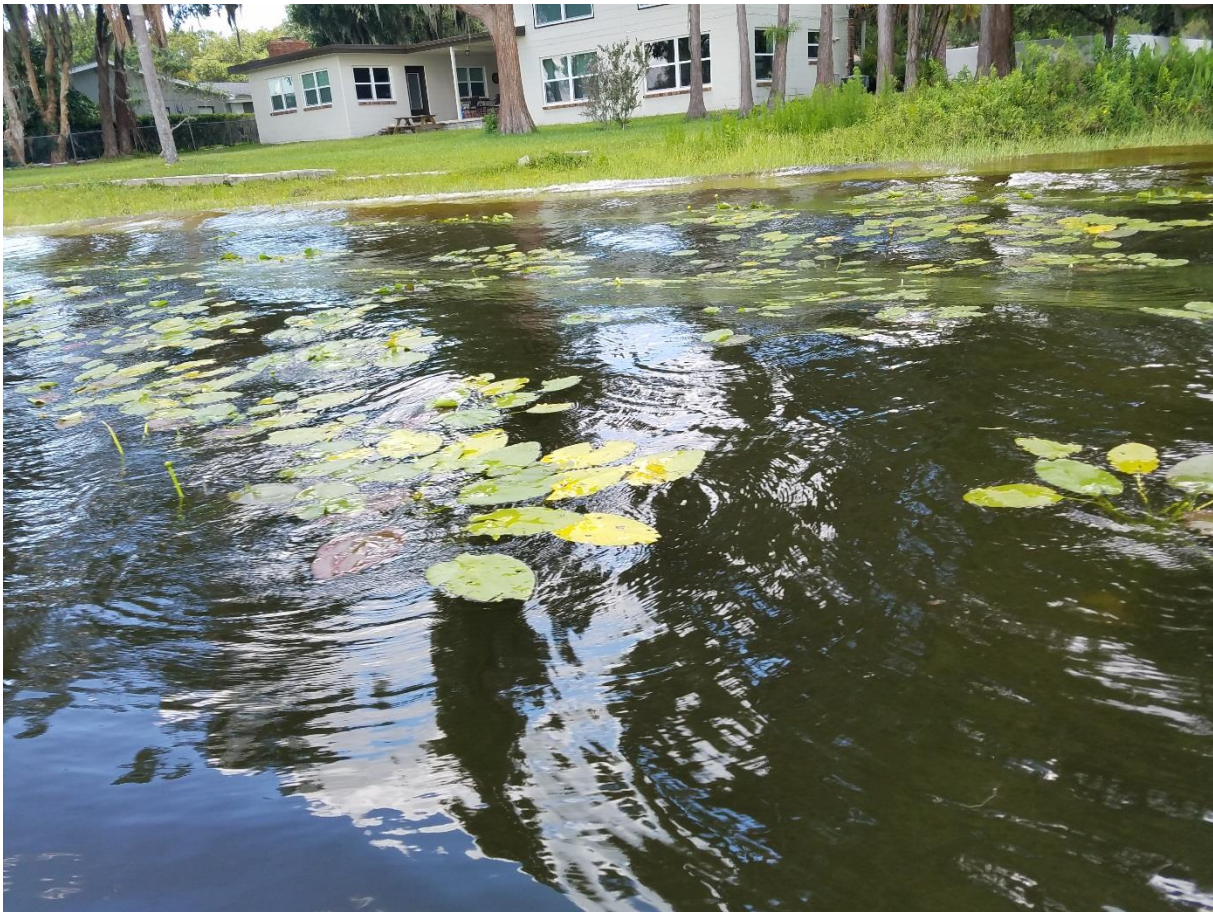
Figure 5 *Nuphar* dominated the water surface in Lake Maurine

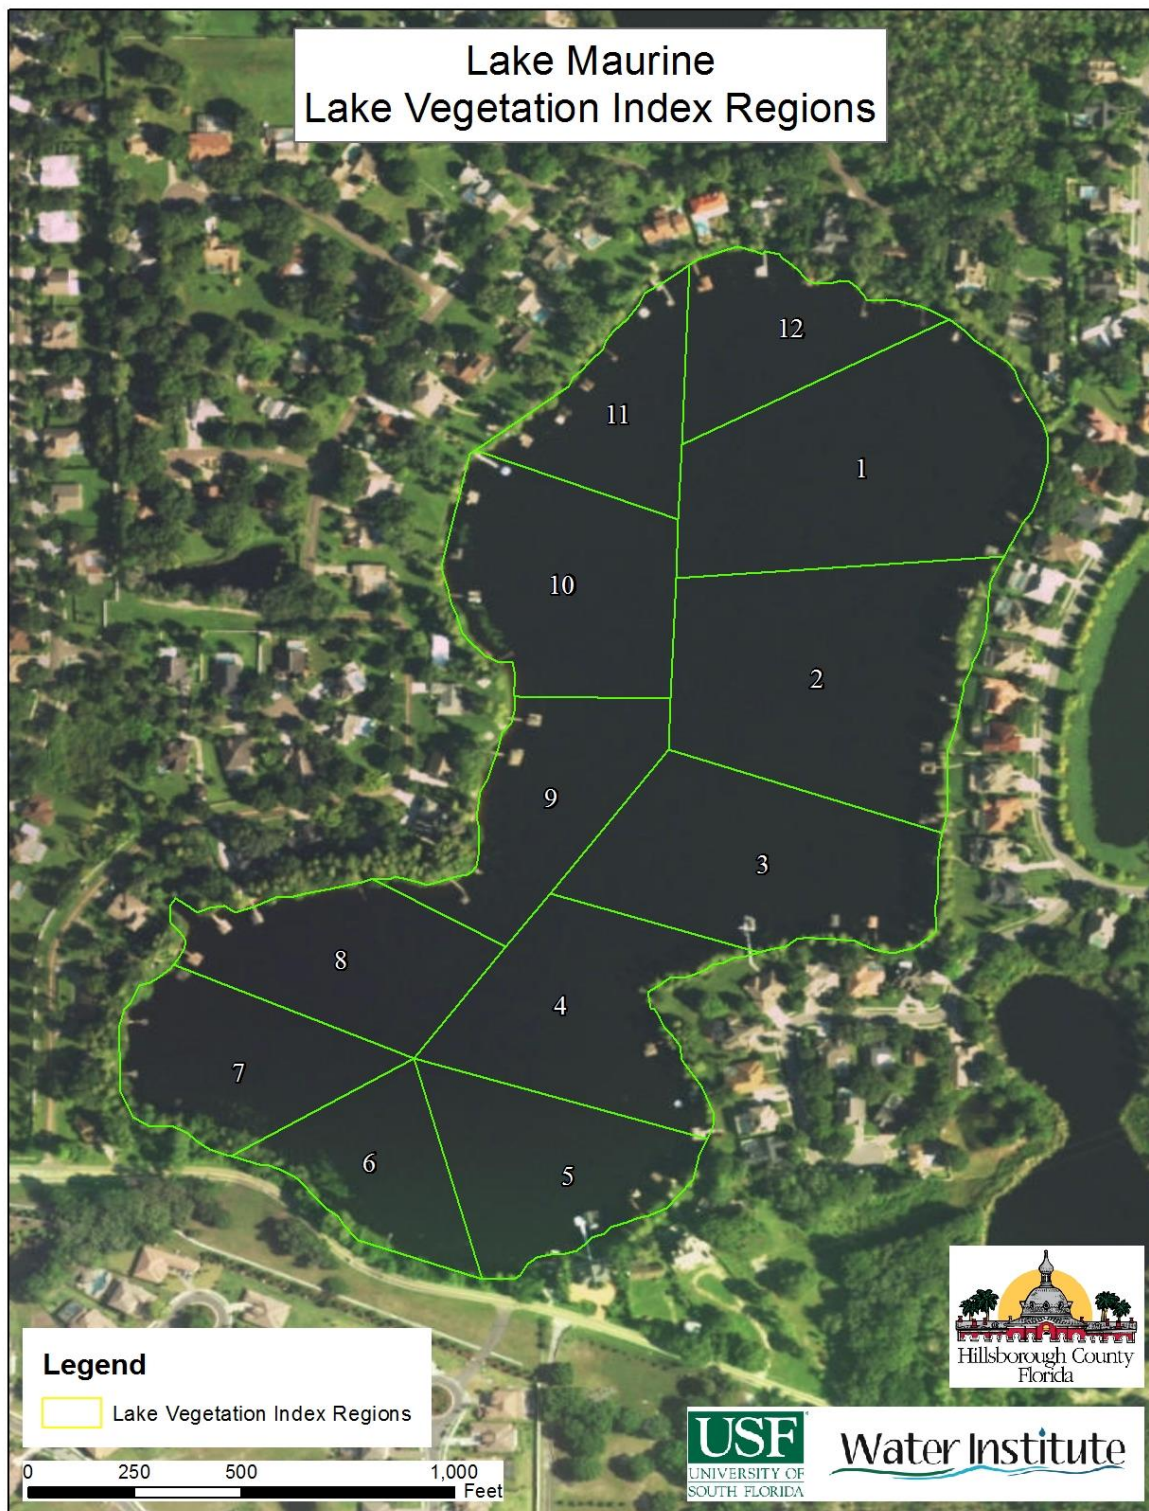
Figure 7: Lake Vegetation Index region map for Lake Maurine

The calculated LVI score for Lake Maurine was 42, above the impairment threshold of 37. Figure 7 shows the map of Lake Maurine detailing the LVI regions used for the assessment. Table 2 details the species list results of the Lake Vegetation Index. Table 3 details the scoring result for the Lake Vegetation Index.
