# Little Fishhawk Creek at Fishhawk Boulevard

# **Study Area**

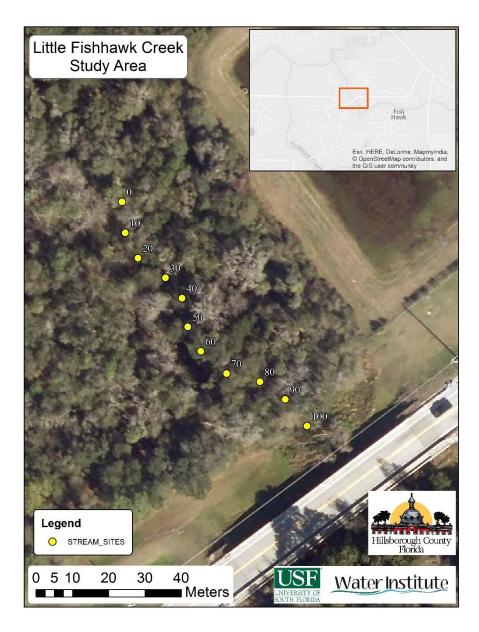
Figure 1. 2017 Little Fishhawk Creek at Fishhawk Boulevard Assessment Study Area Map

Little Fishhawk Creek is located south of the Alafia River in the town of Fishhawk, Hillsborough County Florida. The sample site selected for the study was located immediately downstream of the Fishhawk Boulevard Bridge and was assessed on March 23, 2017. Little Fishhawk Creek is located in FDEP WBID 1657 which contains 3,647 acres of land. Little Fishhawk Creek drains into the Alafia River south of Lithia Springs Park. The watershed surrounding Little Fishhawk Creek is dominated by Residential (40.93%), Natural Land/Open Water (23.61%) and Cropland and Pastureland (16.55%) land uses. The Landscape Development Intensity Index of the watershed is 4.84. The LDI value of the 100 meter buffer around the stream was 2.27.

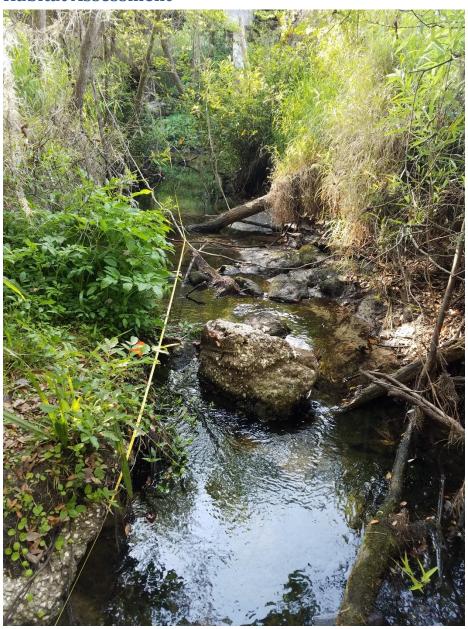
Figure 2 Overview photograph of Little Fishhawk Creek at Fishhawk Blvd sample site

Little Fishhawk Creek at Fishhawk Blvd received a Habitat Assessment score of 121 due to Optimal scores for Habitat Smothering, Artificial Channelization, Riparian Buffer Zone Width and Riparian Zone Vegetation Quality. Suboptimal scores were recorded for substrate diversity, Water Velocity and Bank Stability. Marginal scores were achieved for Substrate Availability.

The major productive habitats found at the sample site were Snags (4.5%), Roots/Undercut Banks (1.5%) and Rock (1.8%). The water velocity was measured at the 60 meter mark and averaged 0.21m/s.

During the Rapid Periphyton Survey, periphyton was not observed in the 99 individual grab samples performed. The average canopy cover in the 100 meter region was 86%. The Secchi Disk Depth was measured as 1.2m at the 50 meter mark. The average water depth at the time of the assessment was .25m.

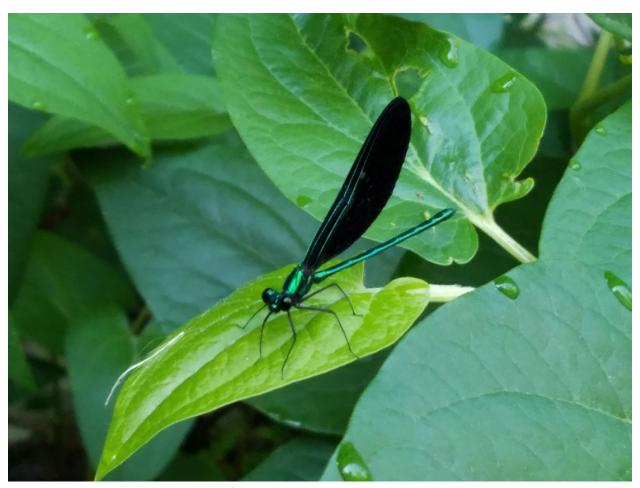
Figure 3. Saururus cernuus along the banks of Little Fishhawk Creek at the Fishhawk Blvd sampling site

The Linear Vegetation Survey identified 7 species rooted in the water at the time of the assessment. One of these species are classified as non-native, invasive species. The remaining 6 species are native to this region. The vegetation community along this sample location showed little evidence of frequent disturbance. There were a total of 10 species observations in the 100 meter study area. The mean Coefficient of Conservatism (CoC) metric for the study area was 4.73 and the % FLEPPC metric for the study area was 10%.
