McDonald Branch

Study Area

Habitat Assessment

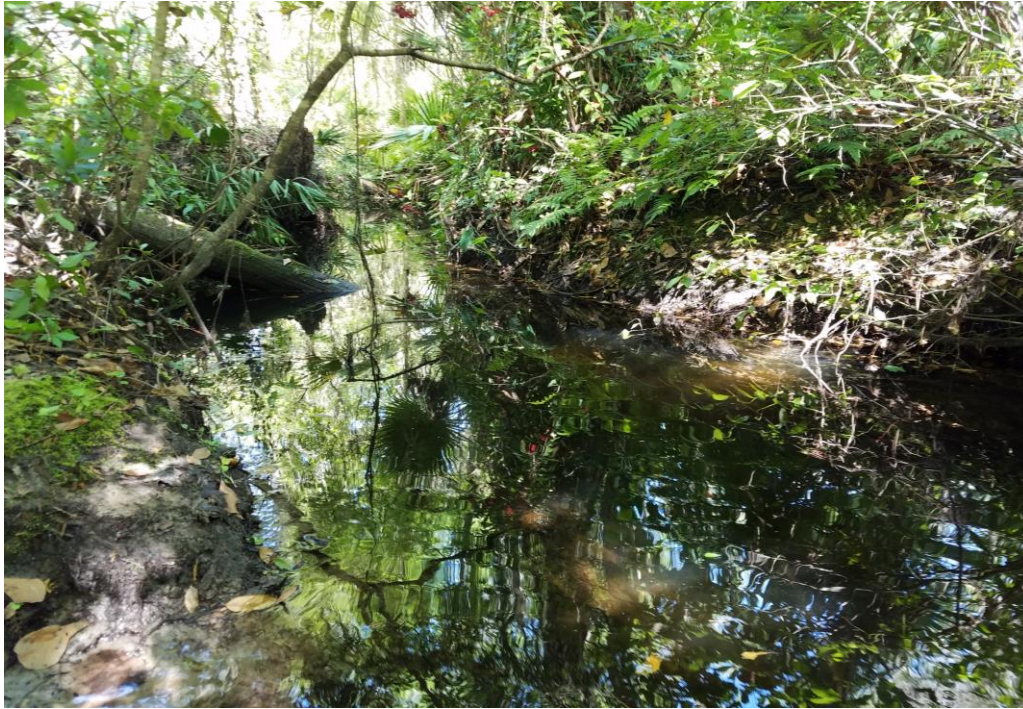
Figure 2 Overview photograph of McDonald Branch sample site

McDonald Branch received a Habitat Assessment score of 115 with no signs of artificial channelization. Primary habitat components received marginal scores for Substrate Diversity and Habitat Smothering, due to the presence of only two major productive habitats (7.3% Snags, 8.5% Roots/undercut banks) and an inadequate number of stable pools, and received suboptimal scores for Substrate Availability and Water Velocity. Secondary habitat components received optimal scores for Artificial Channelization, Bank Stability, and Riparian Buffer Zone Width. The right bank scored optimal Riparian Zone Vegetation Quality, while the left bank scored in the suboptimal range due to extensive wild hog damage along the buffer zone.
