Rice Creek

Study Area

Rice Creek is located south of the Alafia River in the town of Fishhawk, Hillsborough County Florida. The sample site selected for the study was located at Balm Riverview and was assessed on April 3, 2017. Rice Creek is located in FDEP WBID 1659 which contains 3,250 acres of land and drains into the Alafia River. The watershed surrounding Rice Creek is dominated by Residential (46.1%), Natural Land/Open Water (22.1%), and Field/Pasture (16.55%) land uses. The Landscape Development Intensity Index of the watershed is 5.36. The LDI value for the immediate 100 meter buffer around Rice Creek is 3.67 and dominated by Natural Land (44.17%), Residential (23.89%) and Cropland/Pastureland (16.08%).

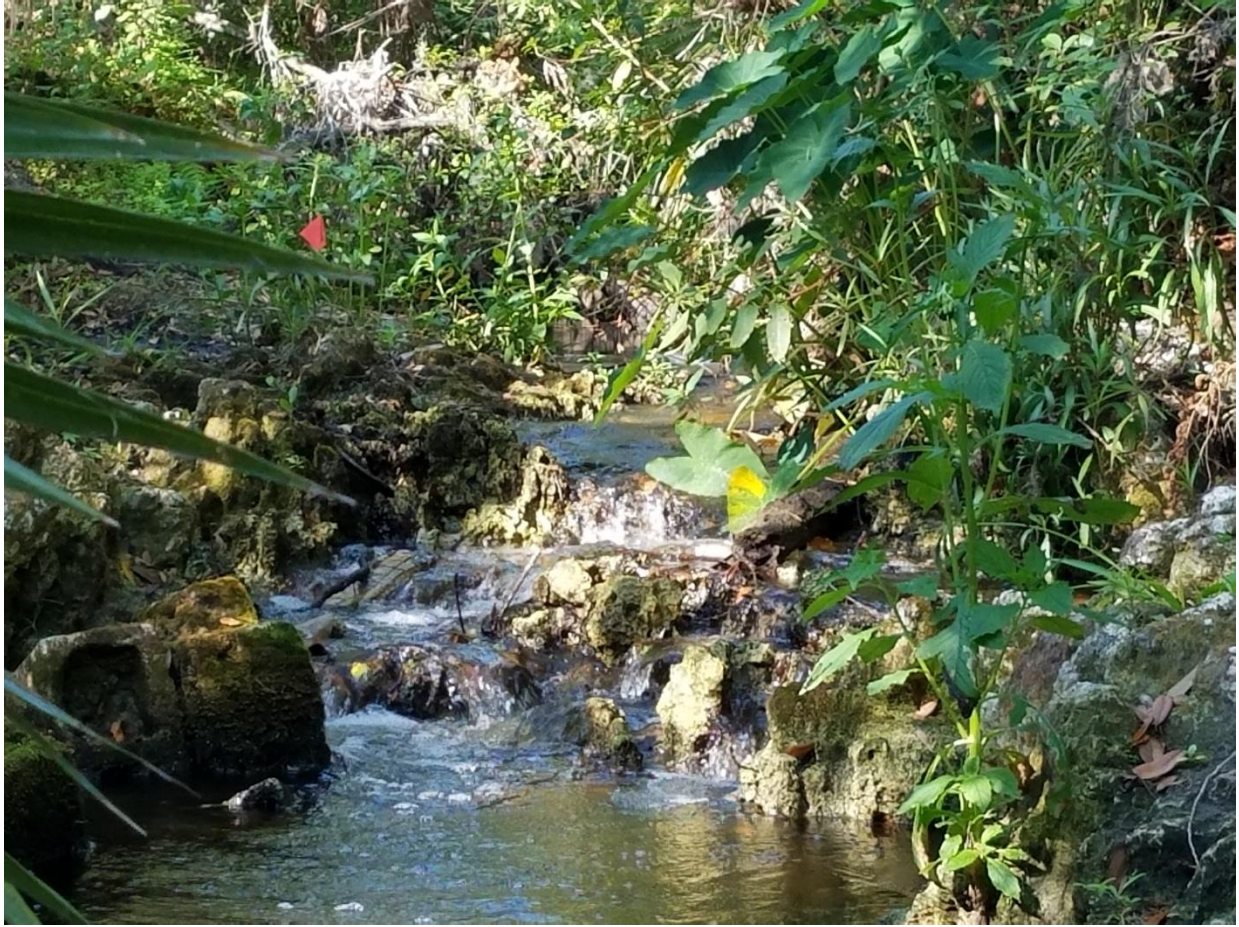
Figure 2 Overview photograph of Rice Creek at Balm Riverview Road sample site

Rice Creek achieved a Habitat Assessment score of 122. Primary habitat components received optimal scores for Substrate Diversity and Habitat Smothering, a suboptimal score for Water Velocity, and a marginal score for Substrate Availability. Secondary habitat components received optimal scores for Artificial Channelization, Bank Stability and Riparian Buffer Zone Width (right bank), and received suboptimal scores for Riparian Buffer Zone Width (left bank) and Riparian Zone Vegetation Quality.

The major productive habitats found at the sample site were Snags (2.4%), Roots/Undercut Banks (0.7%), Leaf pack/mats (2.0%), and Rock (7.0%). The water velocity was measured at the zero meter mark and averaged 0.17m/s.

During the Rapid Periphyton Survey, periphyton was observed in 5 of the 99 individual grab samples performed, and two of these points were ranked 4-6. The average canopy cover in the 100 meter region was 83%. The Secchi Disk Depth was measured as 0.5m at the 50 meter mark. The average water depth at the time of the assessment was 1.14m.
