Rocky Creek

Study Area

Habitat Assessment

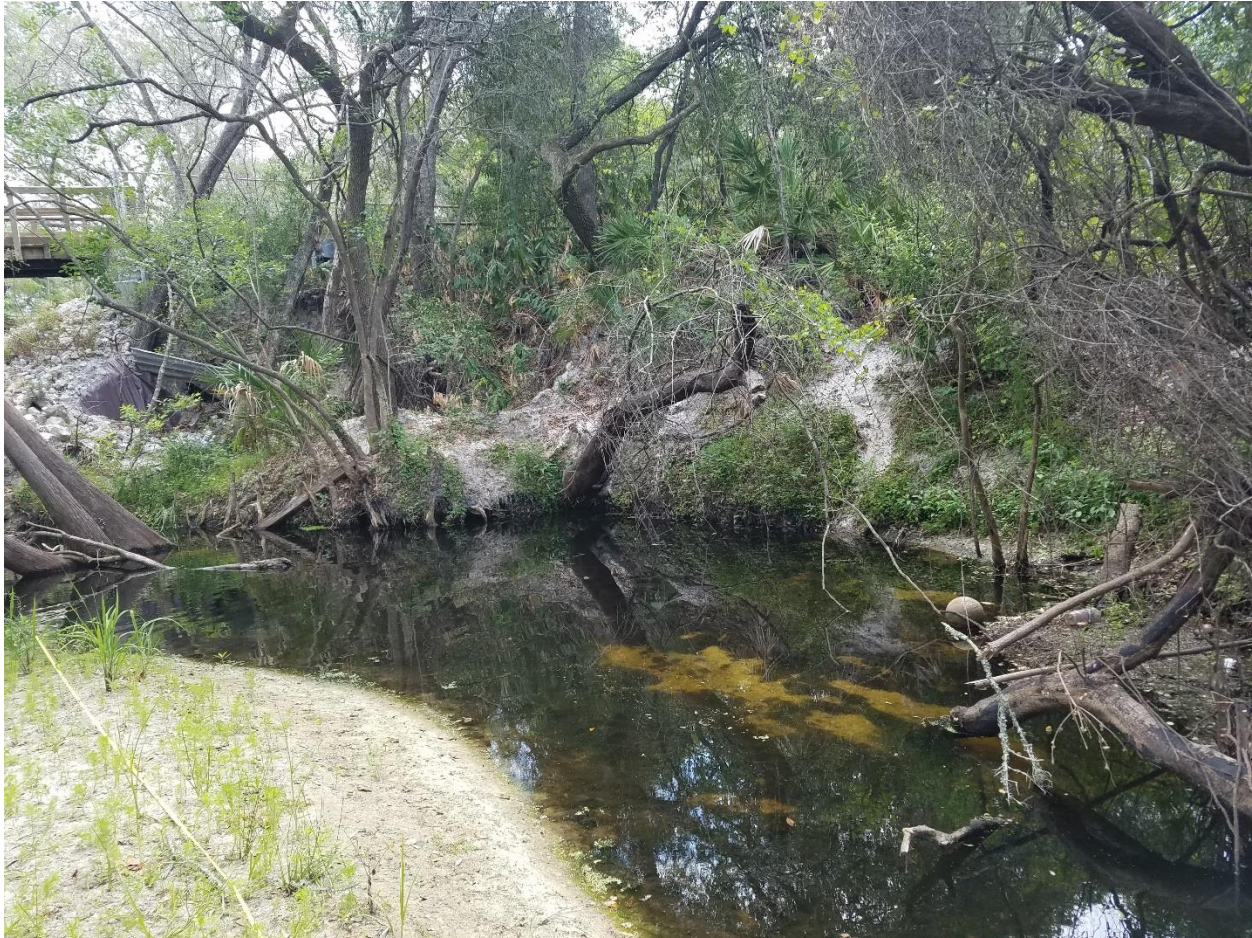
Figure 2 Overview photograph of Rocky Creek sample site

Rocky Creek near Veterans Expressway received a suboptimal Habitat Assessment score of 108. Primary habitat components received suboptimal scores for Substrate Diversity, Water Velocity and Habitat Smothering, and a poor score for Substrate Availability (2.3% Snags and 2.9% Rock). Secondary habitat components received optimal scores for Artificial Channelization, Bank Stability and Riparian Buffer Zone Width while suboptimal scores were recorded for Riparian Zone Vegetation Quality.

During the Rapid Periphyton Survey, periphyton was observed in 82 of the 99 individual grab samples performed. Of the 82 grab samples with periphyton, 71 points were ranked 4-6 (71.7%) The average canopy cover in the 100 meter region was 61.9%. The Secchi Disk Depth was measured as 1.5 meters visible on bottom at the 10 meter mark. The average water depth at the time of the assessment was 0.5 meters. The dominant species in the periphyton community was *Lyngbya spp.*

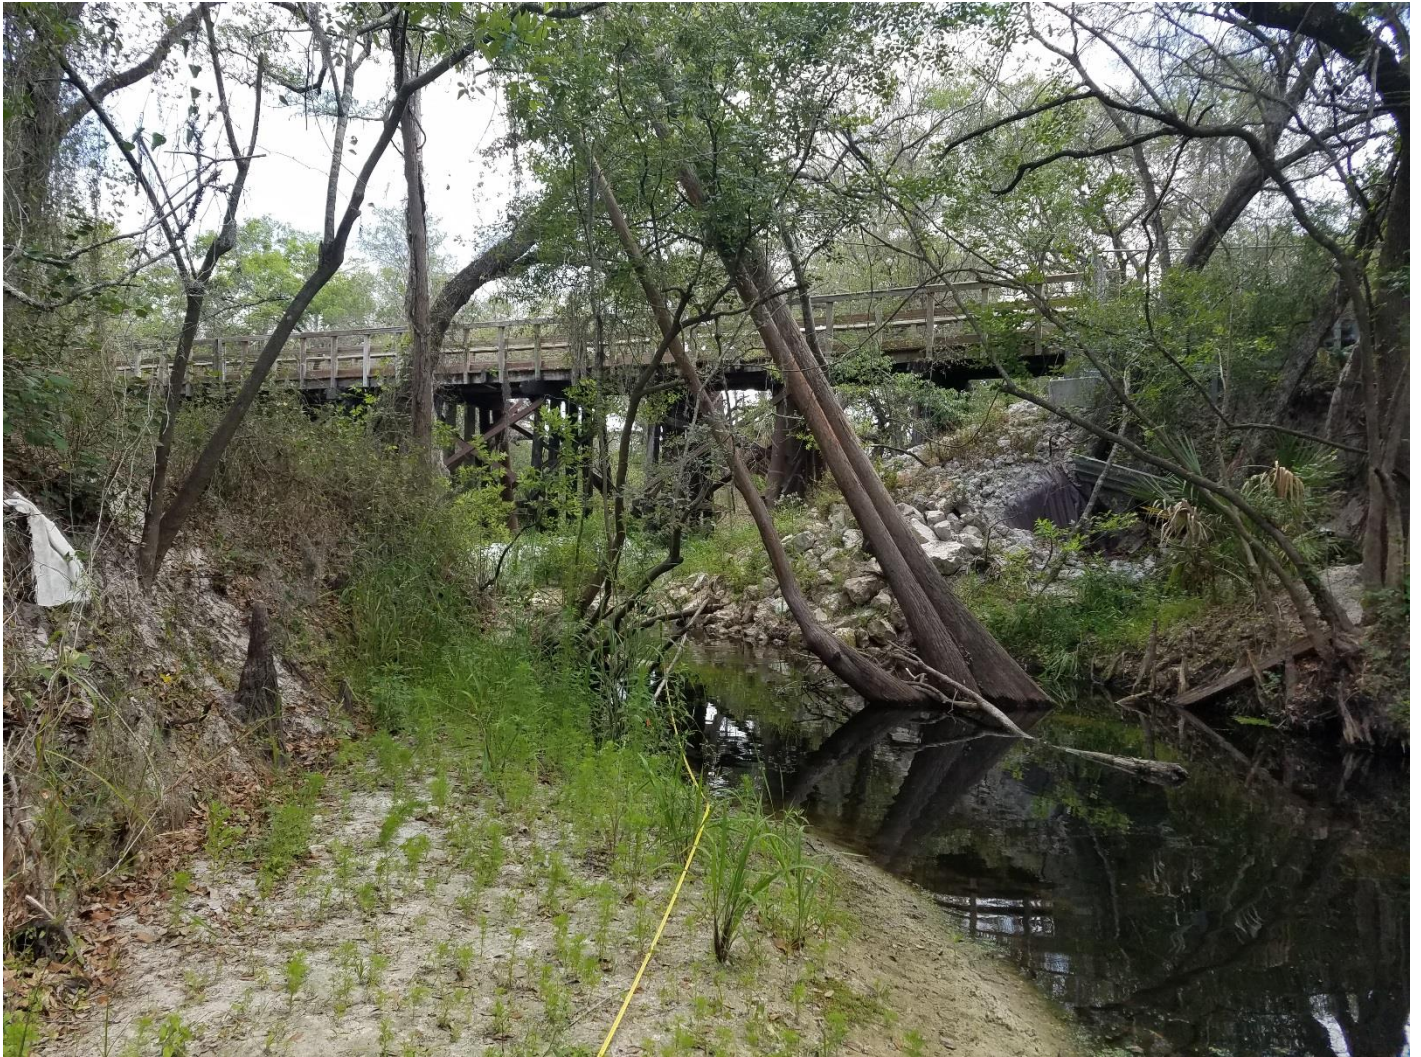
Figure 3. Shoreline conditions along Rocky Creek

The Linear Vegetation Survey identified 13 species rooted in the water at the time of the assessment. Three of these species are non-native, invasive species (*Alternanthera philoxeroides*, *Landoltia punctata* and *Salvinia minima*). There were a total of 66 species observations in the 100 meter

study area. The mean Coefficient of Conservatism (CoC) metric for the study area was 1.87 and the % FLEPPC metric for the study area was 42%.

Rocky Creek at Veterans Expressway is located with some buffer of natural, undeveloped land surrounding it in an urban landscape. The stream itself showed moderate alterations to the stream flow, buffer and banks in the region assessed. At the time of the habitat assessment, the water levels were low, corresponding to the end of the dry season, however sufficient habitat for macroinvertebrates was observed. Due to these factors, the Habit Assessment resulted in a Suboptimal score of 108. Disruption to the vegetation community was observed in the results of the Linear Vegetation Survey with Rocky Creek not meeting either metric for Average Coefficient of Conservatism or the Percent FLEPPC. Rocky
