Slomans Branch Creek

Study Area Analysis

Study Area

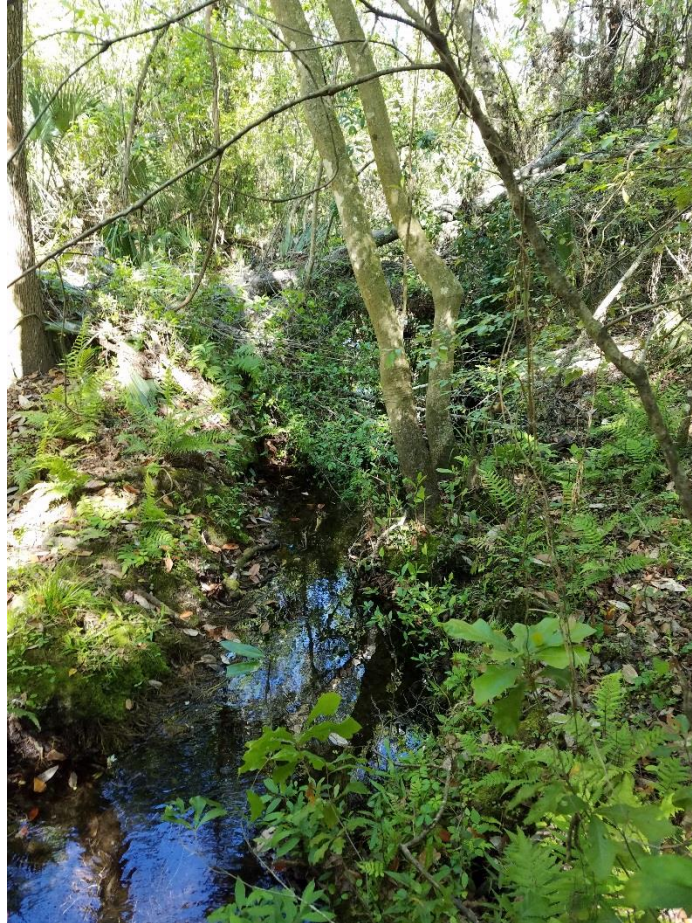
Figure 2 Overview photograph of Sломans Branch Creek sample site

Sломans Branch received a Habitat Assessment score of 101 primarily due to high scores in the secondary habitat components. Primary habitat components received a suboptimal score for Habitat Smothering, a marginal score for Water Velocity, and poor scores for Substrate Diversity and Substrate Availability. Secondary habitat components received optimal scores for Artificial Channelization, Bank Stability, and Riparian Buffer Zone Width (left bank), and received suboptimal scores for Riparian Buffer one Width (right bank) and Riparian Zone Vegetation Quality.

One major productive habitat was found at the sample site (3.5% Snags). Minor Habitats included Roots/ undercut banks (1.9%), Leaf Packs (1.8%) and Rock (0.75%) with the remainder classified as sand and shell rubble. The water velocity was measured at the 90 meter mark and averaged 0.07m/s.

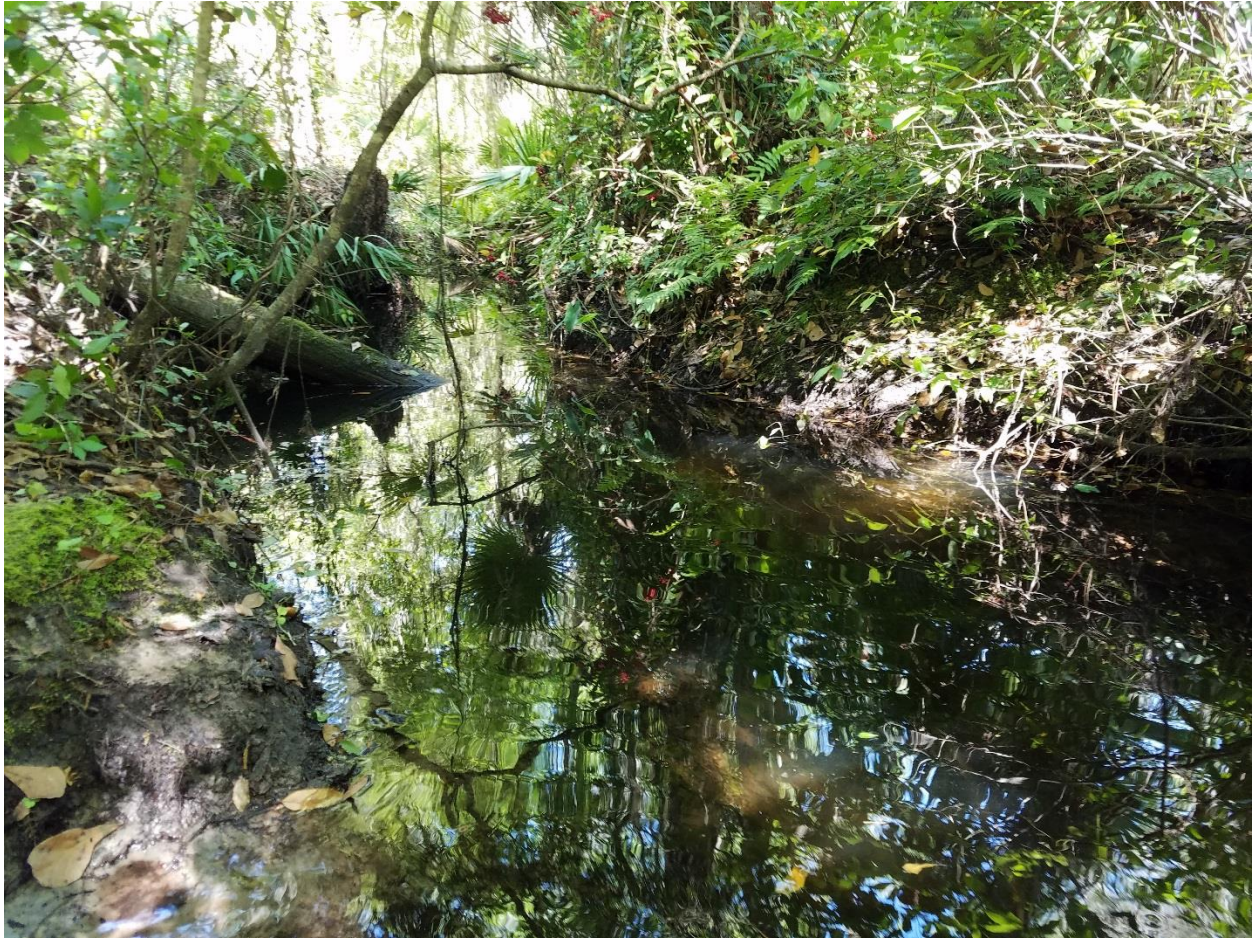
Figure 3. Typical conditions of Slomans Branch Creek at the time of the assessment

The Linear Vegetation Survey identified 5 species rooted in the water at the time of the assessment. One of these species, *Colocasia esculenta*, is classified as non-native, invasive species. The remaining 6 species are native to this region. The vegetation community along this sample location showed some evidence of frequent disturbance due to wild hogs. There were a total of 23 species observations in the 100 meter study area. The mean Coefficient of Conservatism (CoC) metric for the study area was 1.75 and the % FLEPPC metric for the study area was 9%.
