South Crystal Lake

Figure 1: 2017 South Crystal Lake Assessment Study Area Map

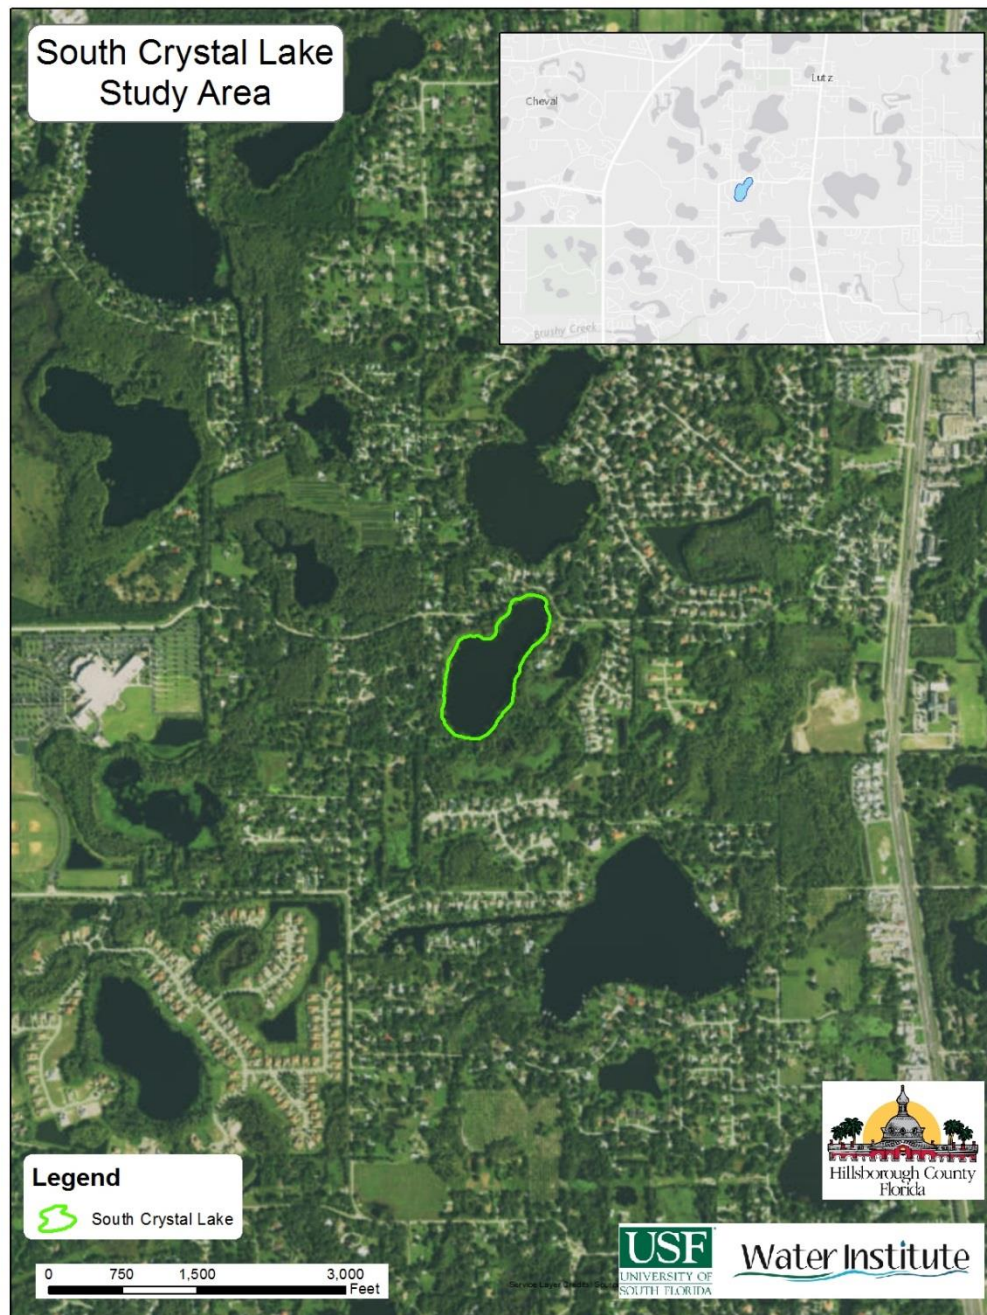
South Crystal Lake is located in the Coastal Old Tampa Bay Watershed, south of Crystal Lake Road in Lutz, Florida. The Landscape Development Intensity Index of the 100 meter buffer around South Crystal Lake is dominated by Medium Density Residential (58.48%) and Natural Lands (40.88%) land uses. The resulting LDI value for the 100 meter buffer around South Crystal Lake is 4.88.

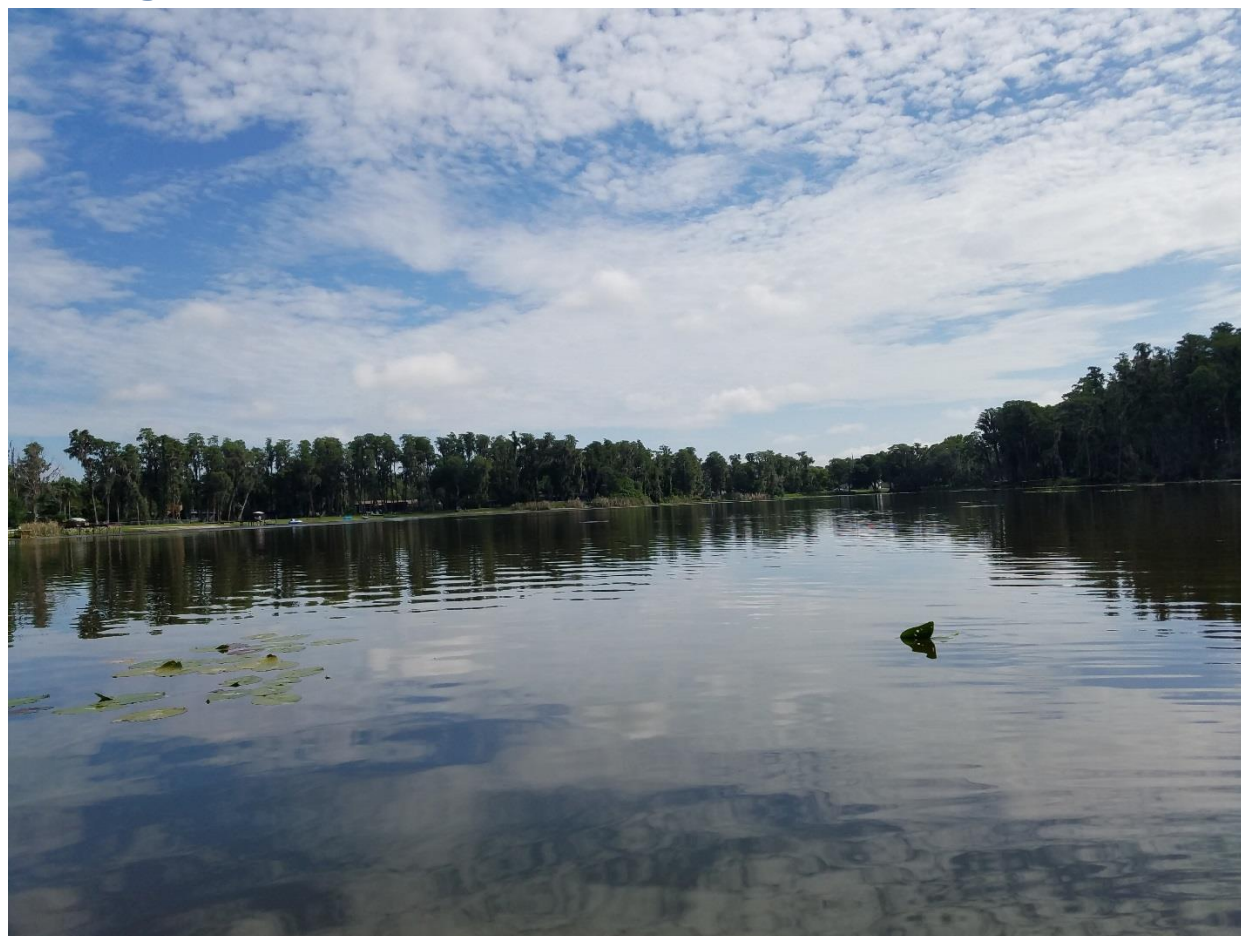
Figure 3: Overview photograph of South Crystal Lake

The lake assessment for South Crystal Lake was conducted on June 15, 2017. South Crystal Lake received a lake habitat assessment (FEDP form FD 9000-6) score of 72 due to suboptimal scores for Vegetation Quality, Stormwater Inputs and Adverse Watershed Land Use. Marginal scores were achieved for Bottom Substrate Quality, Lakeside Adverse Human Alterations and Upland Buffer Zone. Secchi received poor scores.

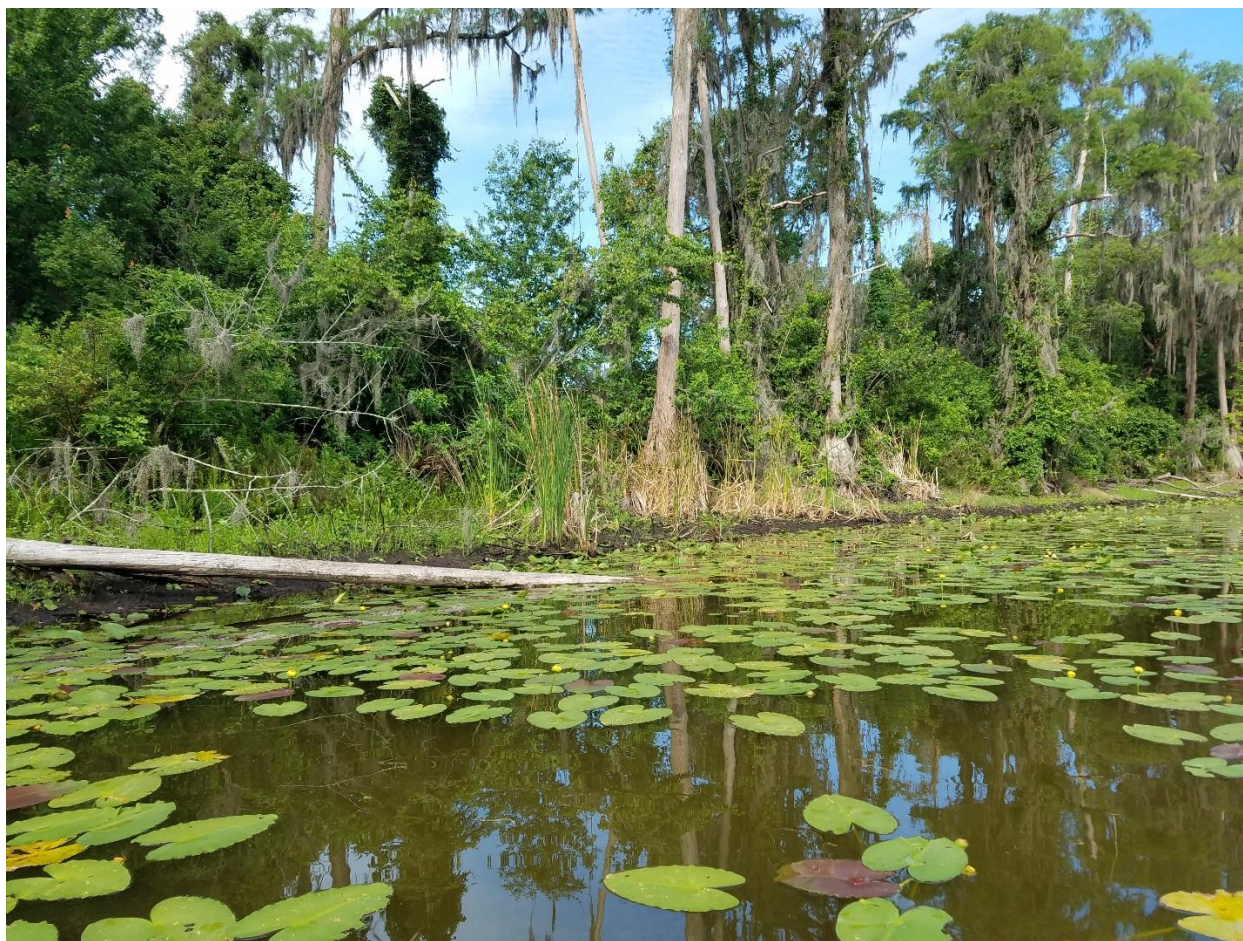
Figure 4: South Crystal Lake had a buffering zone of emergent vegetation surrounding the south eastern portion of the lake containing a mixture of native and invasive species.

The Lake Vegetation Index identified 22 species of wetland vegetation growing in the four selected sections along South Crystal Lake. The majority of these species (17) are native species. The remaining 5 species (*Panicum repens*, *Sphagneticola trilobata*, *Schinus terebinthifolius*, *Urochloa mutica*, and *Ludwigia peruviana*) are non-native and invasive to this region. The vegetation community along South Crystal Lake is dominated by a variety of emergent species including *Quercus laurifolia*, *Taxoidum*, and *Cephalanthus occidentalis*. (Figure 4). The water's surface in South Crystal Lake was dominated by *Nuphar* (Figure 5). The calculated LVI score South Crystal Lake was 37, meeting the impairment threshold of 37. Figure 6 shows the map of South Crystal Lake detailing the LVI regions used for the assessment. Table 2 details the species list results of the Lake Vegetation Index. Table 3 details the scoring result for the Lake Vegetation Index.

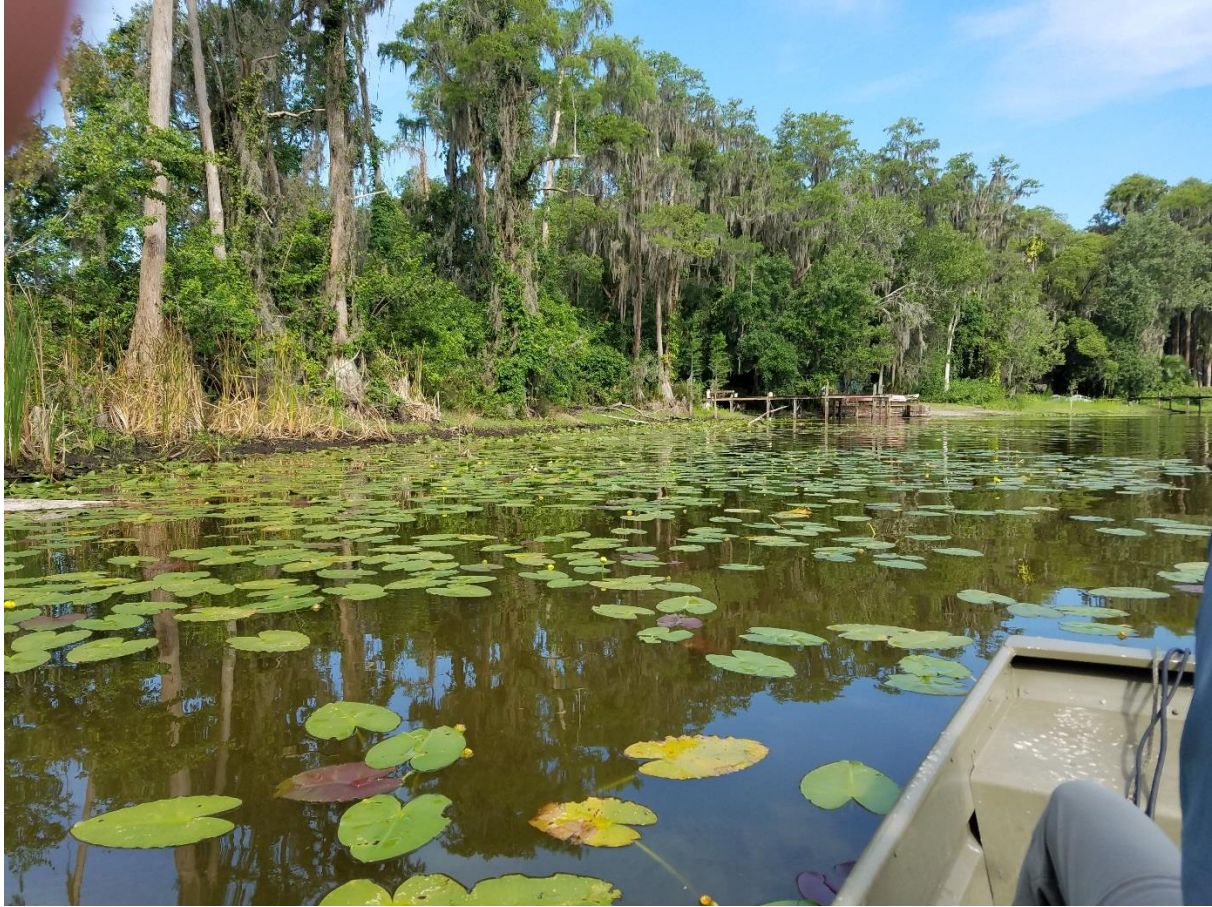
Figure 5: *Nuphar* on South Crystal Lake

By analyzing the collected sonar chart, submerged aquatic vegetation covered approximately 5.6% of the surface area of South Crystal Lake. This submerged vegetation inhabits an estimated 0.1% of the water volume in South Crystal Lake as shown in Figure 7. It should be noted that submerged aquatic vegetation was not observed visually or with the frotus sampling. While we cannot rule out the sonar returns as being SAV, it is likely to be the developing stages of *Nuphar*.

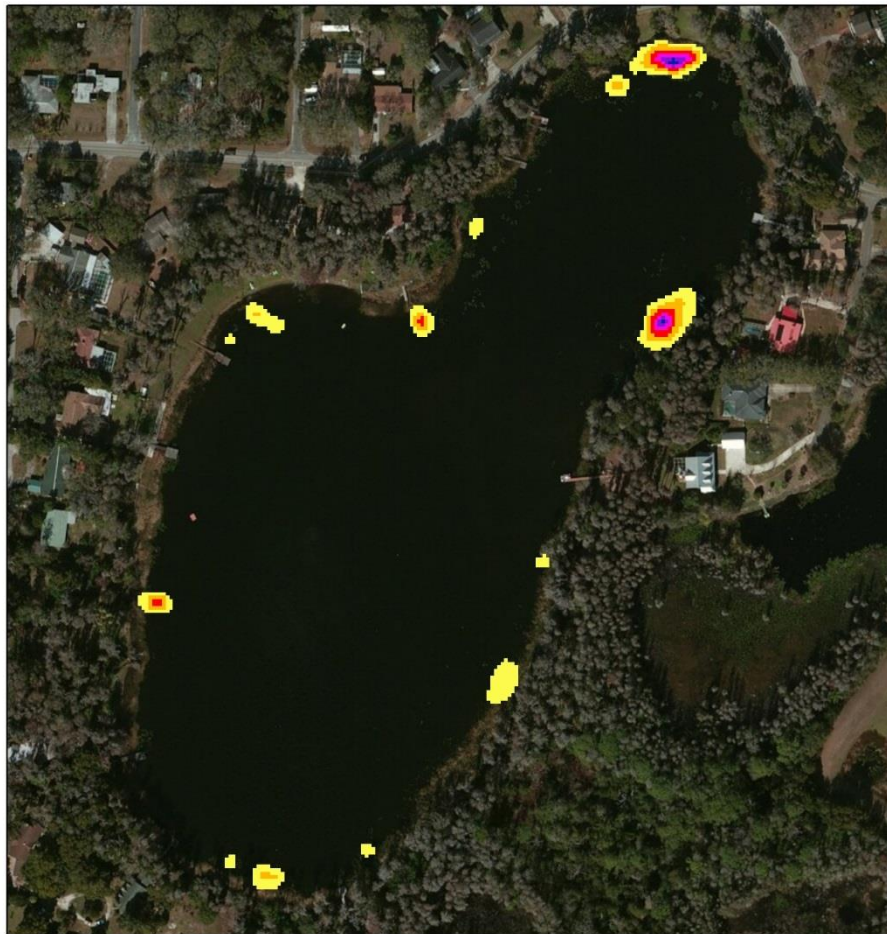
Figure 7 South Crystal Lake Submerged Aquatic Vegetation

Percent Area Covered 5.62%;
 Area of SAV 1.1 Acres;
 Percent Volume Inhabited 0.1%;
 SAV Volume 0.2 Acre-ft.
 (61,098 gallons);
