Cypress Creek

STREAM HABITAT ASSESSMENT, STREAM CONDITIONS INDEX, LINEAR VEGETATION SURVEY, RAPID PERIPHYTON SURVEY AND WATER QUALITY

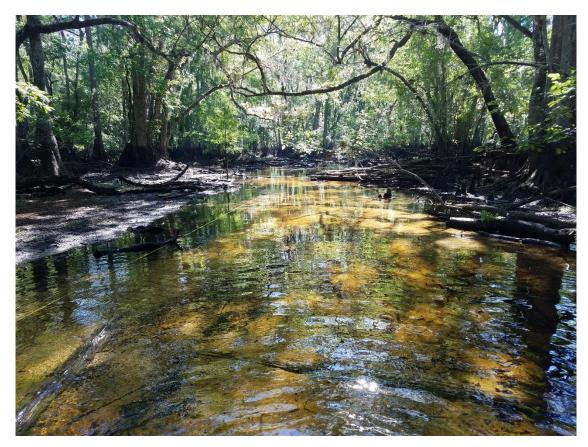
Figure 2 Overview photograph of Cypress Creek at Bruce B. Downs Blvd Sample Site

The region of Cypress Creek where the assessment was conducted is in a dominant natural area. The region was heavily shaded with a mean canopy cover measurement of 84.9%. Cypress Creek averaged 0.20 meters in depth, approximately 7.4 meters wide with a flow of 0.4 m/s.

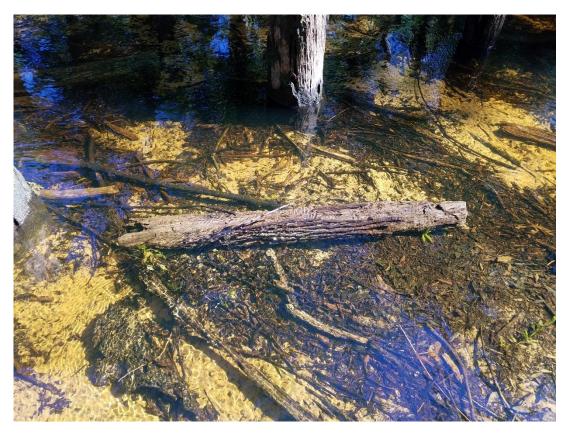
The primary habitat components of the FDEP Habitat Assessment focus on in-water habitat. The primary habitat components score in the optimal category for Water Velocity. Habitat Smothering scored in the marginal category due to insufficient pools and sand smothering. Substrate Diversity and Substrate Availability scored in the Poor category due to a single major productive habitat (Sand) comprising 5% of the stream area. Minor habitats included aquatic macrophytes, leaf packs and sand. The total score for the primary habitat components was a 37 out of 80.

${\it Figure~3~Example~of~the~major~productive~habitat~in~Cypress~Creek}$
