East Canal

STREAM HABITAT ASSESSMENT, STREAM CONDITIONS INDEX, LINEAR VEGETATION SURVEY, RAPID PERIPHYTON SURVEY AND WATER QUALITY

David Eilers | USF Water Institute | March 31, 2018

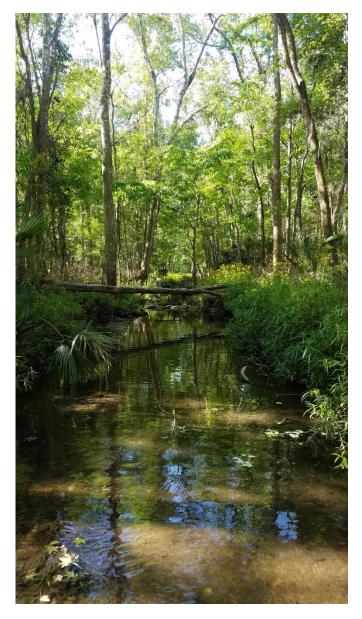
Figure 2 Overview photograph of East Canal near Bailey Road Sample Site

The region of East Canal where the assessment was conducted is on Hillsborough County Preserve land with an active cattle lease. Fences were in place to prevent livestock from being within 50 meters of the stream. The region was heavily shaded with a mean canopy cover measurement of 92%. East Canal averaged 0.3 meters in depth, approximately 3.25 meters wide with a flow of 0.13 m/s.

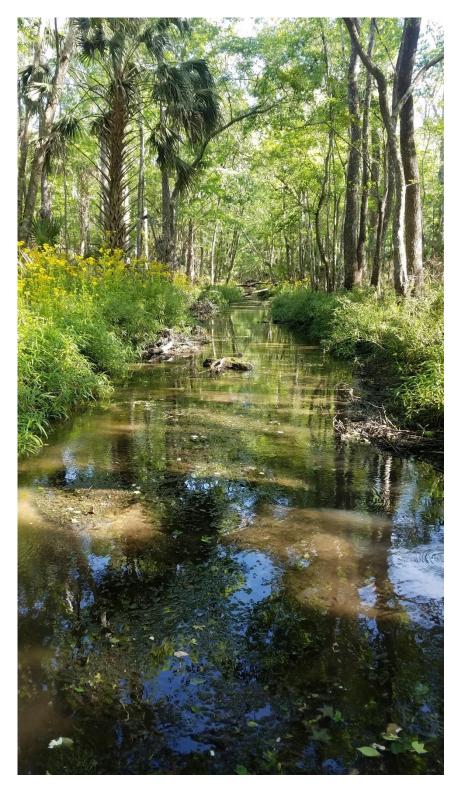
The FDEP Linear Vegetation Survey showed the aquatic vegetation was dominated by non-native invasive species with Hydrilla being present in all 10 regions and dominant in 4 regions where it covered as much as 50% of the stream. Ruellia was also common in each region. The mean Coefficient of Conservatism for the assessment was 0.48 and the Percent FLEPPC metric was 92.59%.

Figure 3 Picture of the aquatic vegetation on East Canal with Hydrilla shown in the foreground
