Lake Hanna Outlet

STREAM HABITAT ASSESSMENT, STREAM CONDITIONS INDEX, LINEAR
VEGETATION SURVEY, RAPID PERIPHYTON SURVEY AND WATER QUALITY

David Eilers | USF Water Institute | December 14, 2017

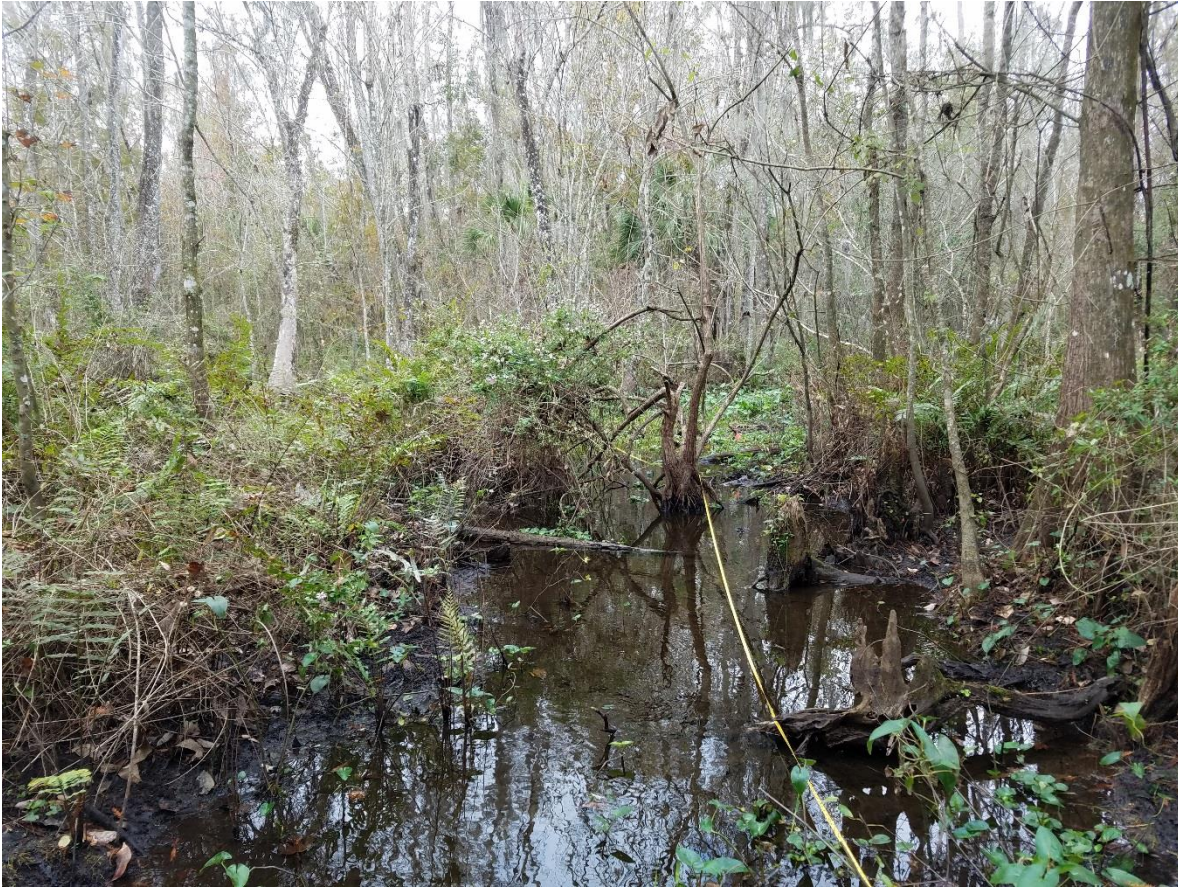
Figure 2 Overview photograph of Lake Hanna Outlet near I-275 Sample Site

At the time of the assessment, Lake Hanna Outfall water levels were receding from the prior summer seasonal rains. Using the FDEP Stream Habitat Assessment, Lake Hanna Outlet scored a 118 at the 100 meter region selected for assessment. The Stream Habitat assessment is split into Primary and Secondary Habitat Components. The primary habitat components scored in the optimal category for Substrate Diversity, containing greater than 2 square meters of each snag, root, leaf and aquatic vegetation. Some of these habitats were affected by a smothering by fine silt and sand. Suboptimal scores were recorded for Water Velocity, averaging 0.17 m/sec. Marginal scores were achieved for Substrate Availability with the region containing only 6.5% major productive habitat. Habitat Smothering received Poor scores due to the amount of siltation and sedimentation found on the productive habitats and general instability in the available pools. The total score for the Primary Habitat Components was a 40 out of a possible 80 points.

The Secondary Habitat Components scored in the Optimal category for Artificial Channelization, Bank Stability, Riparian Buffer Width and Riparian Zone Vegetation Quality. The region did not show signs of alteration, passed all three requirements for bank stability, had

greater than 18 meters of vegetative buffer on each bank and the riparian vegetative buffer contained the expected communities of plants. The majority of the non-native, invasive species have been transported from Lake Hanna.
