# Hillsborough River Reservoir

LAKE HABITAT ASSESSMENT, LAKE VEGETATION INDEX, SUBMERGED  
VEGETATION SURVEY AND WATER QUALITY

David Eilers | USF Water Institute | July 21, 2018

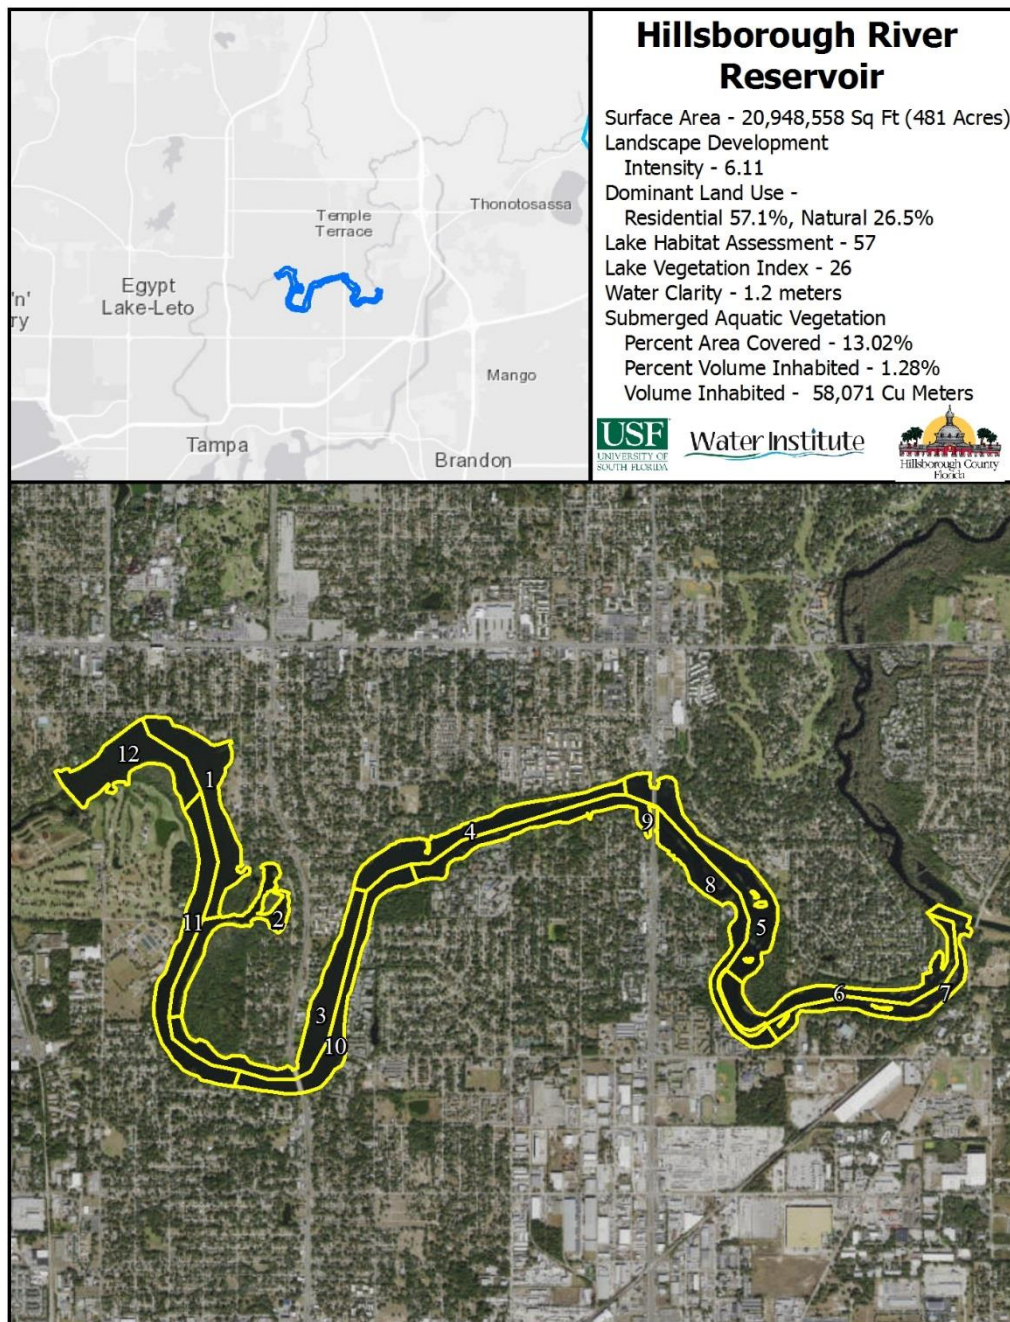
*FIGURE 1: 2018 HILLSBOROUGH RIVER RESERVOIR ASSESSMENT STUDY AREA MAP*

The Hillsborough River Reservoir is located in central Hillsborough County, Florida. The Landscape Development Intensity Index of the 100 meter buffer around the Hillsborough River Reservoir is dominated by Residential (57.1%) and Natural (26.5%) land uses. The resulting LDI value for the 100 meter buffer around Hillsborough River Reservoir is 6.11.

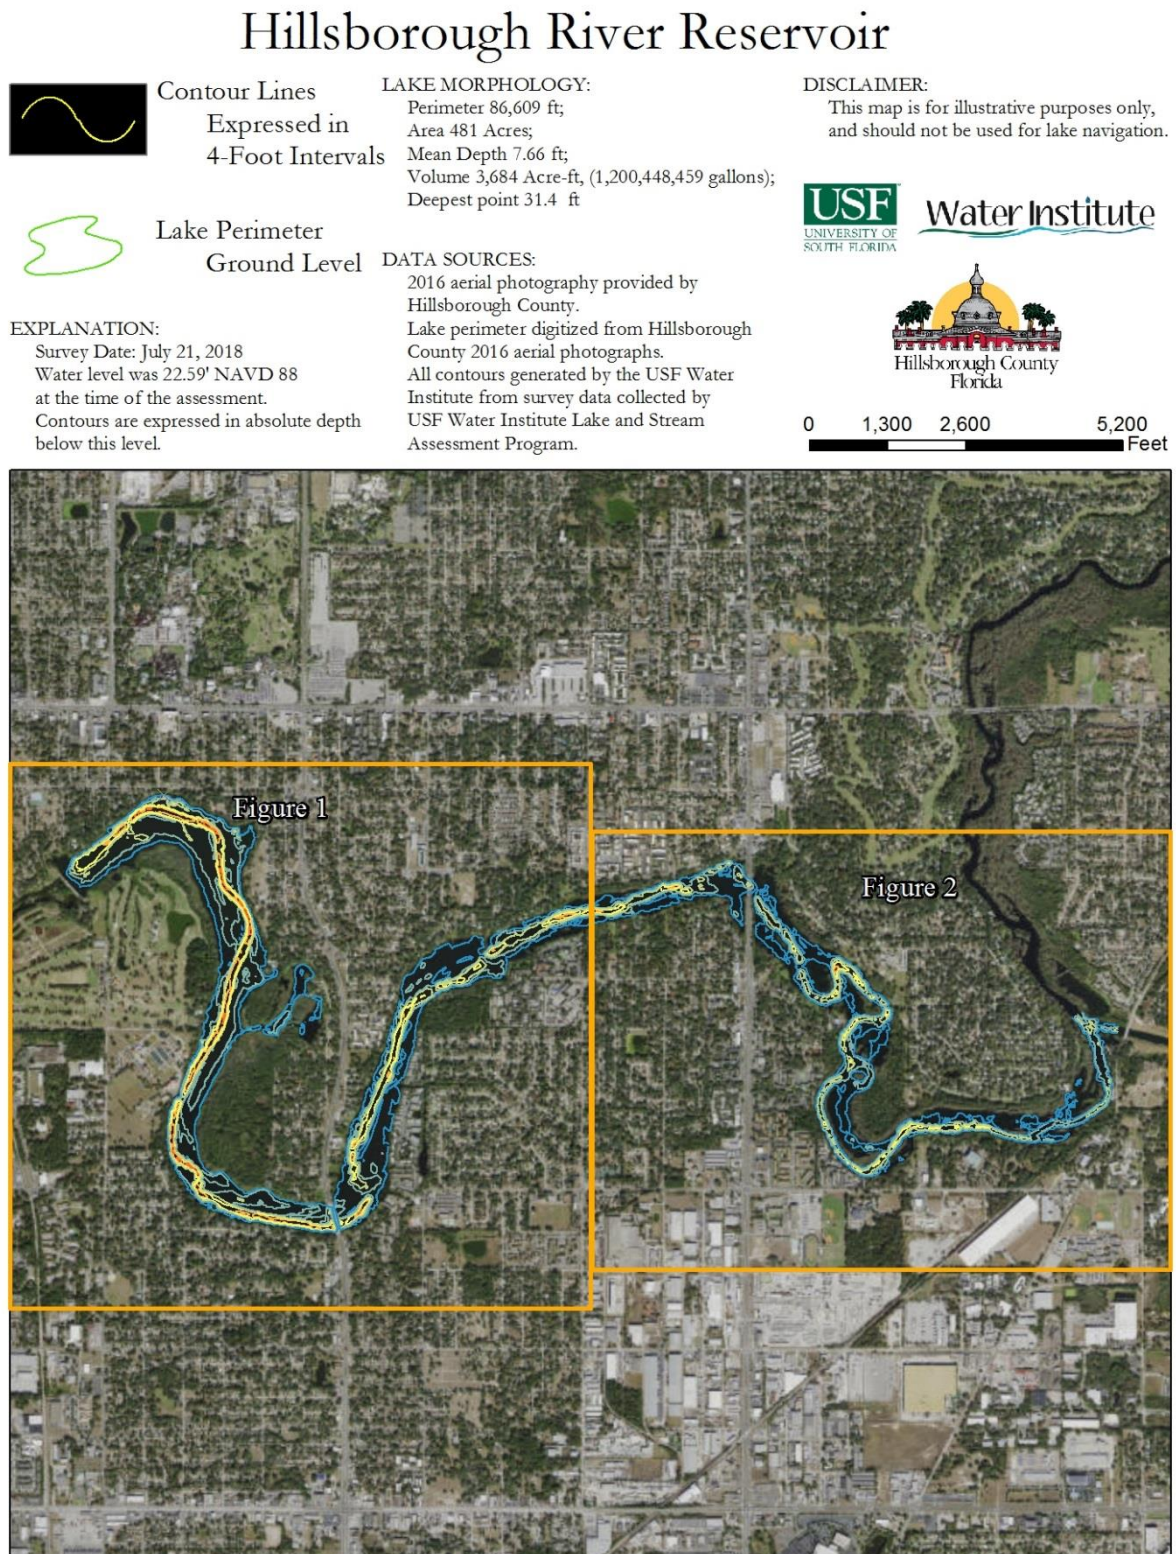
Figure 2: 2017 4-Foot Bathymetric Contour Map for Hillsborough River Reservoir

At the time of the assessment, Hillsborough River Reservoir was experiencing normal water levels (22.59 feet above sealevel NAVD 88) resulting in a 481 acre water body. Hillsborough River Reservoir at the time of the assessment had a mean water depth of 7.66 feet and a maximum observed depth of 31.4 feet. The volume at this time was approximately 1,200,448,459 gallons. Figures 2, 3 and 4 shows the resulting bathymetric contour map for Hillsborough River Reservoir from data collected on July 21, 2018. The collected data has been overlain the 2016 Hillsborough County aeriels.

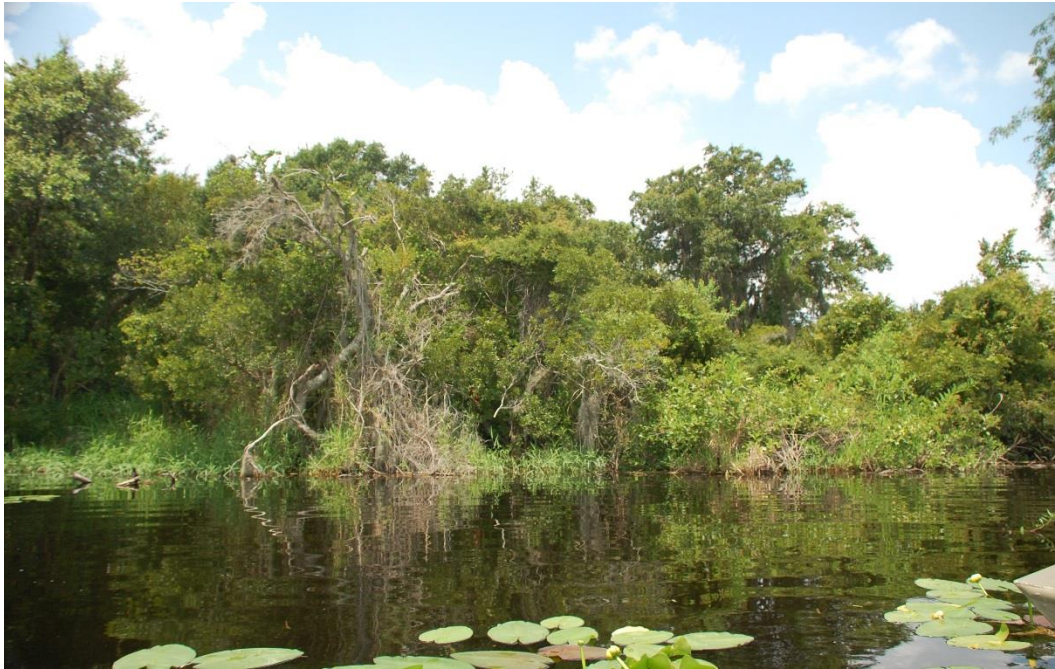
*Figure 5 Overview photograph of the Hillsborough River Reservoir showing typical shoreline vegetation in a undeveloped area.*

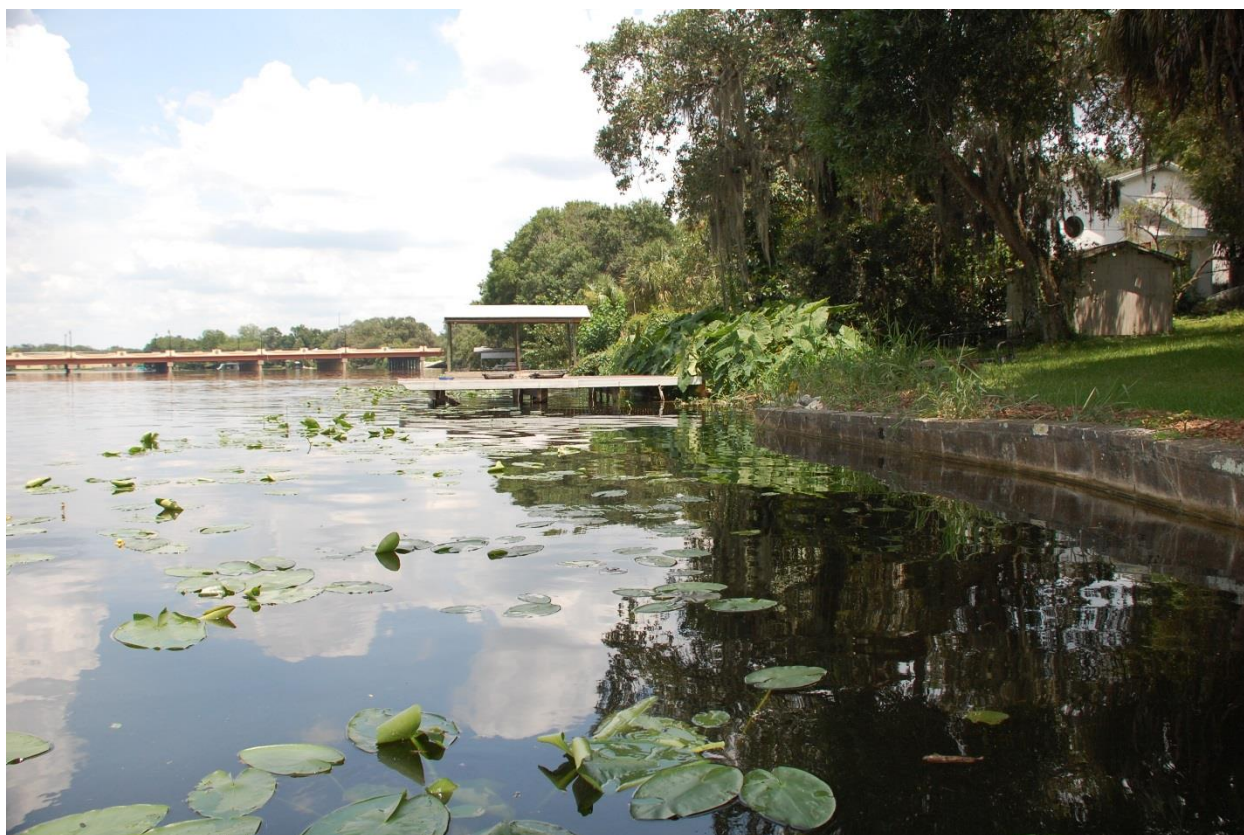
The water in the Hillsborough River Reservoir was characterized as highly tannic and moderately turbid with a color value of 111.9 PCU. The secchi disk depth was 1.1 meters in part due to the high tannins and turbidity. The vegetation quality of the plants in and buffering the Hillsborough River Reservoir are predominantly native species with moderate growths of non-native nuisance species such as *Schinus terebinthifolius*, *Panicum repens* and *Hydrilla verticillata*. Some direct inputs of stormwater were noted through pipes and ditches to the reservoir. The bottom substrate quality was dominated by sand with coarse particulate organic matter near shore and some accumulation of muck. Approximately 57% of the surrounding land has been developed for residential housing including several docks and seawalls. Few homeowners have maintained an upland buffer zone along the shoreline.

Figure 6 The shoreline of the Hillsborough River Reservoir has been developed extensively with docks and seawalls, removing the buffering capacity of shoreline vegetation.

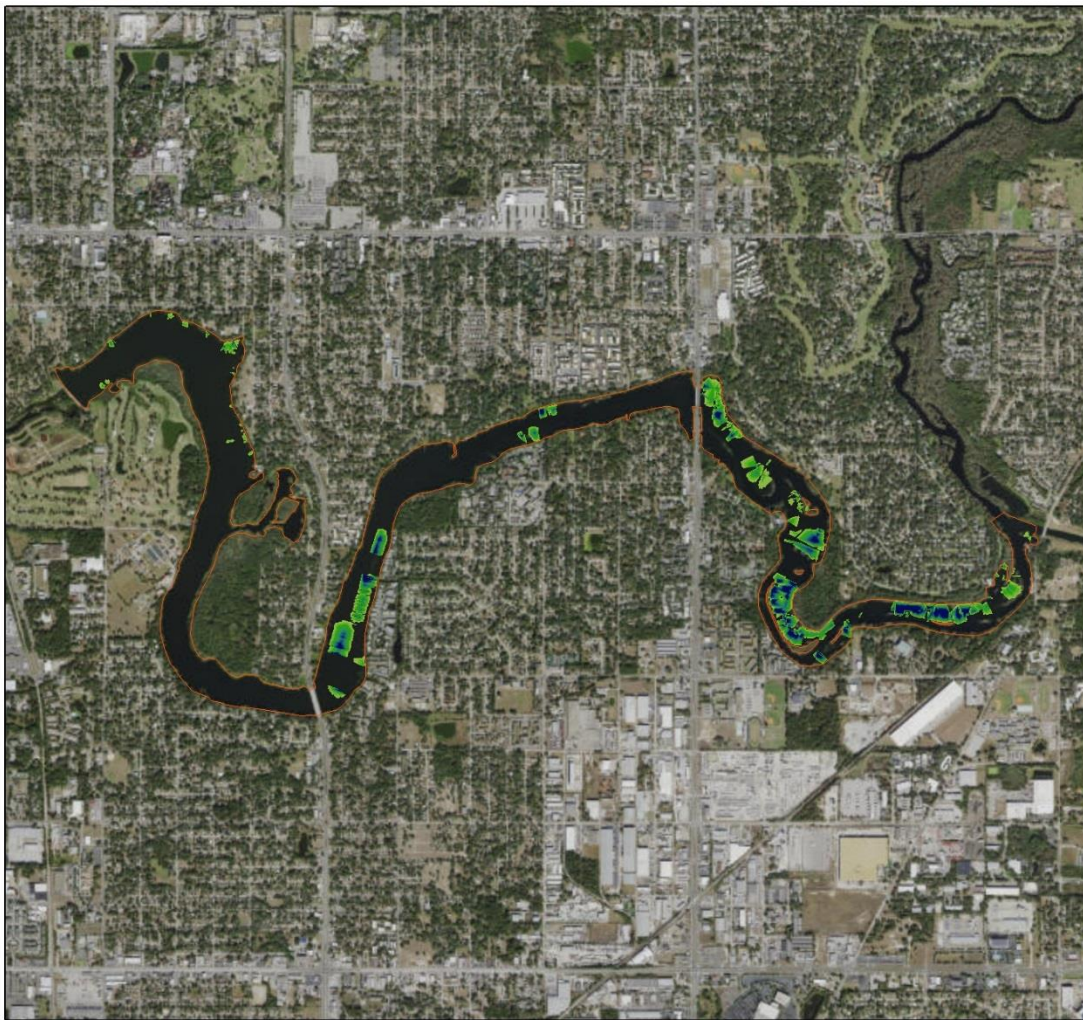
Figure 3 Hillsborough River Reservoir Submerged Aquatic Vegetation Assessment Results

Survey Date: July 21, 2018  
Water level was 22.59' NAVD 88 at the time of the assessment.  
Submerged Aquatic Vegetation was analyzed from collected sonar data.  
The height of the SAV where present is shown in 0.2 foot increments.

Area 2,727,699 square ft; 62.6 Acres;  
(13.0% of Lakes Surface Area)  
Mean SAV Height 0.75 ft;  
Volume 2,050,762 Cu ft, (15,340,869 gal);  
(1.28 % of Lakes Volume)

The Lake Vegetation Index identified 58 species of wetland vegetation growing in the four selected sections along Hillsborough River Reservoir. The majority of these species (43) are native species. The remaining 15 species (*Panicum repens*, *Alternanthera philoxeroides*, *Dioscorea bulbifera*, *Eichhornia crassipes*, *Hydrilla verticillata*, *Landoltia punctata*, *Pistia stratiotes*, *Schinus terebinthifolius*, *Urochloa mutica*, *Sphagneticola trilobata*, *Salvinia minima*, *Colocasia esculenta*, *Cyperus alternifolius*, *Ruellia simplex* and *Ludwigia peruviana*) are non-native and invasive to this region. The vegetation community along Hillsborough River Reservoir is dominated by a variety of emergent species including *Panicum repens*, *Fraxinus caroliniana*, *Taxodium* and *Schinus terebinthifolius*. The water's surface in Hillsborough River Reservoir was dominated by *Nuphar*. A total of 3 species of submerged aquatic vegetation were observed, *Hydrilla verticillata*, *Ceratophyllum demersum* and *Najas guadalupensis*. Submerged vegetation was limited in the lake due to the low water visibility and tanins blocking available light. By analyzing the collected sonar chart, submerged aquatic vegetation potentially covered approximately 13.0% of the surface area of Hillsborough River Reservoir. This submerged vegetation inhabits an estimated 1.28% of the water volume in Hillsborough River Reservoir. Figure 7 shows the results of the SAV analysis indicating the location and percent of the water column inhabited by SAV.

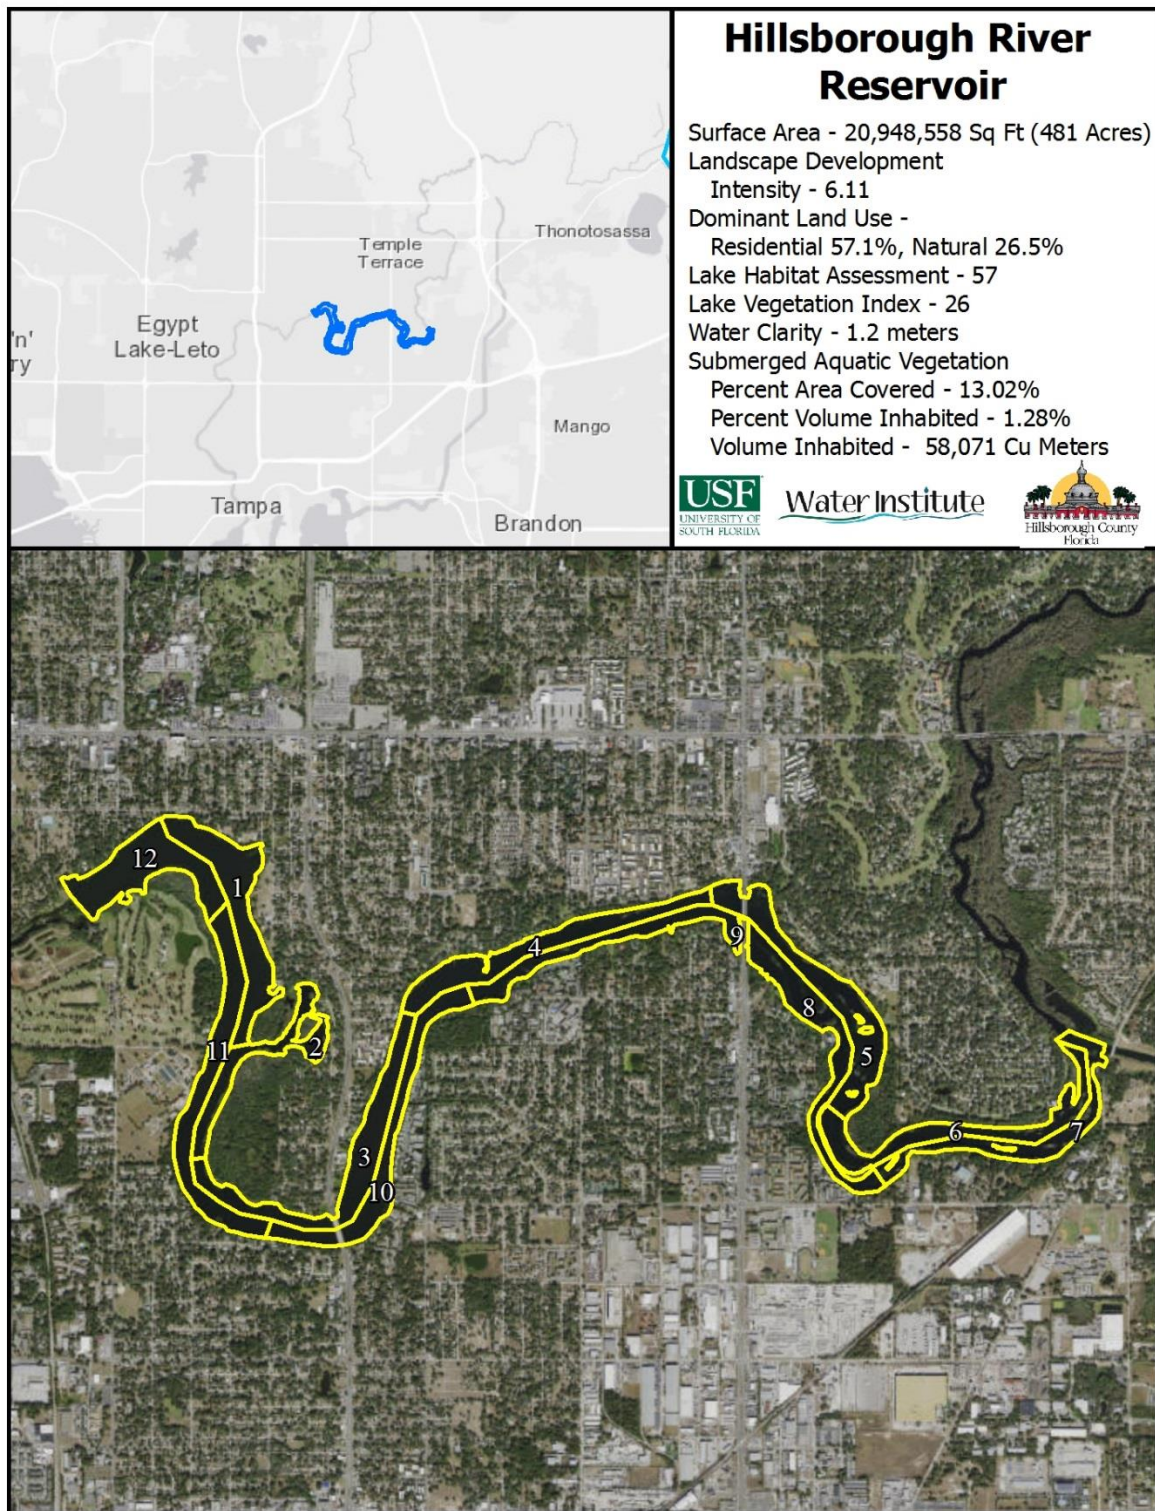
Figure 8: Lake Vegetation Index region map for Hillsborough River Reservoir

The calculated LVI score for Hillsborough River Reservoir was 26, below the impairment threshold of 37. Figure 8 shows the map of Hillsborough River Reservoir detailing the LVI regions used for the assessment (Regions 1, 4, 7, 10). Table 2 details the species list results of the Lake Vegetation Index. Table 3 details the scoring result for the Lake Vegetation Index.
