Lake Commiston

LAKE HABITAT ASSESSMENT, LAKE VEGETATION INDEX, SUBMERGED
VEGETATION SURVEY AND WATER QUALITY

David Eilers | USF Water Institute | June 14, 2018

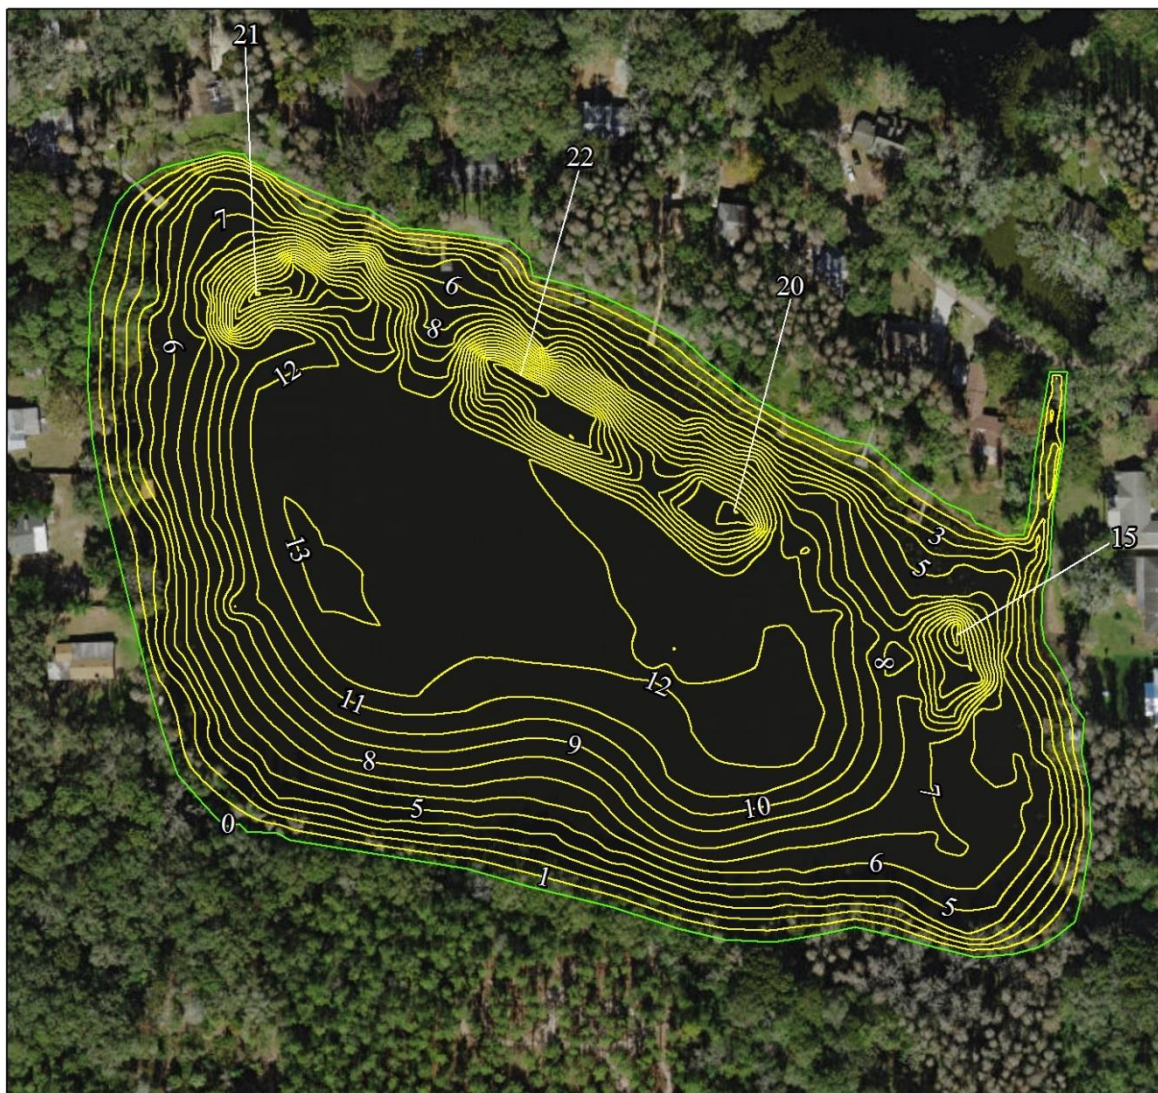
Figure 2: 2017 1-Foot Bathymetric Contour Map for Lake Commiston

Lake Commiston is a depressional system that has been heavily altered in the past due to dredge and fill operations prior to residential construction. The evidence from this activity is shown as the series of deep holes along the northern shoreline. The deepest natural depth in the lake was a little over 13 feet deep, however the dredging activities have left several areas over 20 feet in depth.

At the time of the assessment, Lake Commiston was experiencing normal water levels (61.27 feet above sealevel NAVD 88) resulting in a 16.2 acre water body. Lake Commiston at the time of the assessment had a mean water depth of 8.37 feet and a maximum observed depth of 23.23 feet. The volume at this time was approximately 44,181,809 gallons. Figure 2 shows the resulting bathymetric contour map for Lake Commiston from data collected on June 14, 2018. The collected data has been overlain the 2016 Hillsborough County aerals.

Survey Date: June 14, 2018
Water level was 61.27' NAVD 88
at the time of the assessment.
Contours are expressed in absolute depth
below this level.

Perimeter 3,774 ft;
Area 16.2 Acres;
Mean Depth 8.4 ft;
Volume 135.6 Acre-ft, (44,181,809 gallons);
Deepest point 23.23 ft

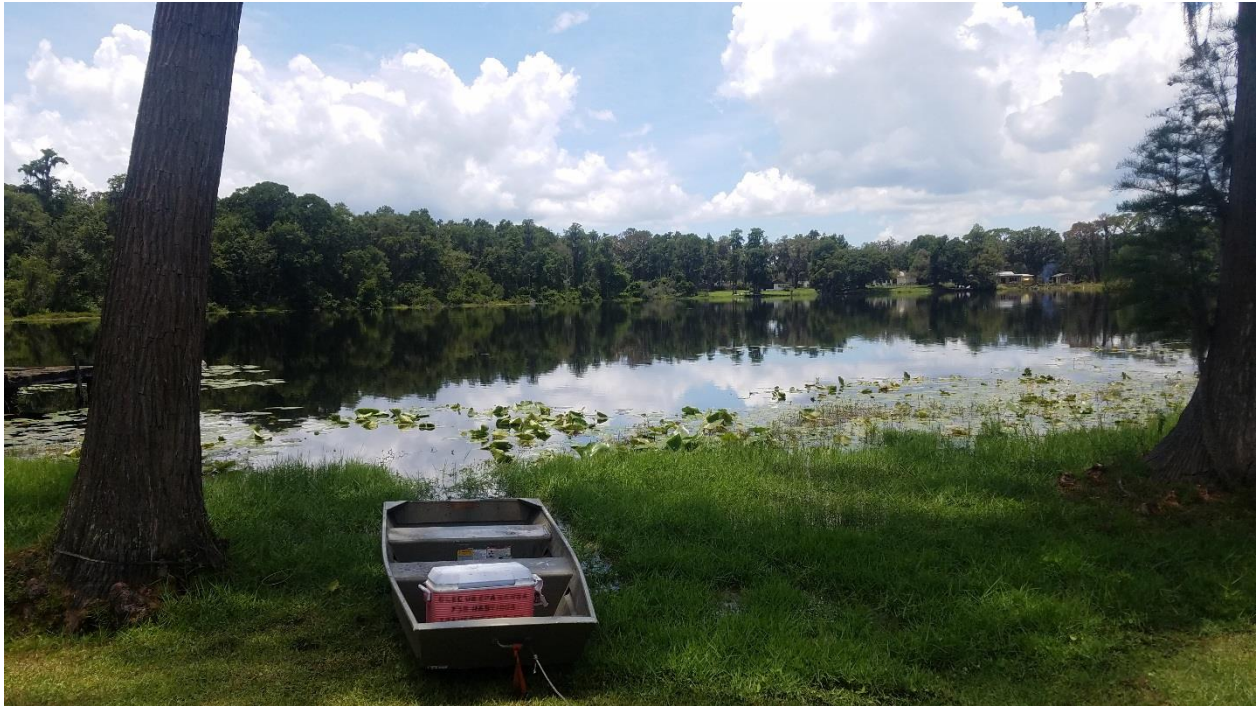
Figure 3 Overview photograph of Lake Commiston showing typical shoreline vegetation as well as the undeveloped northern shore.

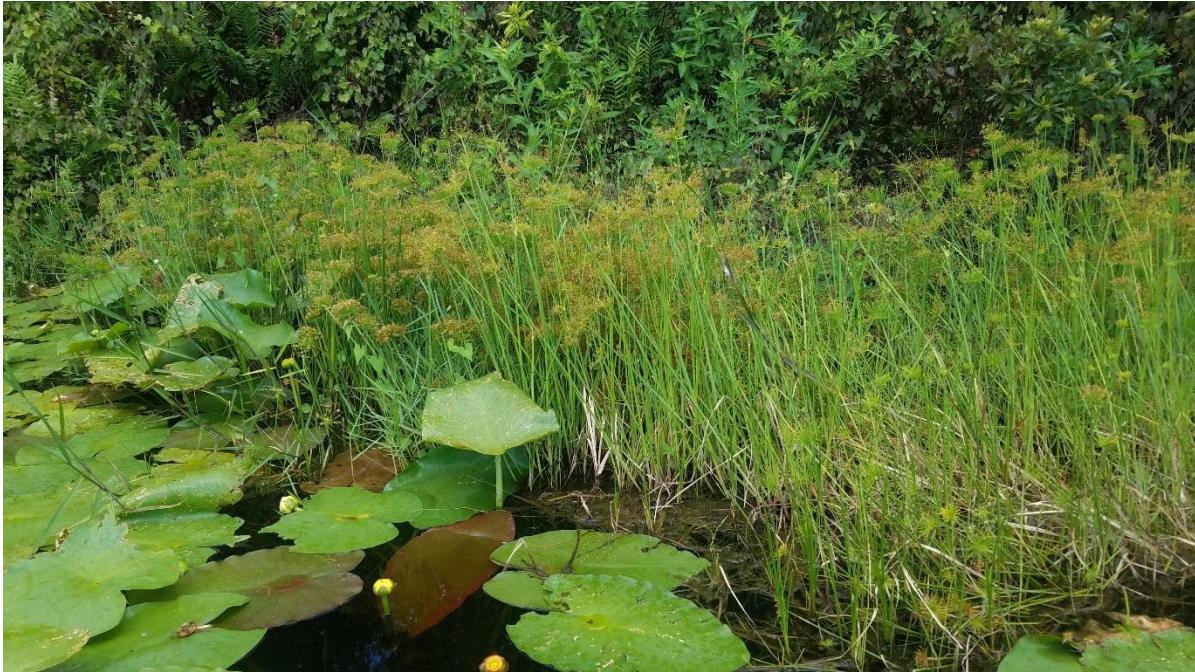
Figure 4 Lake Commiston had a buffering zone of emergent vegetation surrounding the lake containing a mixture of native and invasive species.

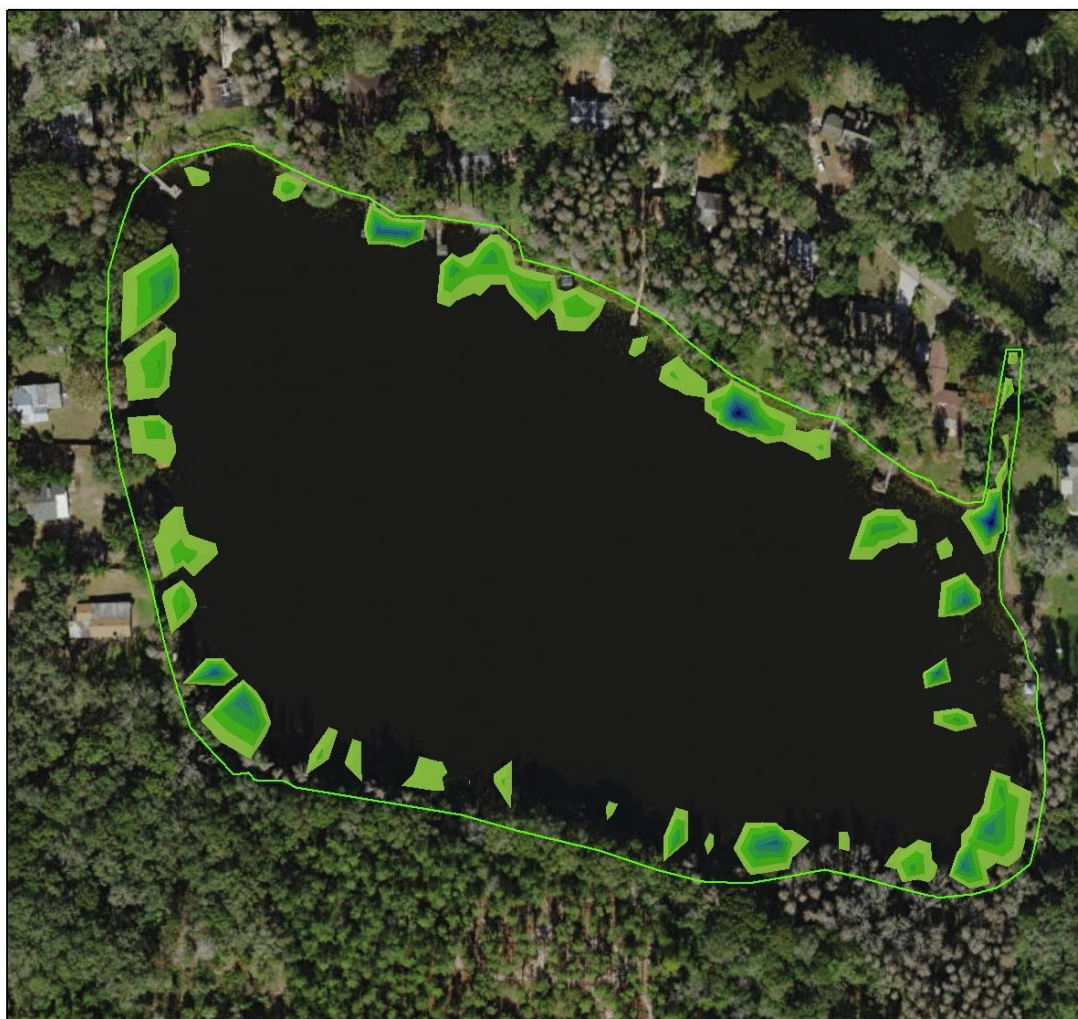
Figure 6 Lake Commiston Submerged Aquatic Vegetation Assessment Results

A total of 1 species of submerged aquatic vegetation was observed, *Eleocharis baldwinii*. Submerged vegetation was rarely observed in the lake due to the low water visibility and tanins blocking available light. By analyzing the collected sonar chart, submerged aquatic vegetation potentially covered approximately 11.01% of the surface area Lake Commiston. This submerged vegetation inhabits an estimated 0.28% of the water volume in Lake Commiston. Figure 6 shows the results of the SAV analysis indicating the location and percent of the water column inhabited by SAV.

Survey Date: June 14, 2018
 Water level was 61.27' NAVD 88 at the time of the assessment.
 Submerged Aquatic Vegetation was analyzed from collected sonar data.
 The height of the SAV where present is shown in 0.2 foot increments.

Area 77,716 square ft; 1.8 Acres;
 (11.01% of Lakes Surface Area)
 Mean SAV Height 0.22 ft;
 Volume 16,751 Cubic ft, (125,310 gallons);
 (0.28% of Lakes Volume)

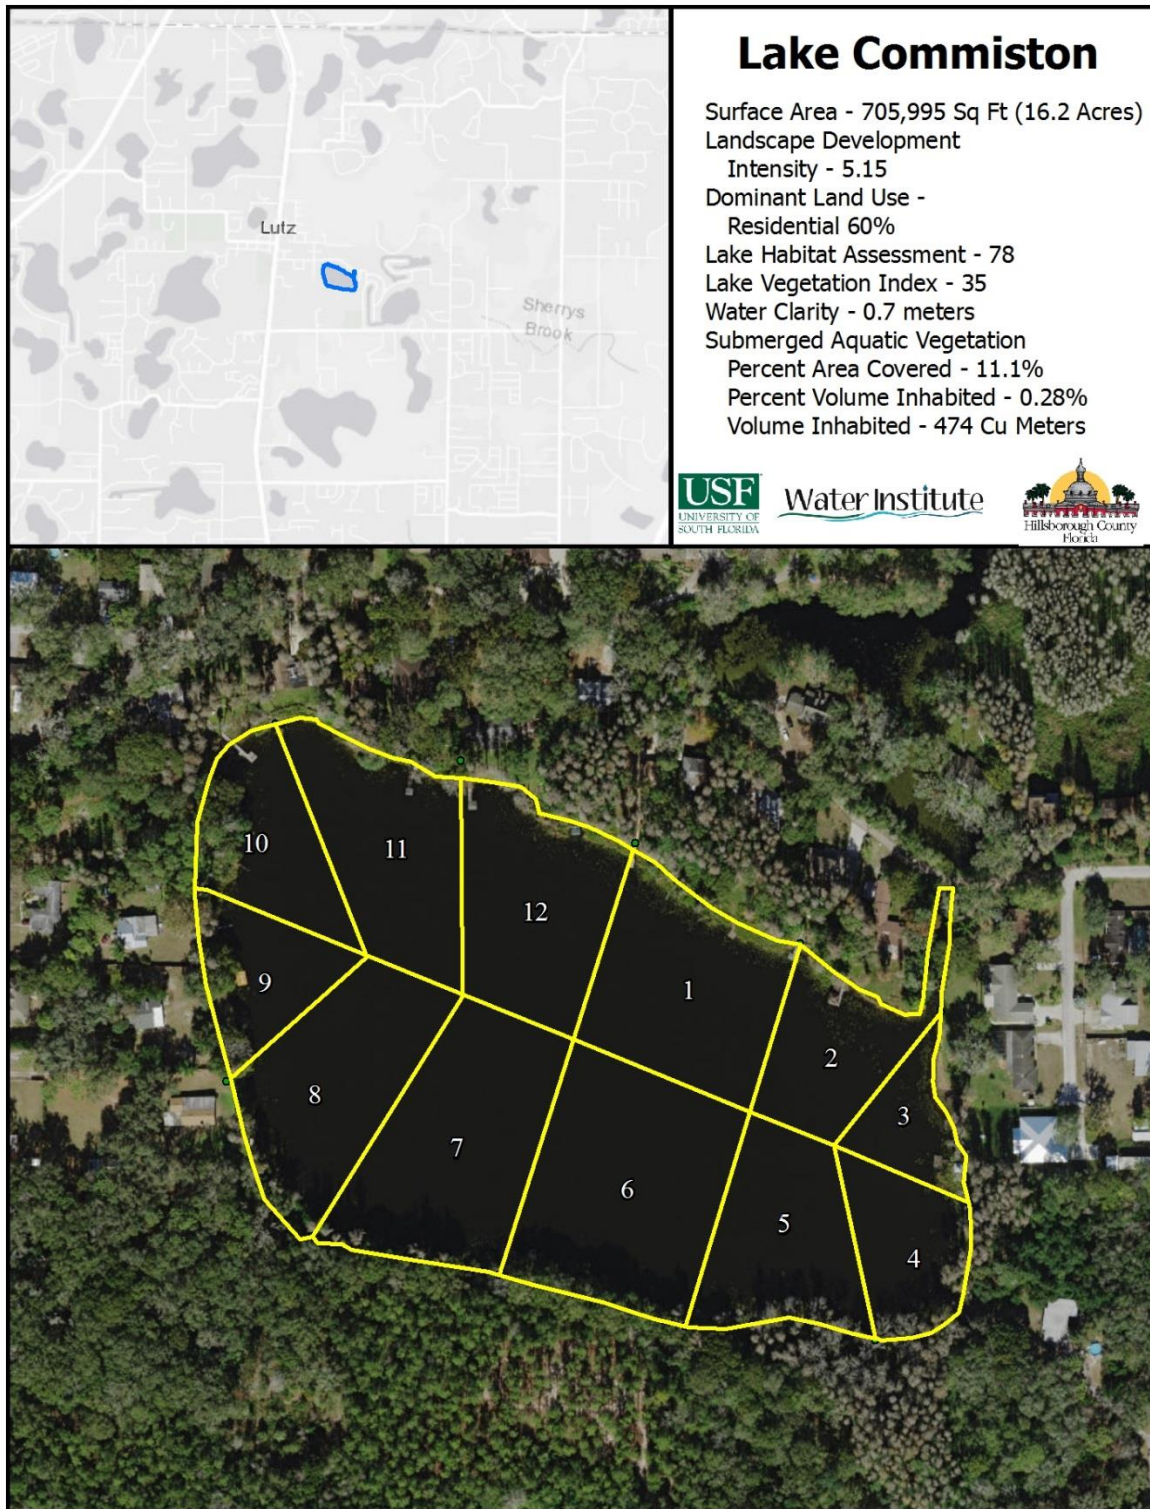
Figure 7: Lake Vegetation Index region map for Lake Commiston

The calculated LVI score for Lake Commiston was 35, below the impairment threshold of 37. Figure 8 shows the map of Lake Commiston detailing the LVI regions used for the assessment

(Regions 2, 5, 8, 11). Table 2 details the species list results of the Lake Vegetation Index. Table 3 details the scoring result for the Lake Vegetation Index.
