# Lake Keene

LAKE HABITAT ASSESSMENT, LAKE VEGETATION INDEX, SUBMERGED  
VEGETATION SURVEY AND WATER QUALITY

David Eilers | USF Water Institute | June 20, 2018

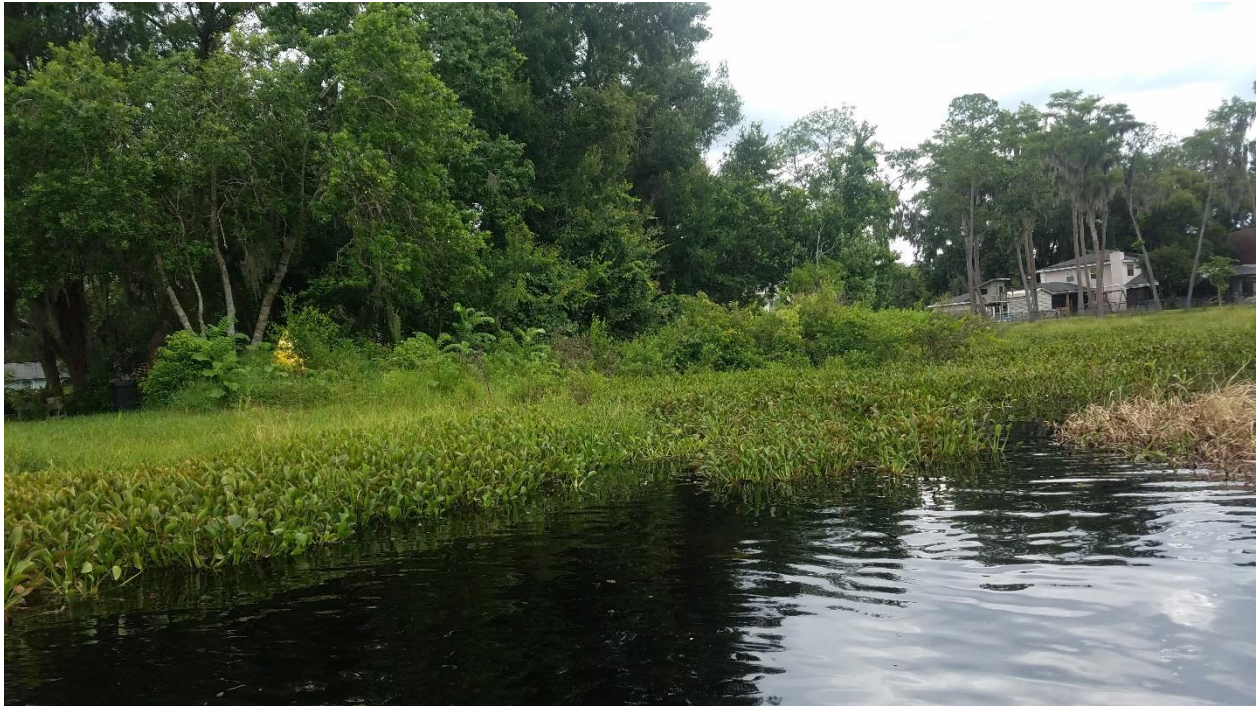
Figure 3 Overview photograph of Lake Keene showing typical shoreline vegetation dominated by *Eichhornia*.

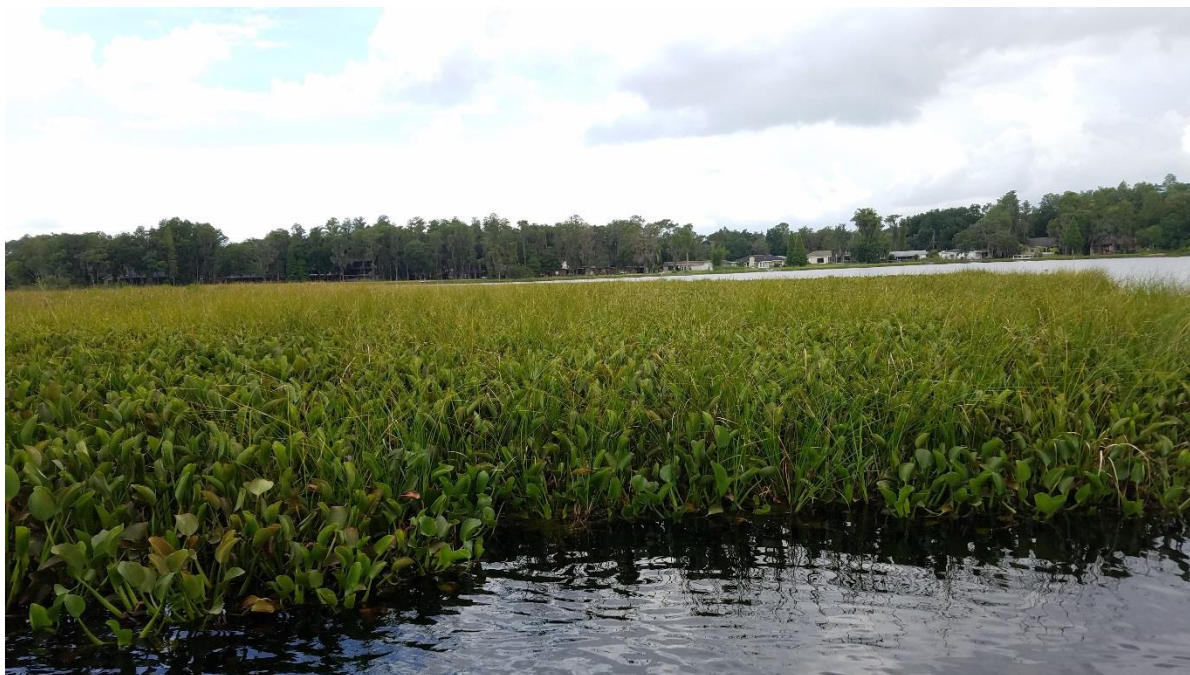
The water in Lake Keene was characterized as highly tannic and slightly turbid with a color value of 52.6 PCU. The secchi disk depth was 1.1 meters in part due to the high tannins and turbidity. The vegetation quality of the plants in and buffering Lake Keene are dominated by growths of non-native nuisance species such as *Eichhornia crassipes* and *panicum repens*. Some direct inputs of stormwater were noted through pipes and ditches to the lake. The bottom substrate quality was dominated by sand with coarse particulate organic matter near shore and some accumulation of muck. Approximately 67.2% of the surrounding land has been developed for residential housing including several docks. The majority of homeowners have removed the upland buffer zone along the shoreline.

Figure 4 Lake Keene had an abundant growth of *Eichhornia crasipes* at the time of the assessment.

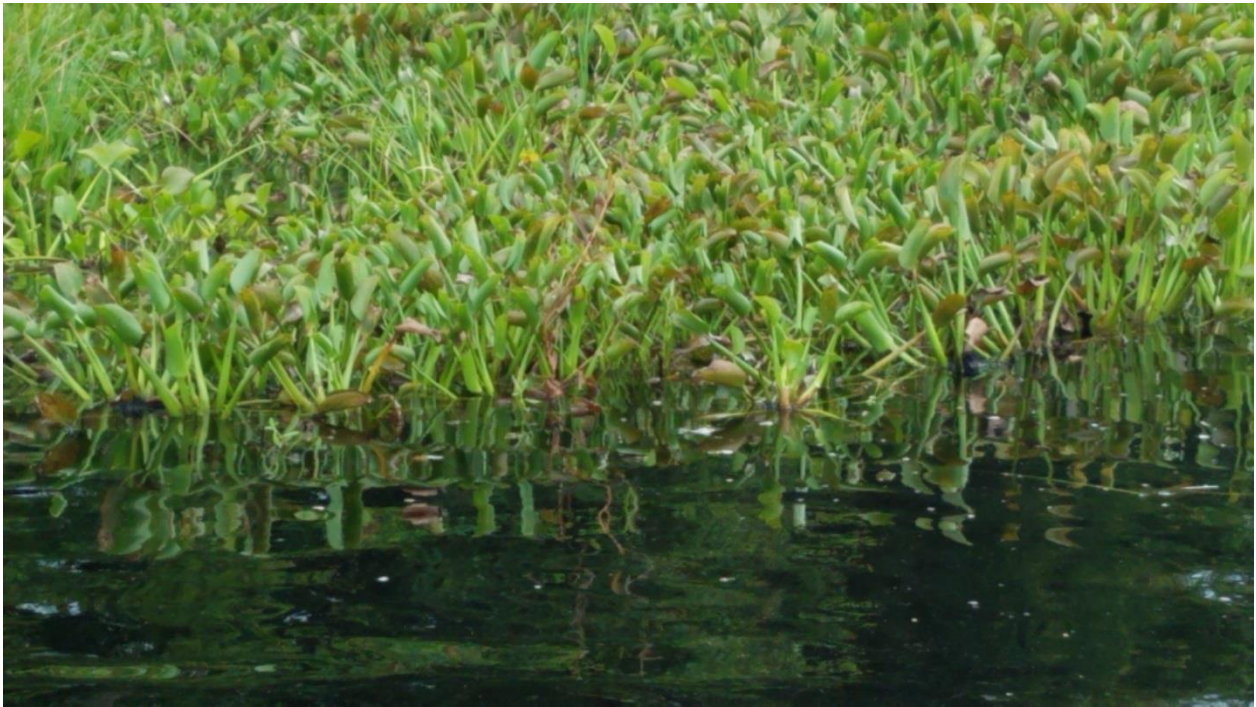
The Lake Vegetation Index identified 41 species of wetland vegetation growing in the four selected sections (Region 2, 5, 8, 11) along Lake Keene. The majority of these species (29) are native species. The remaining 12 species (*Panicum repens*, *Alternanthera philoxeroides*, *Oxycaryum cubense*, *Salvinia minima*, *Eichhornia crassipes*, *Sphagneticola trilobata*, *Urochloa mutica*, *Echinochloa crusgalli*, *Melaleuca quinquenervia*, *Schinus terebinthifolius*, *Sapium sebiferum* and *Ludwigia peruviana*) are non-native and invasive to this region. The vegetation community along Lake Keene is dominated by a variety of emergent species including *Panicum repens*, *Oxycaryum cubense*, *Taxodium* and *Ludwigia peruviana*. The water's surface in Lake Keene was dominated by *Eichhornia crassipes* (Figure 5).

*Figure 5 Eichhornia crassipes dominated the water surface in Lake Keene*

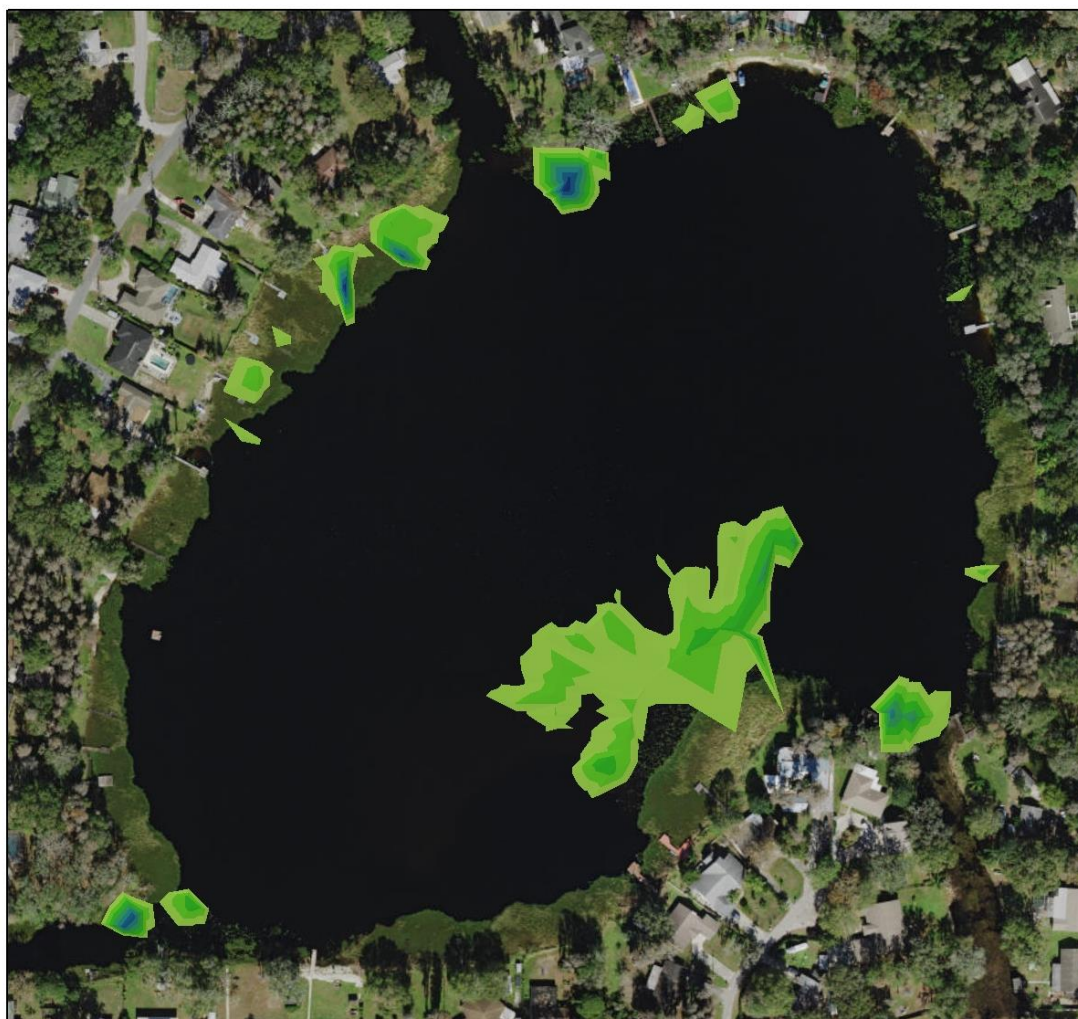
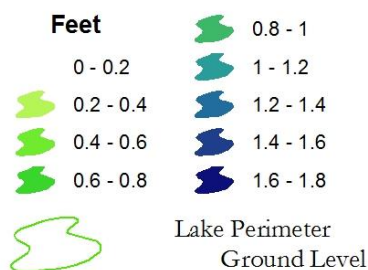
Figure 6 Lake Keene Submerged Aquatic Vegetation Assessment Results

A total of 2 species of submerged aquatic vegetation was observed, *Nitella* and *Eleocharis baldwinii*. Submerged vegetation was rarely observed in the lake due to the large floating mats of *Eichhornia*. By analyzing the collected sonar chart, submerged aquatic vegetation potentially covered approximately 9.1% of the surface area Lake Keene. This submerged vegetation inhabits an estimated 0.3% of the water volume in Lake Keene. Figure 6 shows the results of the SAV analysis indicating the location and percent of the water column inhabited by SAV.

Survey Date: June 20, 2018  
 Water level was 63.28' NAVD 88 at the time of the assessment.  
 Submerged Aquatic Vegetation was analyzed from collected sonar data.  
 The height of the SAV where present is shown in 0.2 foot increments.

Area 117,775 square ft; 2.7 Acres;  
 (9.1% of Lakes Surface Area)  
 Mean SAV Height 0.22 ft;  
 Volume 25,680 Cubic ft, (192,104 gallons);  
 (0.3 % of Lakes Volume)
