# Lake Stemper

LAKE HABITAT ASSESSMENT, LAKE VEGETATION INDEX, SUBMERGED  
VEGETATION SURVEY AND WATER QUALITY

David Eilers | USF Water Institute | June 13, 2018

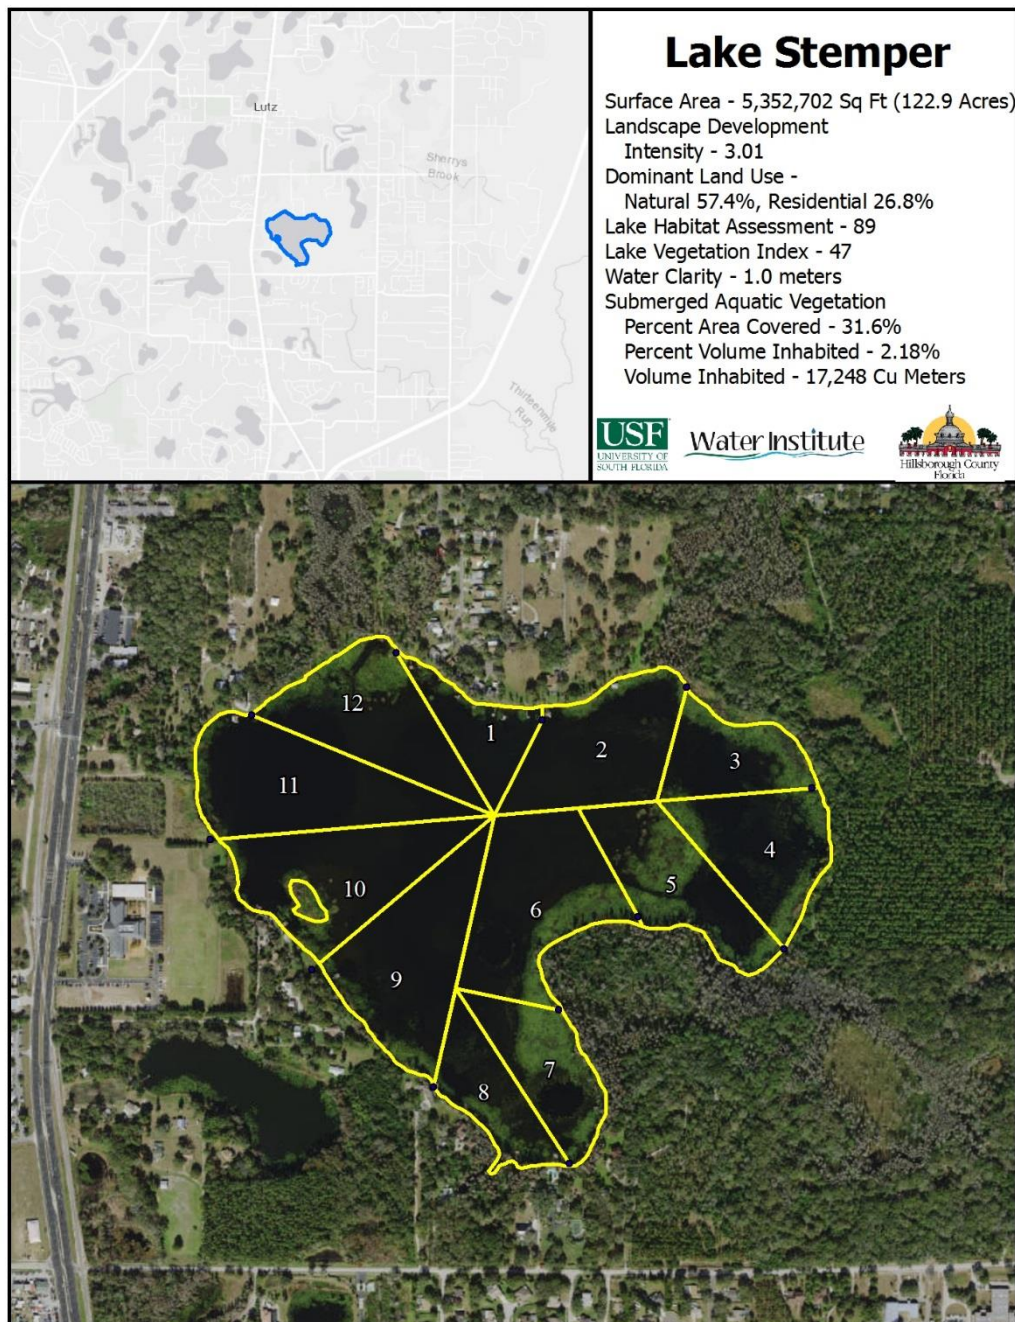
*FIGURE 1: 2018 LAKE STEMPER ASSESSMENT STUDY AREA MAP*

Lake Stemper is located south of Sunset Lane in the Lutz area of Hillsborough County, Florida. The Landscape Development Intensity Index of the 100 meter buffer around Lake Stemper is dominated by Natural (57.4%) and Residential (26.8%) land uses. The resulting LDI value for the 100 meter buffer around Lake Stemper is 3.01.

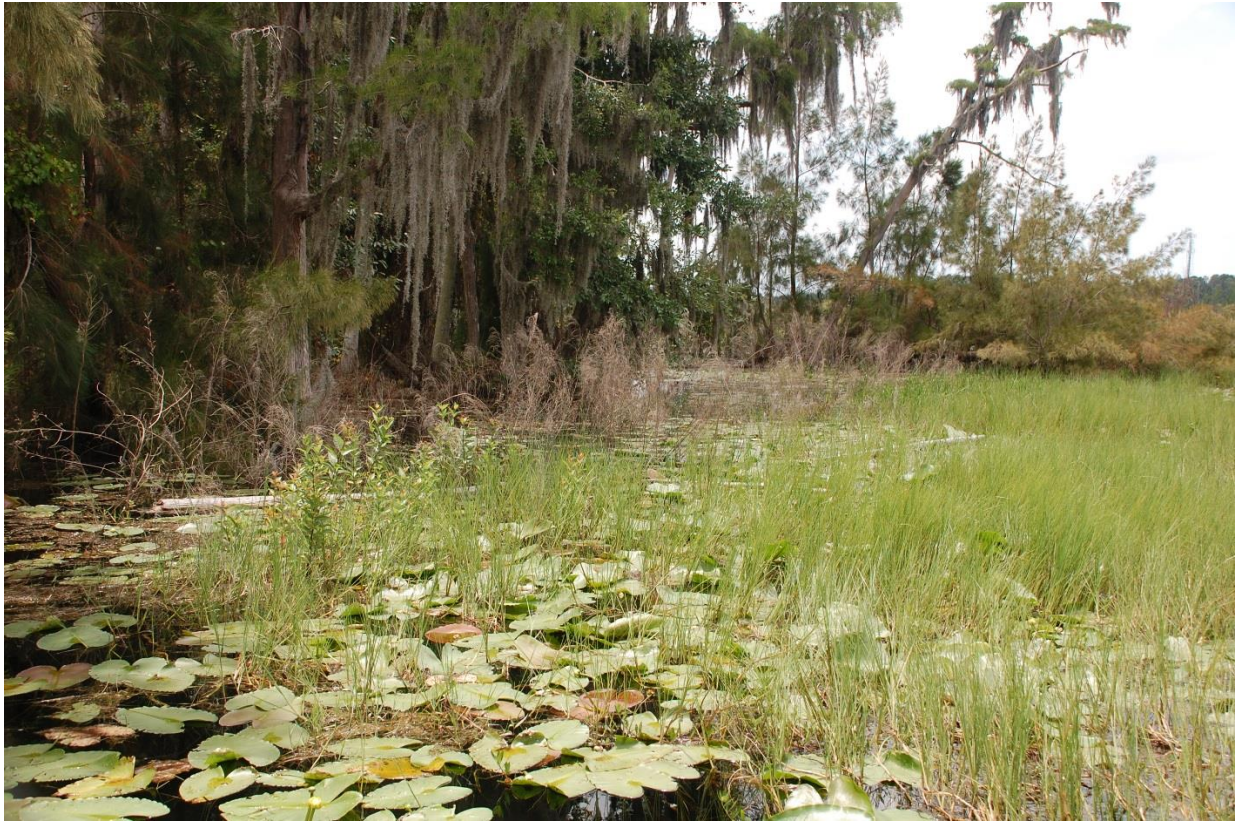
*Figure 3 Overview photograph of Lake Stemper showing typical shoreline vegetation.*

The lake assessment for Lake Stemper was conducted on June 13, 2018. Lake Stemper received a lake habitat assessment (FEDP form FD 9000-6) score of 89 due to optimal scores for Adverse Watershed Land Use, suboptimal scores for Vegetation Quality, Stormwater Inputs, Upland Buffer Zone and Lakeside Adverse Human Alterations. Marginal scores were achieved for Bottom Substrate Quality and Secchi.

The water in Lake Stemper was characterized as somewhat tannic and slightly turbid with a mean color value of 32.45 PCU. The secchi disk depth was 1.0 meters in part due to the tannins and turbidity. The vegetation quality of the plants in and buffering Lake Stemper are predominantly native species with moderate growths of non-native nuisance species such as *panicum repens*. Some direct inputs of stormwater were noted through pipes and ditches to the lake. The bottom substrate quality was dominated by sand with coarse particulate organic matter near shore and some accumulation of muck. Approximately 26.8% of the surrounding land has been developed for residential housing including several docks. Some homeowners have maintained an upland buffer zone along the shoreline while others have removed this vegetation for turf grass lawns.

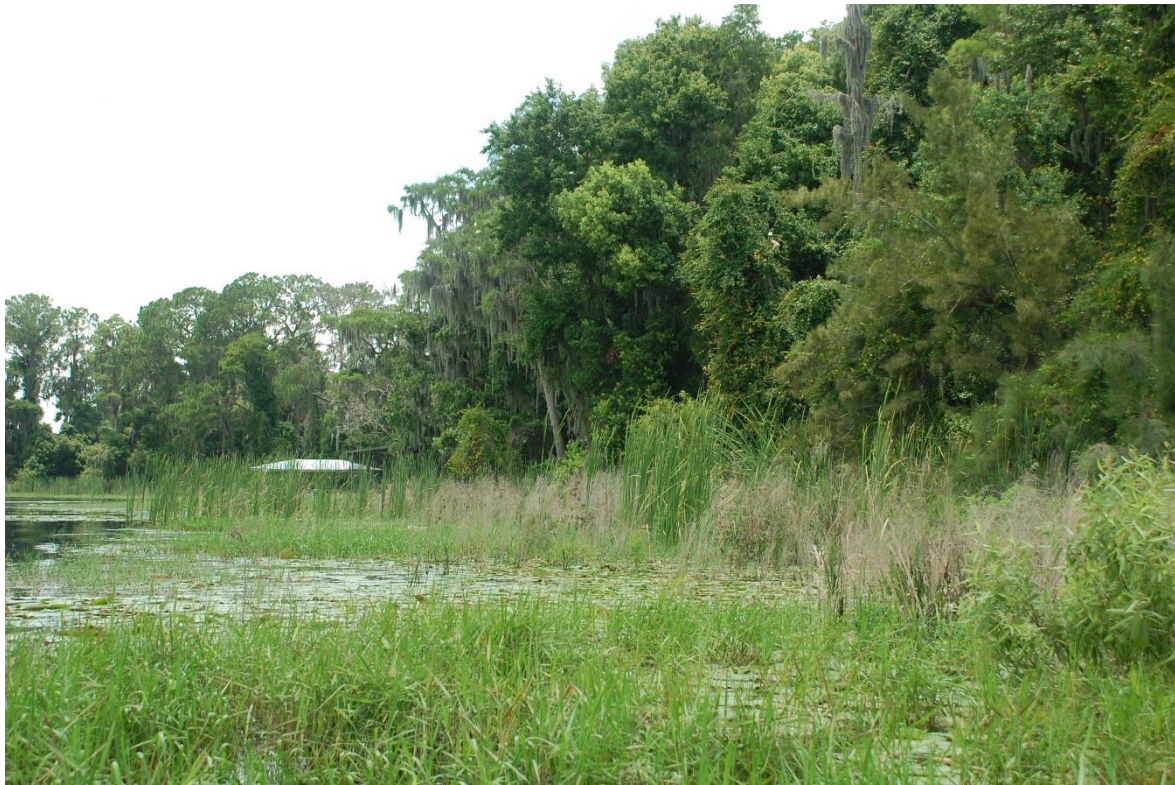
Figure 4 Lake Stemper had a buffering zone of emergent vegetation surrounding the lake containing a mixture of native and invasive species.
