Twin Lake Outlet

STREAM HABITAT ASSESSMENT, STREAM CONDITIONS INDEX, LINEAR
VEGETATION SURVEY, RAPID PERIPHYTON SURVEY AND WATER QUALITY

David Eilers | USF Water Institute | January 2, 2018

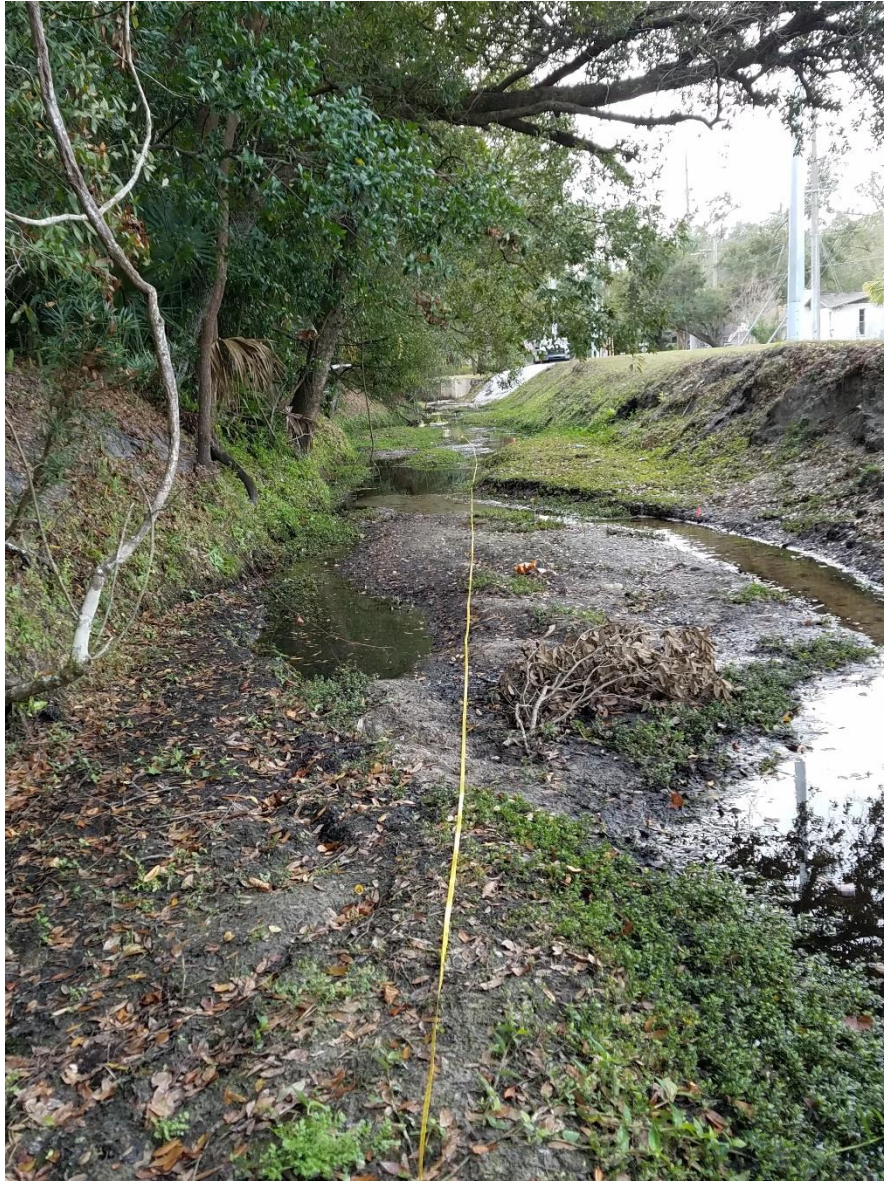
Figure 2 Overview photograph of the Twin Lake Outlet

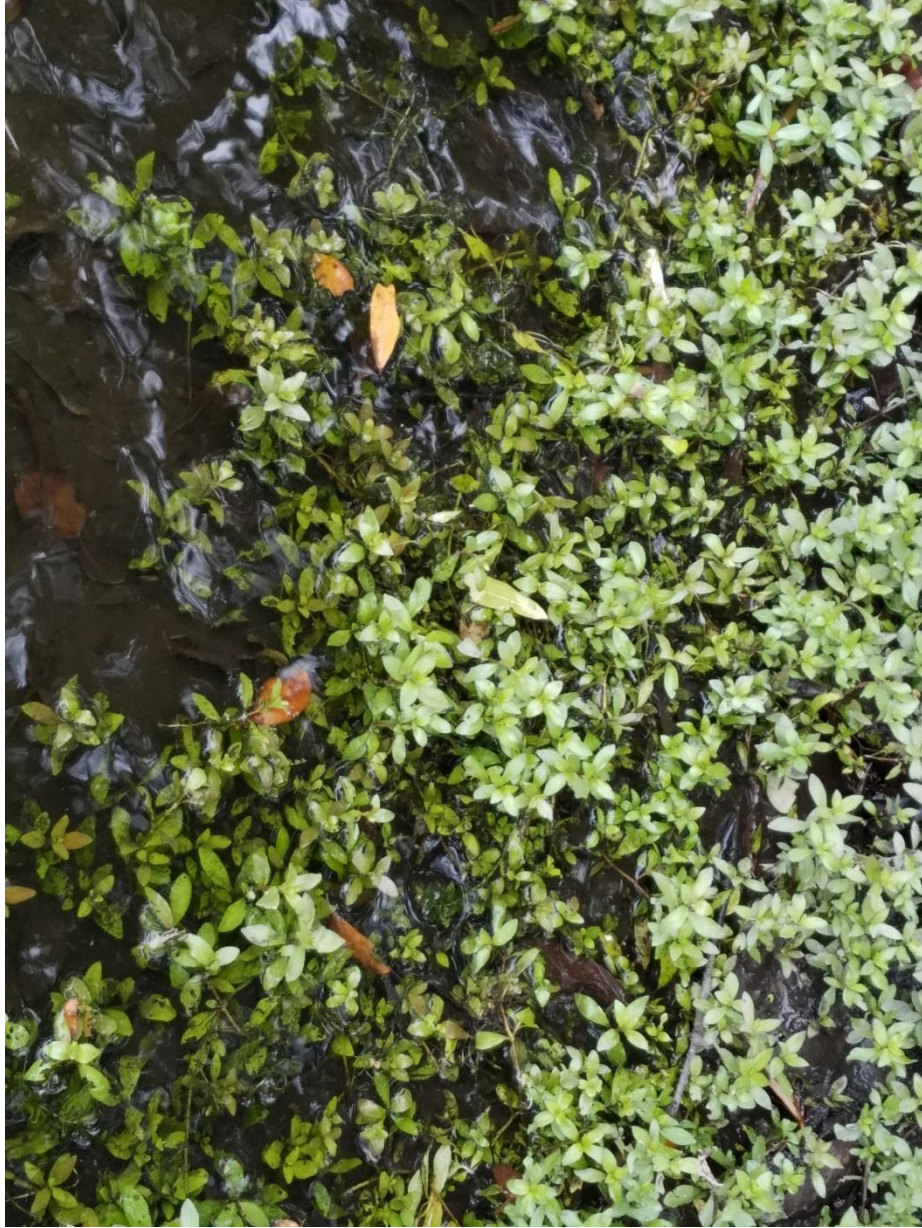
The FDEP Linear Vegetation Survey identified 9 species rooted in the stream. Six of the nine species were non-native, invasive species. *Hygrophila polysperma* was dominant in 8 of the 10 vegetation regions. The calculated Mean Coefficient of Conservatism was 0.62 with 74.4% of observations consisting of FLEPPC listed plants.

Figure 3 Picture of Hygrophila polysperma in Twin Lake Outlet
