Bellows Lake Outlet (East Lake Outlet)

STREAM HABITAT ASSESSMENT, STREAM CONDITIONS INDEX, LINEAR VEGETATION SURVEY, RAPID PERIPHYTON SURVEY AND WATER QUALITY

David Eilers | USF Water Institute | January 9, 2019

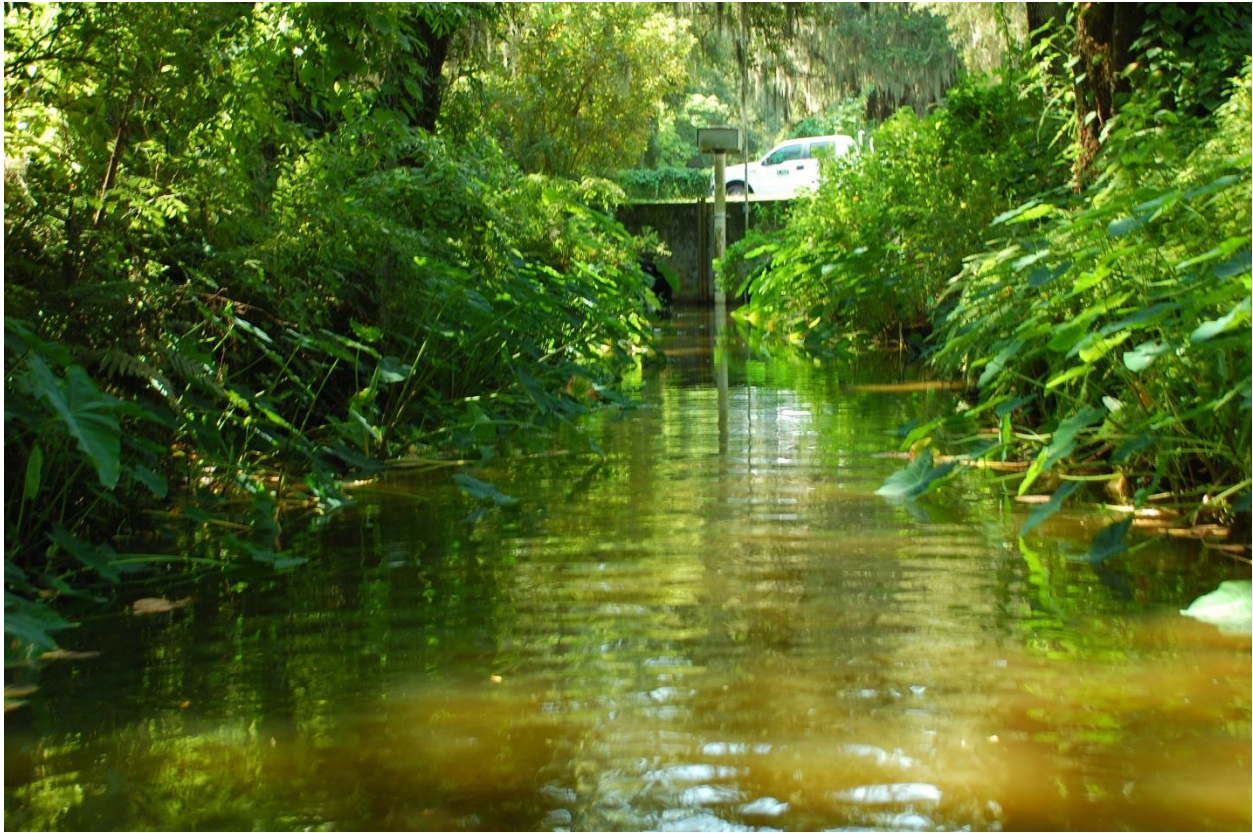
Figure 2 Overview photograph of Bellows Lake Outlet at Chelsea St Sample Site

The region of Bellows Lake Outlet where the assessment was conducted is in a dominant residential area. The region was moderately shaded with a mean canopy cover measurement of 75.4%. Bellows Lake Outlet averaged 0.20 meters in depth, approximately 3.25 meters wide with a flow of 0.25 m/s.

The secondary habitat components of the FDEP Habitat Assessment focus on the surrounding features of the stream. Bellows Lake Outlet flows through a residential area surrounded by commercial and industrial area. In this region, Bellows Lake Outlet has been heavily modified and straightened. The secondary habitat components scored in the suboptimal category for Bank Stability primarily due to the constructed nature of its banks. Artificial

Channelization, Riparian Buffer Width and Riparian Zone Vegetation Quality all scored in the poor category. The riparian buffer zone surrounding the stream was less than 5 meters on both banks and consisted of non-native species. The secondary habitat components received a score of 23 out of 80. The resulting FDEP Habitat Assessment score was a 54 which is at the lower extent of the marginal classification.
