**Brushy Creek**

STREAM HABITAT ASSESSMENT, STREAM CONDITIONS INDEX, LINEAR VEGETATION SURVEY, RAPID PERIPHYTON SURVEY AND WATER QUALITY

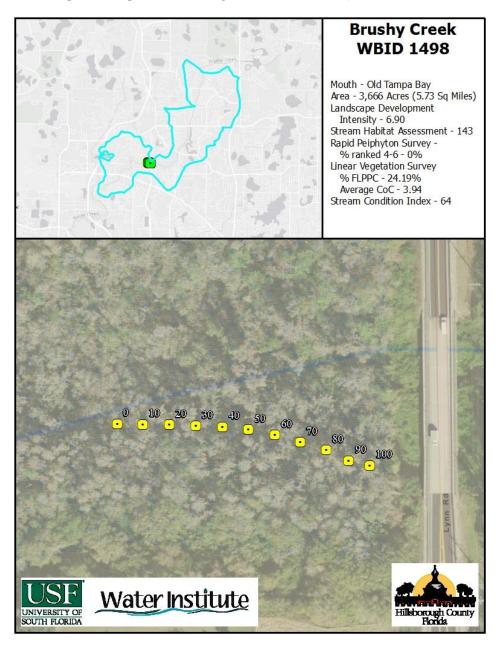
Figure 1 2019 Brushy Creek Study Area Map

Brushy Creek is located in north central Hillsborough County. Its headwaters are located east of Highway 589 and the outfall of Brushy Creek is in Rocky Creek. The assessment of Brushy Creek was conducted on February 5, 2018. At the time of the assessment, the water levels were normal for the time of year. The Brushy Creek WBID covers 5.73 square miles and is dominated by residential (63.5%), natural (15.0%), commercial (5.1%) and institutional (3.3%). The resulting calculated landscape development intensity index score was 6.90.

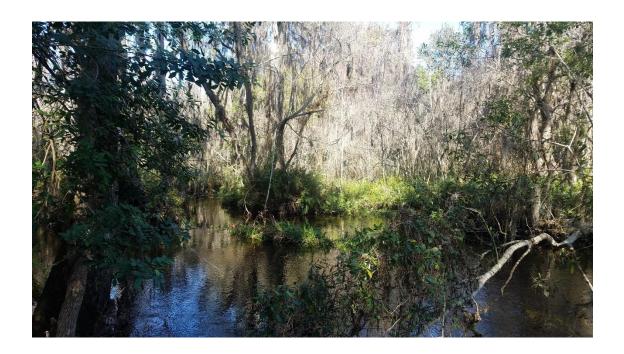
The region of Brushy Creek where the assessment was conducted is in a dominant residential area with a natural buffer immediately surrounding the stream. The region was heavily shaded with a mean canopy cover measurement of 84.0%. Brushy Creek averaged 0.30 meters in depth, approximately 17 meters wide with a flow of 0.35 m/s. In this region, Brushy Creek was split into multiple braided channels.

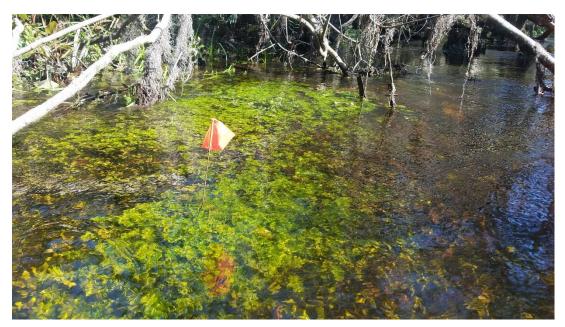
The FDEP Linear Vegetation Survey encountered 22 herbaceous species rooted in the wetted area in Brushy Creek, five of which were non-native species. *Hygrophila polysperma* dominated the vegetation community accounting for 17.5 square meters. This non-native, invasive species are typically transmitted from upstream sources. Five of the species are considered sensitive native species with coefficient of conservatism values above 6.

Figure 3 Hygrophila polysperma dominated the vegetation community rooted in Brushy Creek
