Bullfrog Creek

STREAM HABITAT ASSESSMENT, STREAM CONDITIONS INDEX, LINEAR
VEGETATION SURVEY, RAPID PERIPHYTON SURVEY AND WATER QUALITY

David Eilers, Heather Grant | USF Water Institute | February 6, 2019

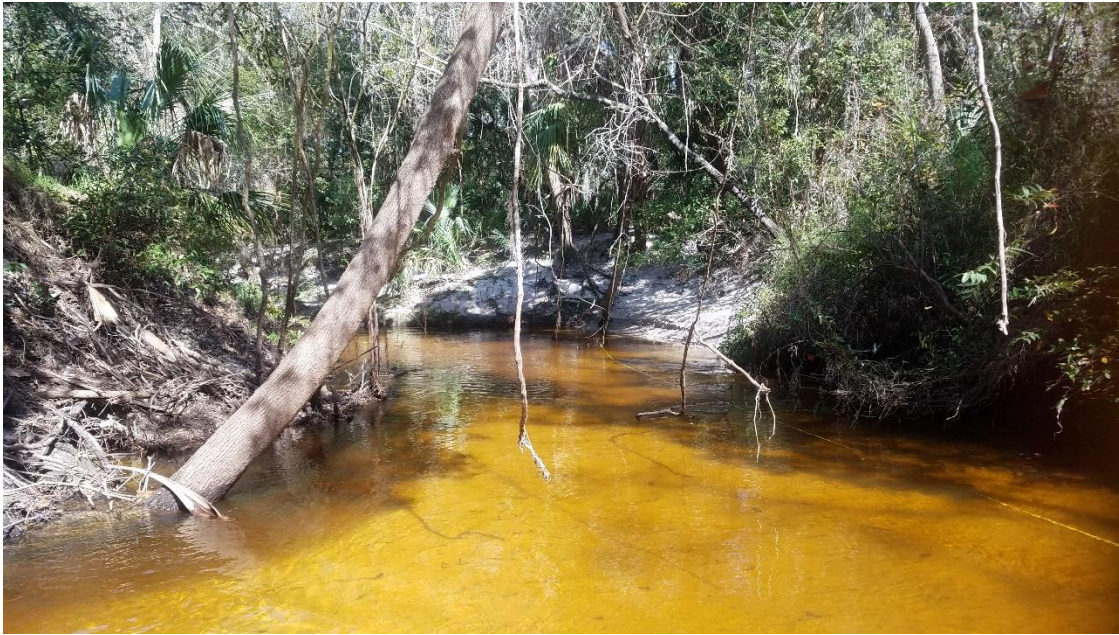
The region of Bullfrog Creek where the assessment was conducted is in a dominant natural area along Vance Vogel Park. The region was heavily shaded with a mean canopy cover measurement of 73.0%. Bullfrog Creek averaged 0.35 meters in depth, approximately 7.5 meters wide with a flow of 0.27 m/s.
