# Cypress Creek

STREAM HABITAT ASSESSMENT, STREAM CONDITIONS INDEX, LINEAR  
VEGETATION SURVEY, RAPID PERIPHYTON SURVEY AND WATER QUALITY

David Eilers | USF Water Institute | March 6, 2019

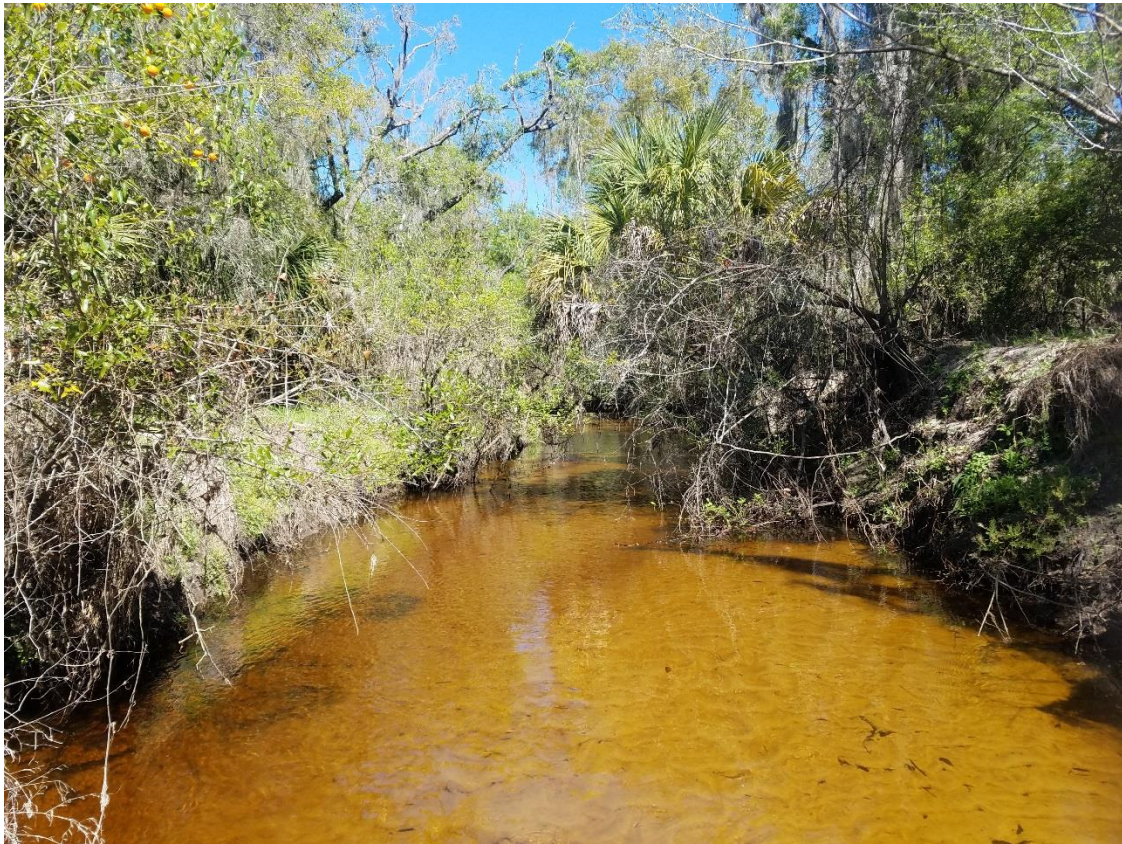
*Figure 2 Overview photograph of Cypress Creek at the Little Manatee River State Park Sample Site*

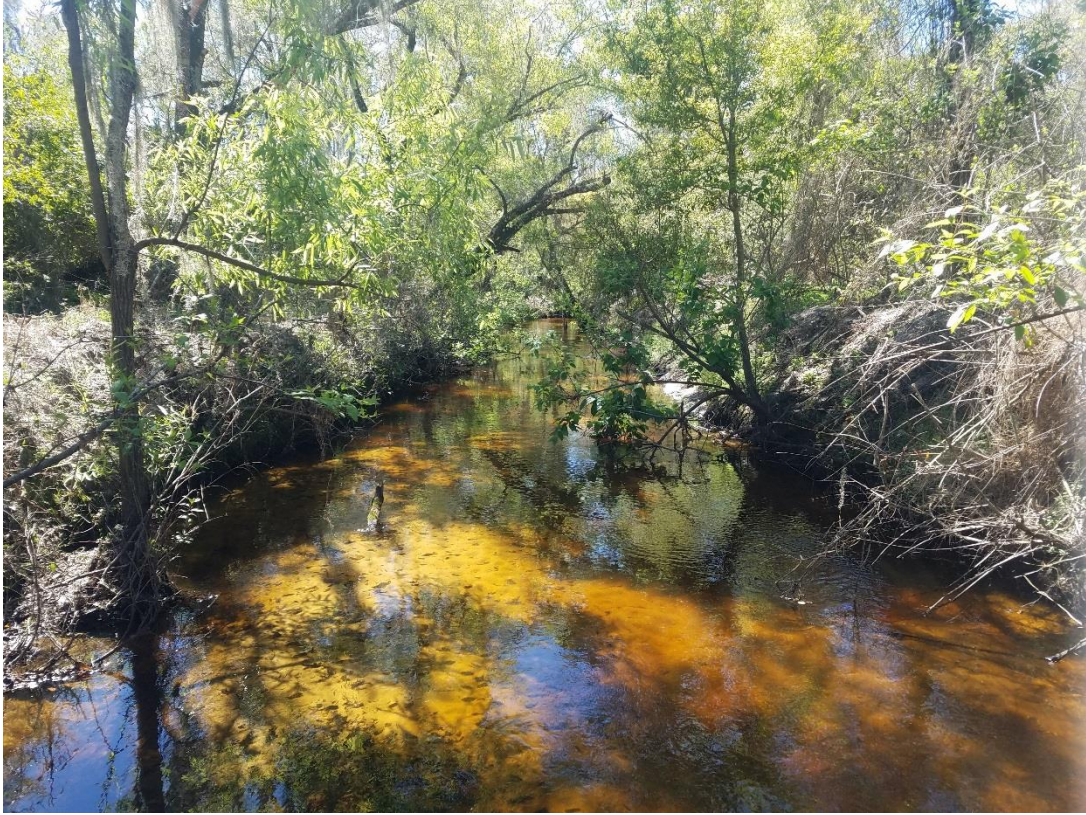
The region of Cypress Creek where the assessment was conducted is in a dominant natural area inside the scrub habitat in Little Manatee State Park. The region was moderately shaded with a mean canopy cover measurement of 56.4%. Cypress Creek averaged 0.30 meters in depth, approximately 5.5 meters wide with a flow of 0.28 m/s.

The primary habitat components of the FDEP Habitat Assessment focus on in-water habitat. The primary habitat components score in the optimal category for Water Velocity. Habitat Smothering scored in the suboptimal category due to unstable pools and sand smothering. Substrate Diversity scored in the marginal category due to limited productive habitats comprising 2.7% of the stream area. Substrate Availability scored in the Poor category due to major productive habitats (Snags and Roots). Minor habitats included aquatic macrophytes, leaf packs and sand. The total score for the primary habitat components was a 39 out of 80.

The secondary habitat components of the FDEP Habitat Assessment focus on the surrounding features of the stream. Cypress Creek flows through a large area of preserve property inside of Little Manatee State Park. In this region, Cypress Creek lacks the typical sinuosity observed in streams in this region of Florida. The secondary habitat components scored in the optimal category for Riparian Buffer Width and Riparian Zone Vegetation Quality due to the large expanse of preserve land. Artificial Channelization and Bank Stability scored in the Suboptimal category due to a lack of sinuosity, presence of spoil banks and eroding sections of banks. The riparian buffer zone surrounding the stream was greater than 18 meters on both banks and consisted of predominately native species. The vegetation in the stream itself was dominated by non-native invasive species (*hydrilla*, *hygrophila*) likely from an upstream source. The secondary habitat components received a score of 62 out of 80. The resulting FDEP Habitat Assessment score was a 101.

*Figure 3 Typical habitat along the 100-meter assessment region*
