# Lake Keystone

LAKE HABITAT ASSESSMENT, LAKE VEGETATION IDEX, SUBMERGED  
VEGETATION SURVEY AND WATER QUALITY

David Eilers, David McIlwaine, Kristina O'Keefe, Julie Lam, Jonathon Chapin | USF Water  
Institute | June 3, 2019

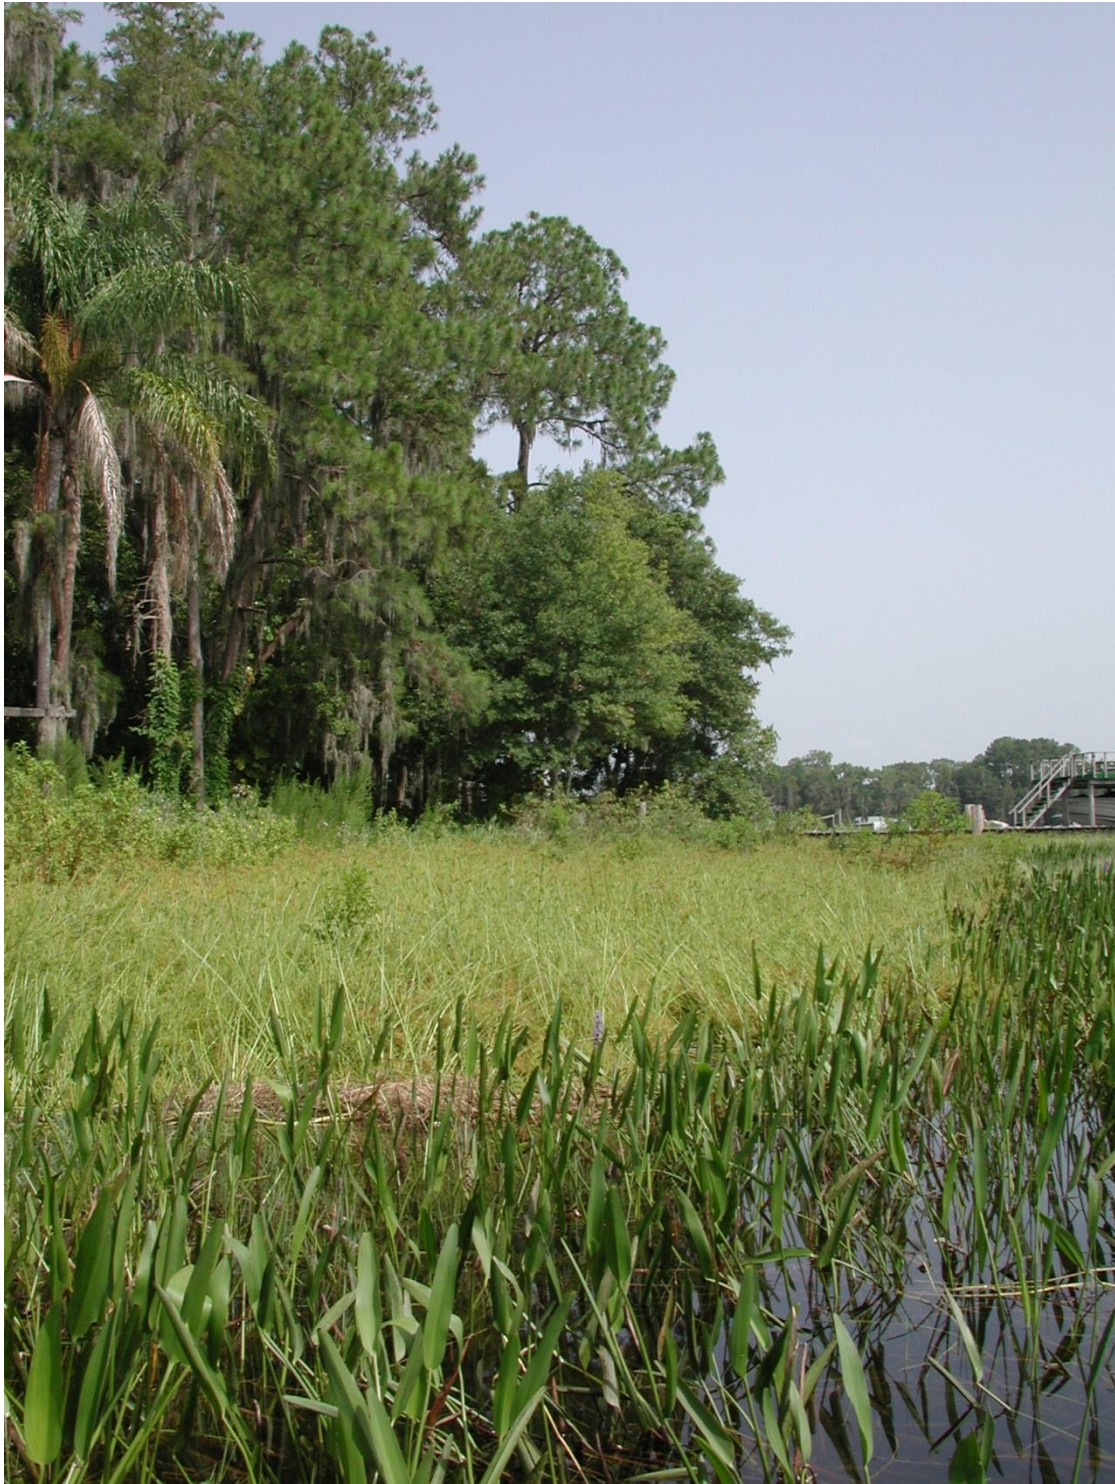
*Figure 3 Overview photograph of Lake Keystone showing typical shoreline vegetation in an undeveloped area.*

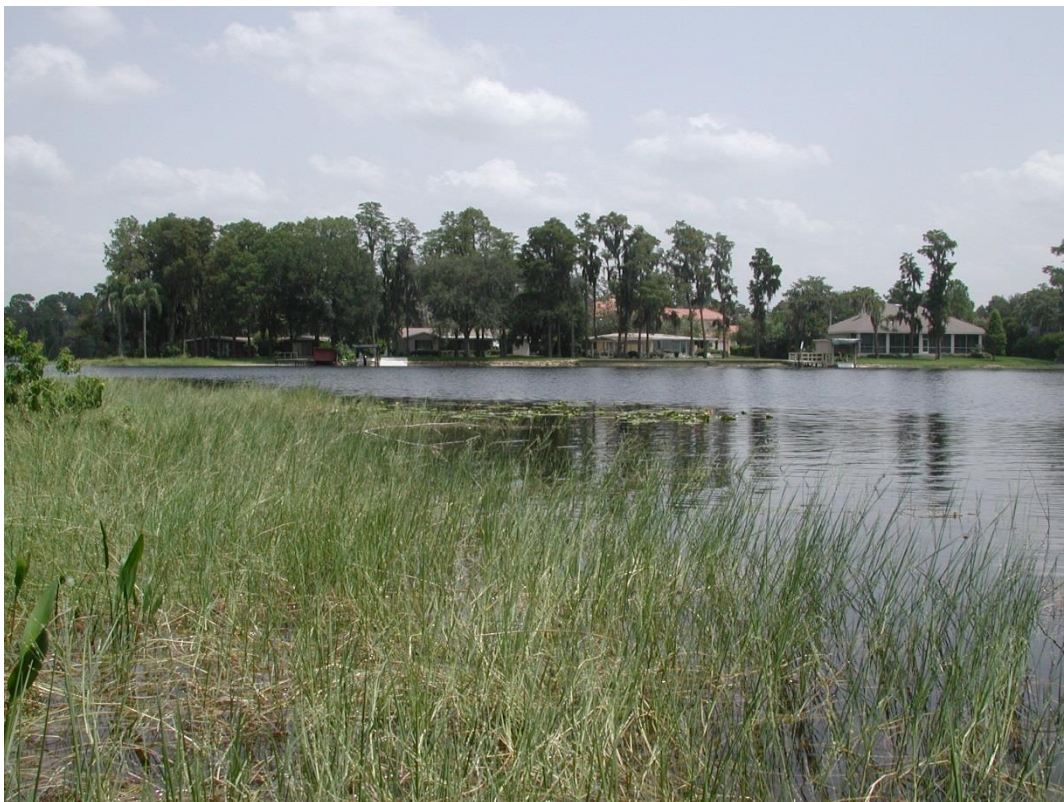
Figure 4 *Panicum repens*, torpedo grass, along a vegetated section of Lake Keystone's shoreline.

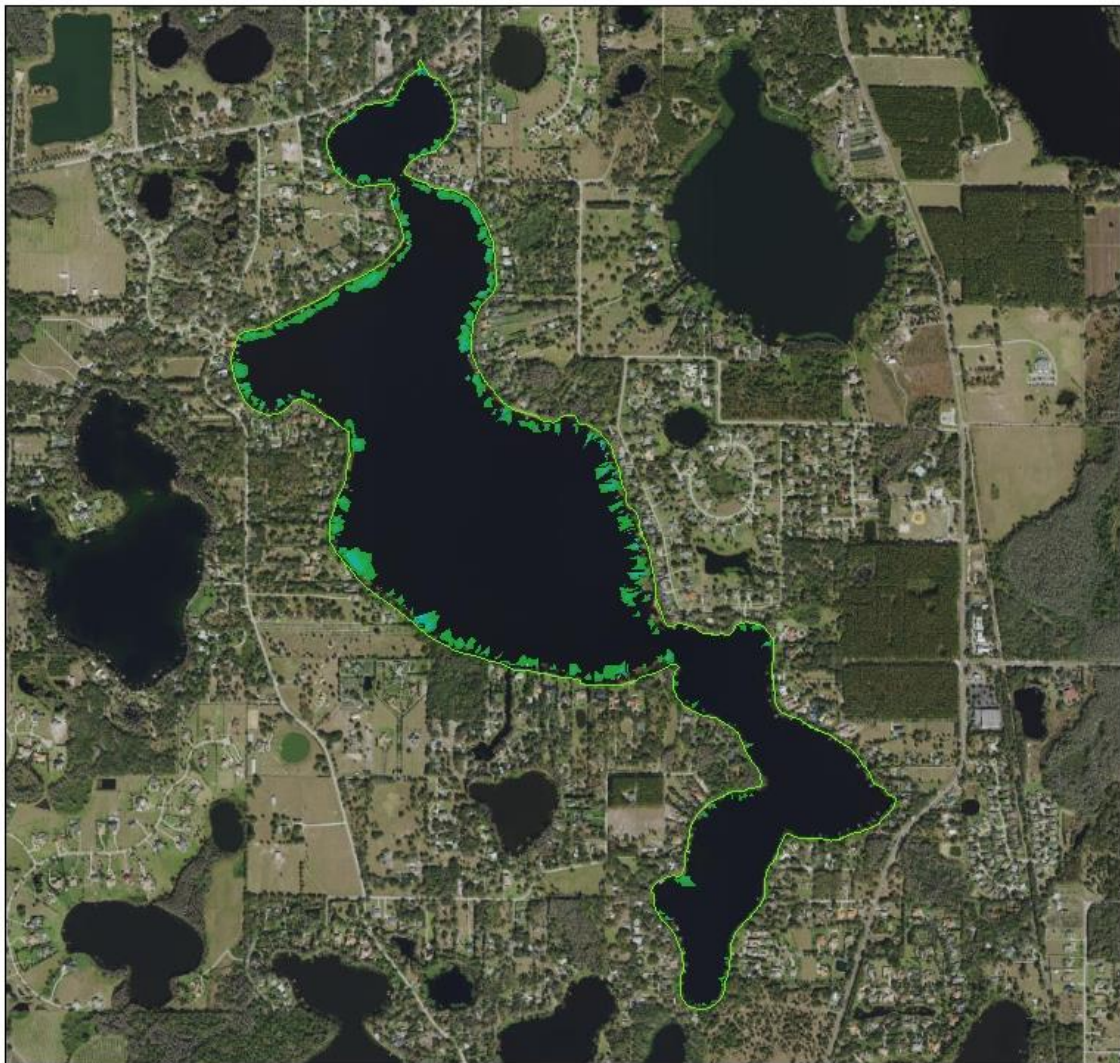
Figure 5 Lake Keystone Submerged Aquatic Vegetation Assessment Results

Survey Date: June 3, 2019  
Water level was 39.59 NAVD 88  
at the time of the assessment  
Submerged Aquatic Vegetation was  
analyzed from collected sonar data.

Area 3,560,114 square ft; 81.7 Acres;  
(18.7% of Lake Surface Area)  
Mean SAV Height 0.45 ft;  
Volume 44,911 Cubic ft (11,864,555 gallons);  
(0.8% of Lakes Volume)

The Lake Vegetation Index identified 49 species of wetland vegetation growing in the four selected sections along Lake Keystone. The majority of these species (38) are native species. The remaining 11 species (*Limnophila sessiliflora*, *Ludwigia peruviana*, *Alternanthera philoxeroides*, *Colocasia esculenta*, *Sphagneticola trilobata*, *Urochloa mutica*, *Casuarina equisetifolia*, *Salvinia minima*, *Schinus terebinthifolius*, *Panicum repens* and *Melaleuca quinquenervia*) are non-native and invasive to this region of Florida. The vegetation community along Lake Keystone is dominated by a variety of emergent species including *Panicum repens*, *Taxodium* and *Ludwigia peruviana*. The water's surface in Lake Keystone was dominated by *Nuphar* and *Nymphaea odorata*. A total of 8 species of submerged aquatic vegetation were observed, *Utricularia gibba*, *Utricularia radiata*, *Chara*, *Nitella*, *Bacopa caroliniana*, *Mayaca fluviatilis*, *Limnophila sessiliflora* and *Eleocharis baldwinii* with *Mayaca fluviatilis* being the dominant species. Submerged vegetation was limited in the lake to a depth of approximately 7.3 feet. By analyzing the collected sonar chart, submerged aquatic vegetation potentially covered approximately 18.7% of the surface area of Lake Keystone. This submerged vegetation inhabits an estimated 0.8% of the water volume in Lake Keystone. Figure 5 shows the results of the SAV analysis indicating the location and height of SAV.
