# Lake Darby

LAKE HABITAT ASSESSMENT, LAKE VEGETATION IDEX, SUBMERGED  
VEGETATION SURVEY AND WATER QUALITY

David Eilers, David McIlwaine, Kristina O'Keefe, Julie Lam, Jonathon Chapin | USF Water  
Institute | May 16, 2019

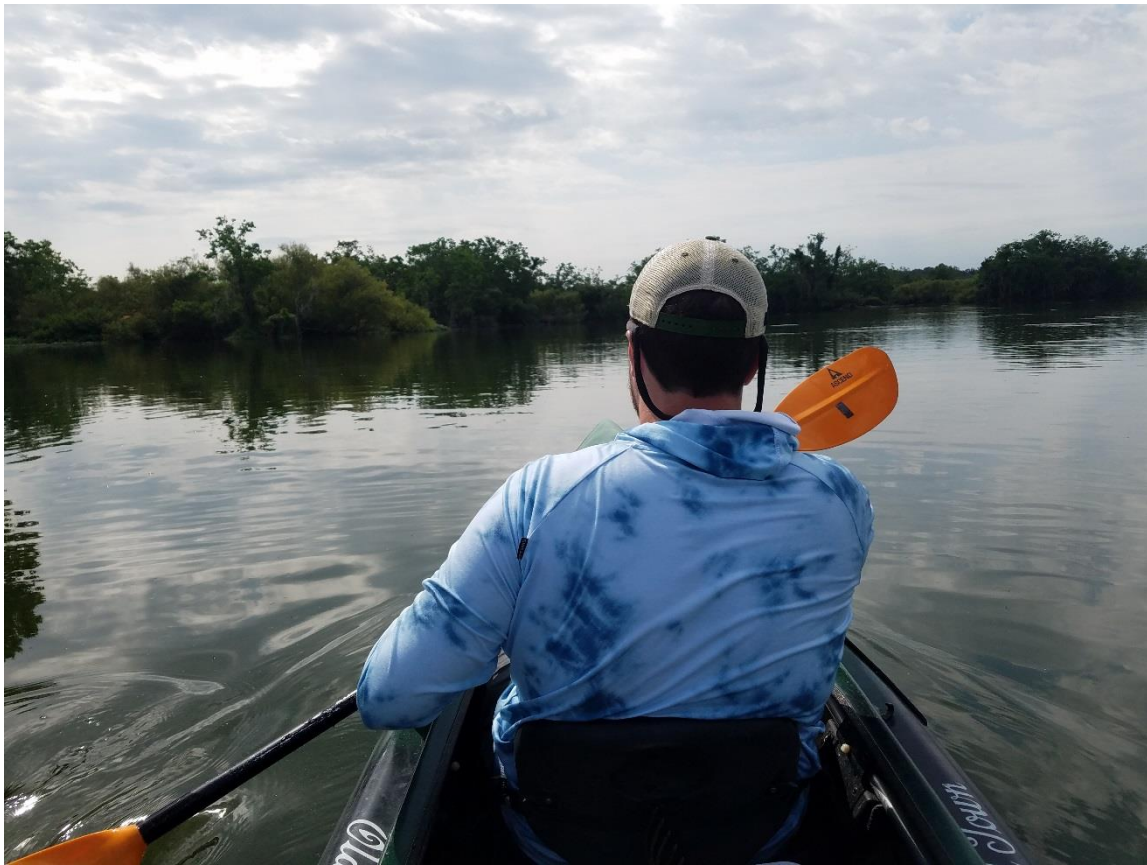
Figure 3 Overview photograph of Lake Darby showing typical shoreline vegetation in an undeveloped area.

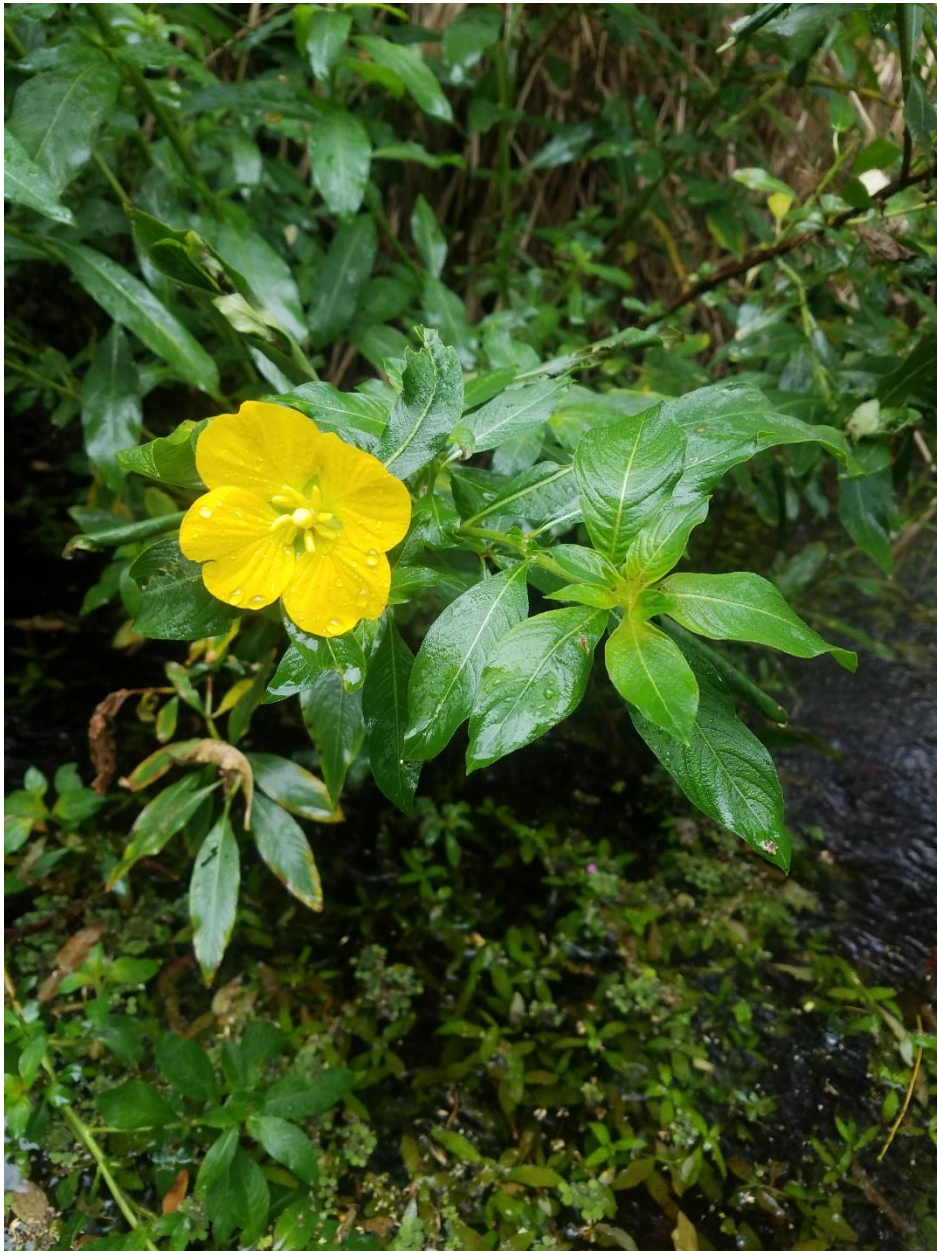
Figure 4 *Ludwigia peruviana*, Peruvian Primrose, along a vegetated section of Lake Darby shoreline.
