Lake Grady

LAKE HABITAT ASSESSMENT, LAKE VEGETATION INDEX, SUBMERGED
VEGETATION SURVEY AND WATER QUALITY

David Eilers, David McIlwaine, Kristina O'Keefe, Julie Lam, Jonathon Chapin | USF Water
Institute | May 17, 2019

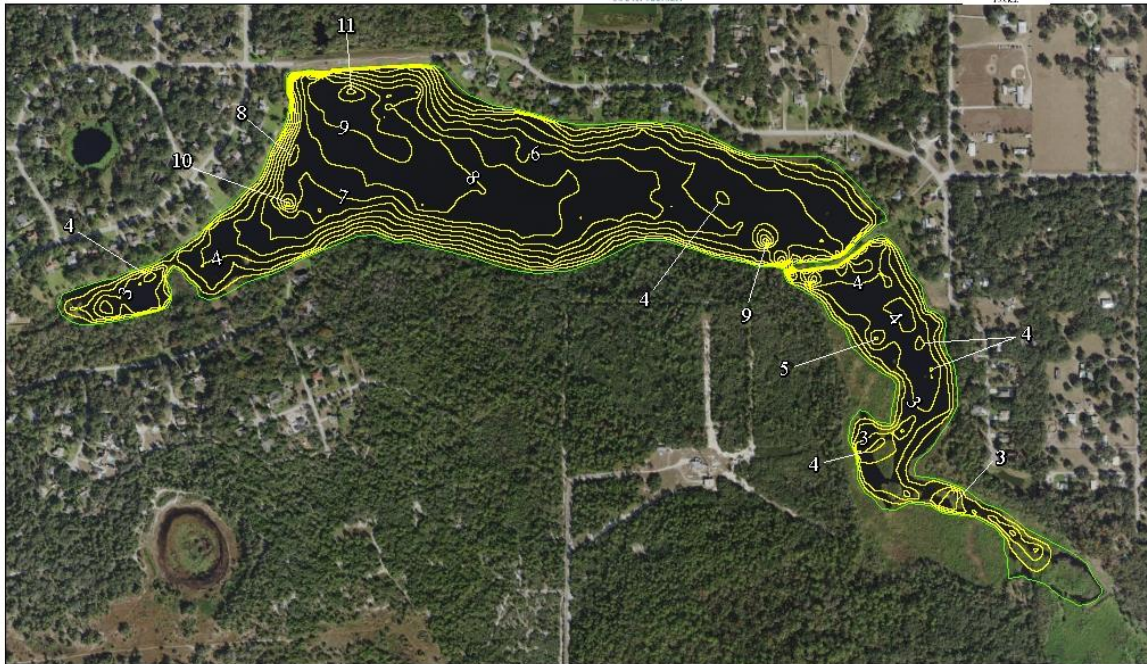
Figure 2: 2019 1-Foot Bathymetric Contour Map for Lake Grady

At the time of the assessment, Lake Grady was experiencing elevated water levels with a water elevation of 34.86 ft NAVD 88 resulting in a 140.5 acre water body. Lake Grady at the time of the assessment had a mean water depth of 4.48 feet and a maximum observed depth of 12.66 feet. The volume at this time was approximately 205,059,066 gallons. Figure 2 shows the resulting bathymetric contour map for Lake Grady from data collected on May 17, 2019. The collected data has been overlain the 2017 Hillsborough County aerials.

Perimeter 22,356 ft;
Area 140.5 Acres;
Mean Depth 4.48 ft;
Volume 629.3 Acre-ft (205,059,066 gallons);
Deepest point 12.66 ft

Survey Date: May 17, 2019
Water level was 34.55 ft NAVD 88
at the time of the assessment.
Contours are expressed in absolute depth
below this level.

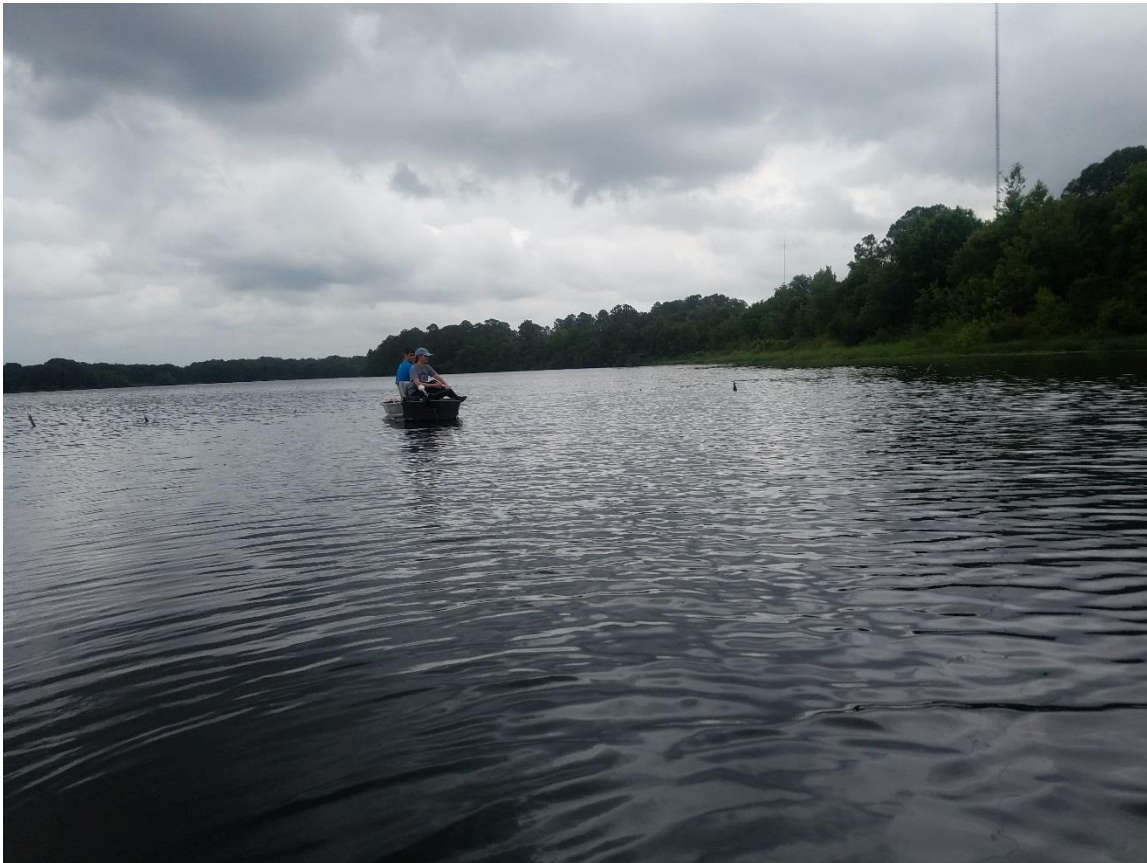
Figure 3 Overview photograph of Lake Grady showing typical shoreline vegetation in an undeveloped area.

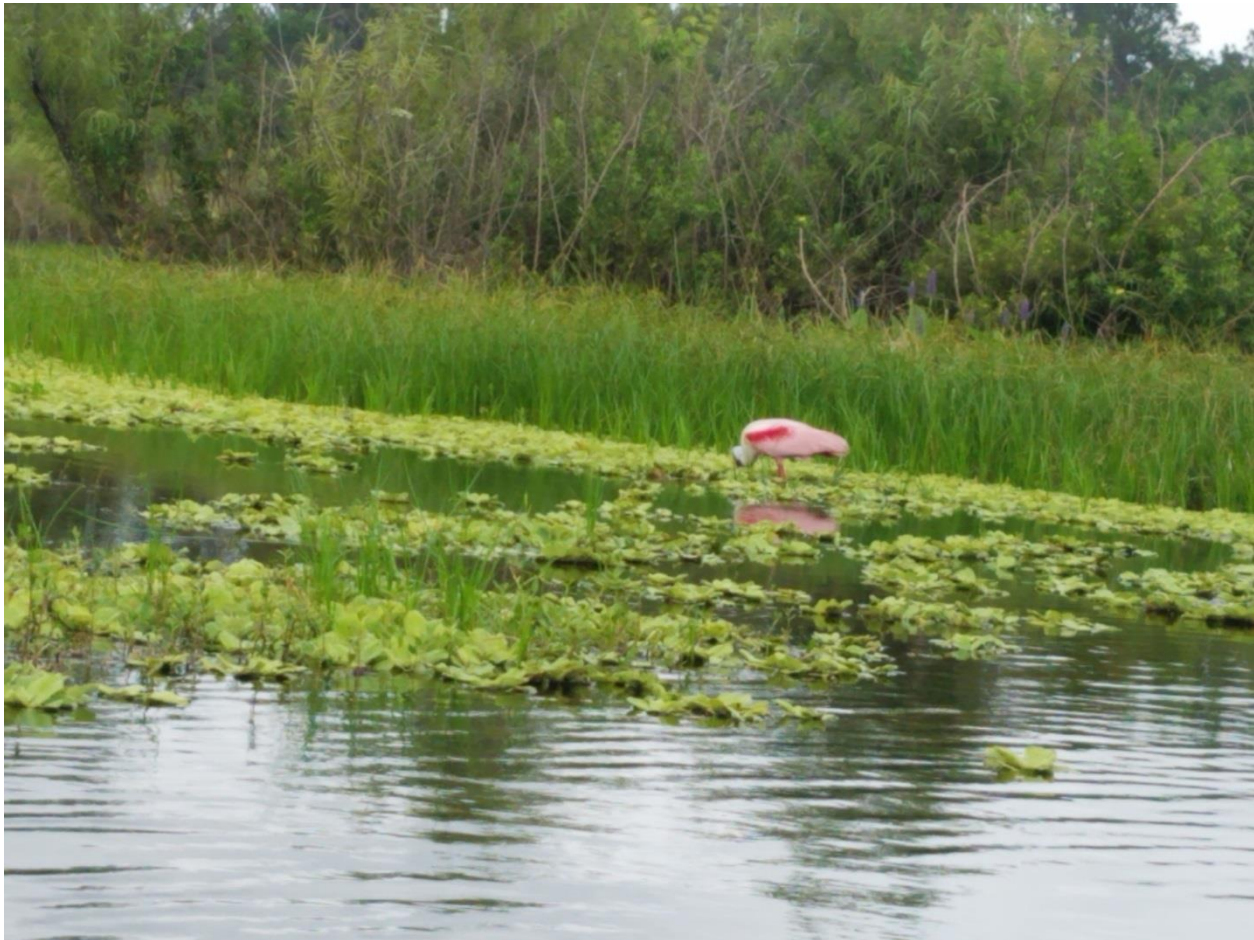
Panicum maximum, *Sphagneticola trilobata* and *Eichhornia crassipes*. Some direct inputs of stormwater were noted through pipes and ditches to the lake, but most stormwater reaches the lake via sheet flow. Due to the impounded nature of Lake Grady, bottom substrate quality was dominated by coarse particulate organic matter near shore and some accumulation of muck. Approximately 39.6% of the surrounding land has been developed for residential housing. The majority of homeowners have not maintained a vegetated buffer zone along the shoreline.

Figure 4 Typical vegetation community along a vegetated section of Lake Grady shoreline.

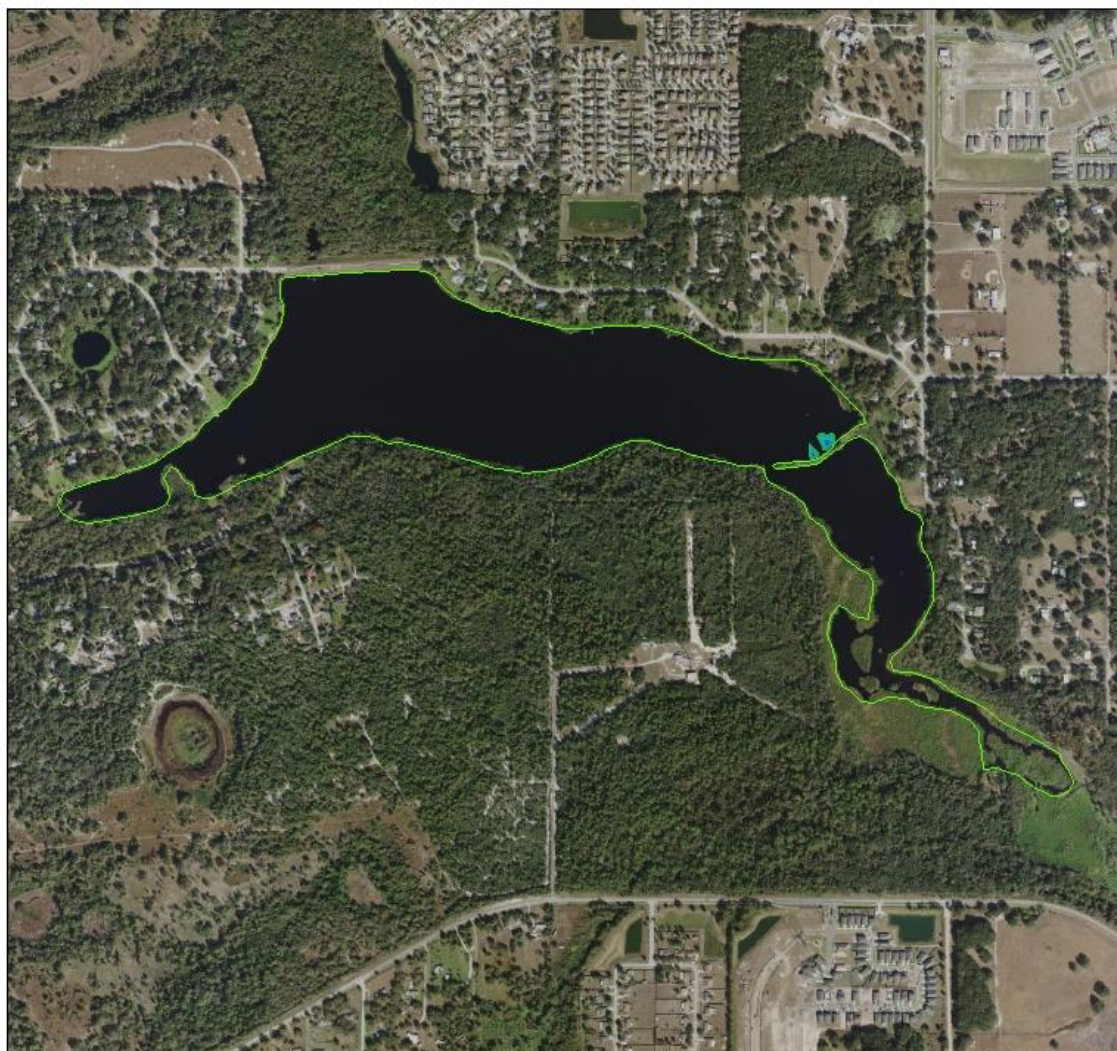
Figure 5 Lake Grady Submerged Aquatic Vegetation Assessment Results

dominated by *Eichhornia crasipes* and *Pistia stratiodes*. Four species of submerged aquatic vegetation were observed in the lake. The extent of submerged vegetation was limited due to the low water visibility and phytoplankton blocking available light. By analyzing the collected sonar chart, submerged aquatic vegetation covered approximately 1.4% of the lakes surface area and 0.05% of the lakes volume. Figure 5 shows the results of the SAV analysis indicating the location and height of SAV.

The system also shows impairment in the vegetation communities according to the Lake Vegetation Index with high overall species (64), but moderate occurrences of non-native, invasive species and few sensitive plant species with an overall LVI score of 19. The assessment observed a very small submerged aquatic vegetation at the time of the assessment occupying 1.4% of the lakes surface area and 0.05% of the lakes volume.
