# Lake LeClare

LAKE HABITAT ASSESSMENT, LAKE VEGETATION INDEX, SUBMERGED  
VEGETATION SURVEY AND WATER QUALITY

David Eilers, David McIlwaine, Kristina O'Keefe, Julie Lam, Jonathon Chapin | USF Water  
Institute | May 28, 2019

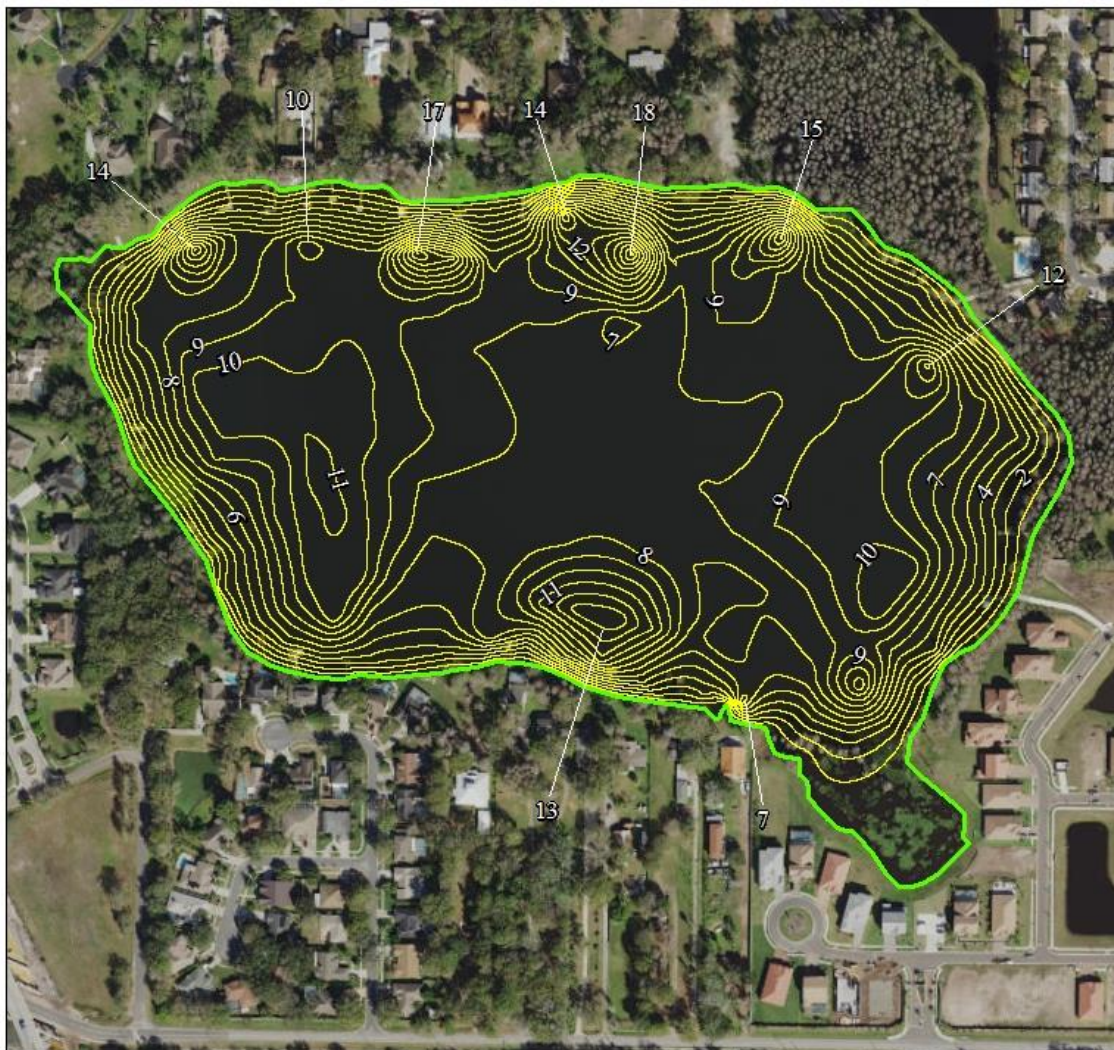
Figure 2: 2019 1-Foot Bathymetric Contour Map for Lake LeClare

At the time of the assessment, Lake LeClare was experiencing elevated water levels (49.59 feet above sea level NAVD 88) resulting in a 48.1 acre water body. Lake LeClare at the time of the assessment had a mean water depth of 7.17 feet and a maximum observed depth of 18.53 feet. The volume at this time was approximately 112,338,072 gallons. Figure 2 shows the resulting bathymetric contour map for Lake LeClare from data collected on May 23, 2019. The collected data has been overlain the 2017 Hillsborough County aerals.

Survey Date: May 15, 2019  
Water level was 49.59 ft NAVD 88  
at the time of the assessment.  
Contours are expressed in absolute depth  
below this level.

Perimeter 6,477 ft;  
Area 48.1 Acres;  
Mean Depth 7.15 ft;  
Volume 344.8 Acre-ft, (112,338,072 gallons);  
Deepest point 18.53 ft

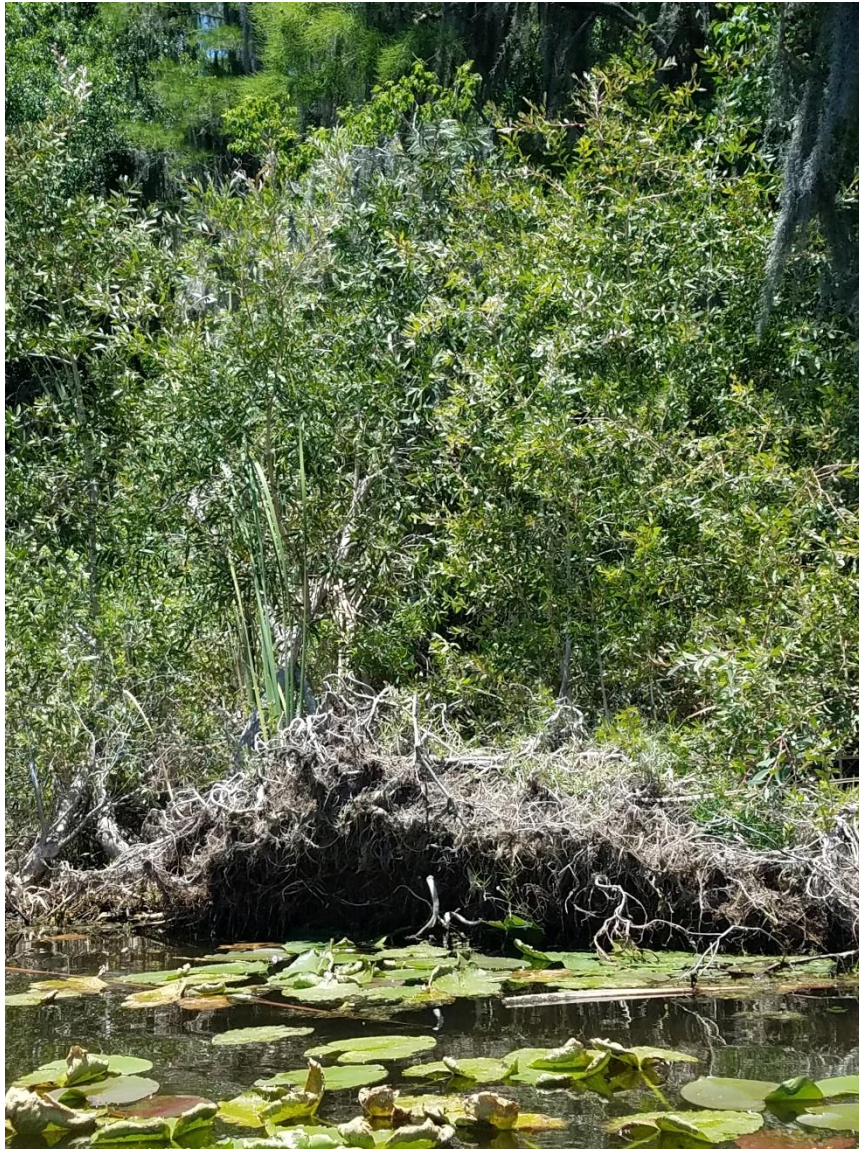
*Figure 3 Overview photograph of Lake LeClare showing typical shoreline vegetation in an undeveloped area.*

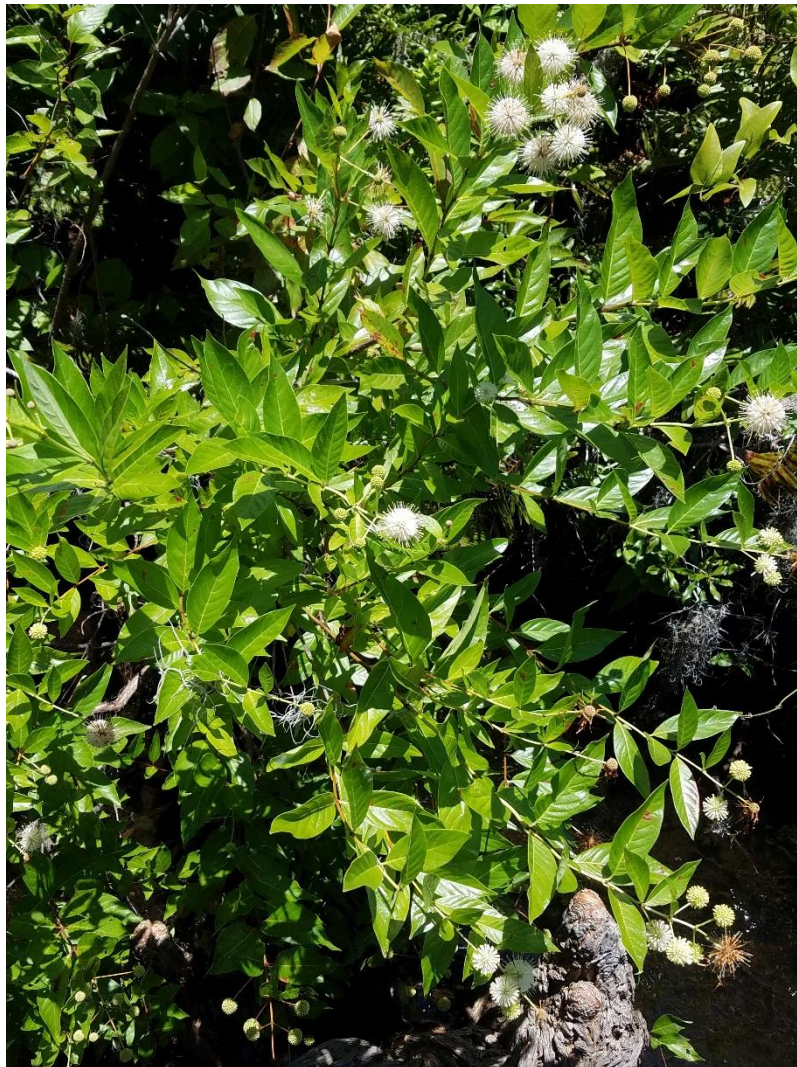
Figure 4 *Cephalanthus occidentalis*, Common Buttonbush, along a vegetated section of Lake LeClare's shoreline.
