Little Bullfrog Creek

STREAM HABITAT ASSESSMENT, STREAM CONDITIONS INDEX, LINEAR
VEGETATION SURVEY, RAPID PERIPHYTON SURVEY AND WATER QUALITY

David Eilers, Stephanie Lawlor | USF Water Institute | February 12, 2019

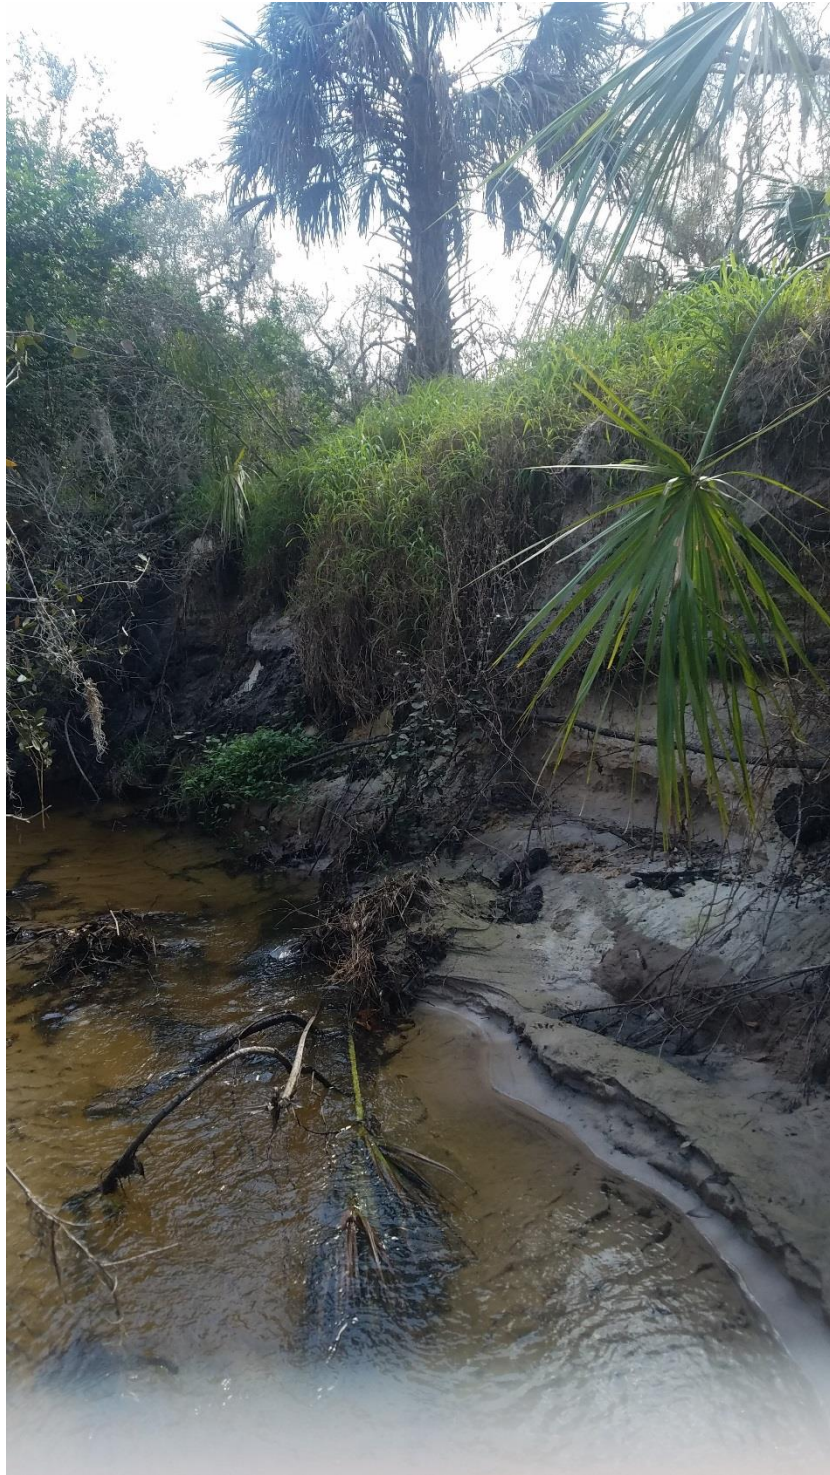
Figure 2 Overview photograph of the Little Bullfrog Creek Sample Site

The region of Little Bullfrog Creek where the assessment was conducted is in a developing residential area. The region was moderately shaded with a mean canopy cover measurement of 63.3%. Little Bullfrog Creek averaged 0.2 meters in depth, approximately 3.65 meters wide with a flow of 0.47 m/s.

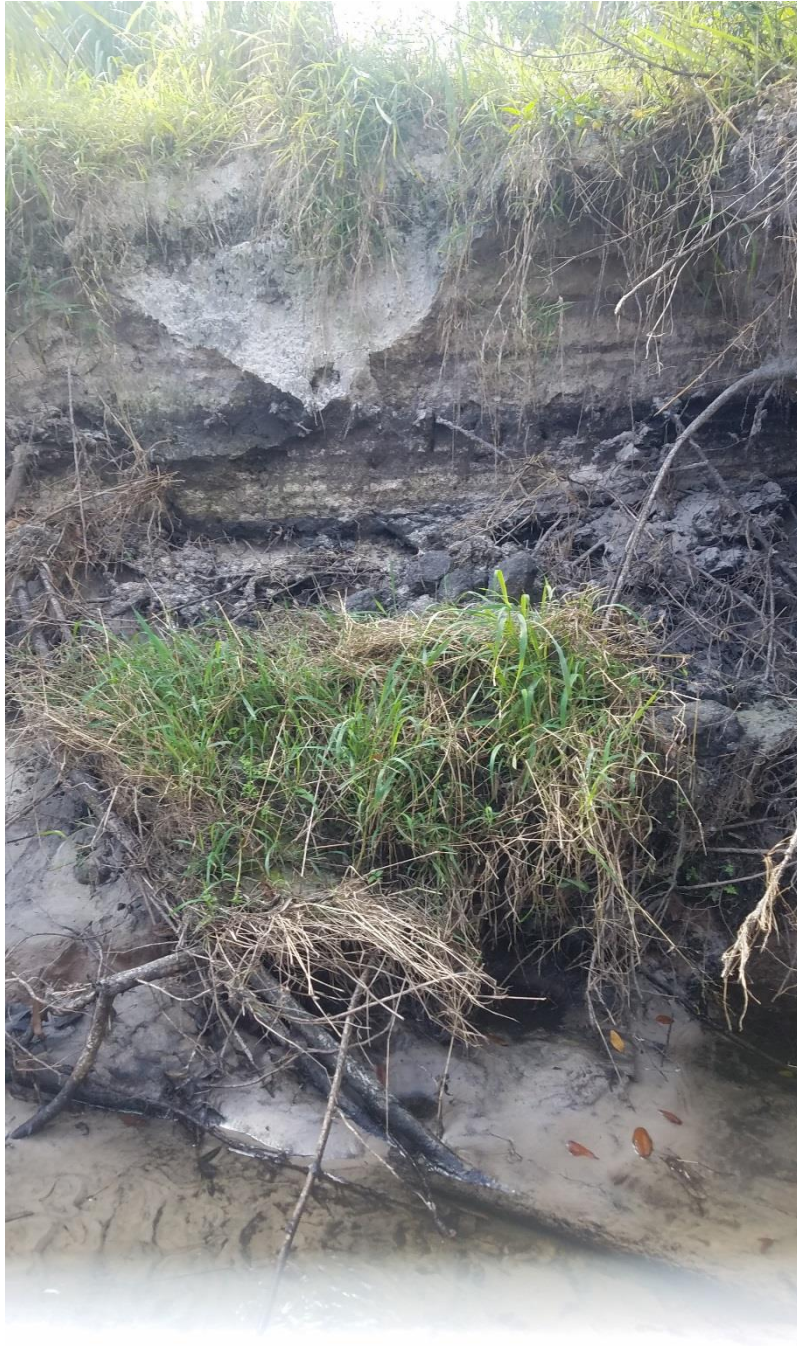
The secondary habitat components of the FDEP Habitat Assessment focus on the surrounding features of the stream. The secondary habitat components scored in the optimal category for Artificial Channelization and Riparian Buffer Zone Width. Bank Stability with many raw, eroded areas and Riparian Zone Vegetation Quality and scored in the marginal category due to collapsing, steep banks and several non-native invasive species. The riparian buffer zone surrounding the stream was greater than 18 meters and consisted of a mixture of native and invasive species indicative of disturbance. The vegetation in the stream itself was dominated by non-native species with 6 non-native invasive species out of 14 total species. The secondary habitat components received a score of 56 out of 80. The resulting FDEP Habitat Assessment score was an 100.

Figure 3 Eroded banks along Little Bullfrog Creek.
