Mango Drain

STREAM HABITAT ASSESSMENT, STREAM CONDITIONS INDEX, LINEAR
VEGETATION SURVEY, RAPID PERIPHYTON SURVEY AND WATER QUALITY

David Eilers | USF Water Institute | January 9, 2019

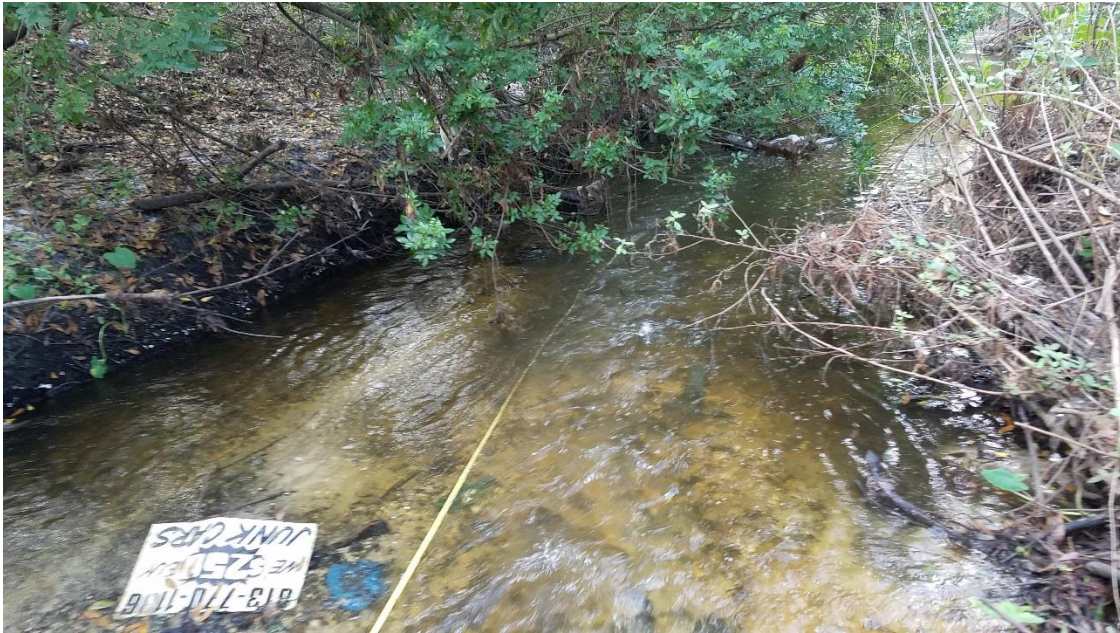
The region of Mango Drain where the assessment was conducted is in a dominant residential and commercial area downstream from Falkenburg Rd. The region was moderately shaded with a mean canopy cover measurement of 75.9%. Mango Drain averaged 0.33 meters in depth, approximately 4.0 meters wide with a flow of 0.55 m/s.

The primary habitat components of the FDEP Habitat Assessment focus on in-water habitat. The primary habitat components score in the optimal category for Water Velocity and Substrate Diversity (Presence of four major productive habitats (snags, roots, rocks, macrophytes)). Marginal scores were achieved for Substrate Availability and Habitat Smothering (Low overall percentage of productive habitats and some of the productive habitats were affected by sand smothering). Minor habitats included leaf, sand and silt deposits. The total score for the primary habitat components was a 55 out of 80.

The secondary habitat components of the FDEP Habitat Assessment focus on the surrounding features of the stream. Mango Drain flows through an area of commercial and residential use. Mango Drain has a narrow corridor to flow through in the urban environment. At the water level at the time of assessment, Mango Drain was low on its banks revealing the eroded sand banks from the wet season. The secondary habitat components scored in the suboptimal category for Bank Stability. Riparian Buffer Width and Riparian Zone Vegetation Quality scored in the marginal category due to a limited buffer width and several nonnative invasive species. Artificial Channelization scored in the poor category due to obvious alterations to the stream banks and removal of sinuosity. The riparian buffer zone surrounding the stream was dominated by *Schinus terebinthifolius*, *Quercus* and *Sambucus nigra*. The buffer averaged 5 meters and contained a mixture of invasive species and species indicative of disturbance. The vegetation in

the stream itself was dominated by a mixture of invasive and native species with 6 non-native invasive species. The secondary habitat components received a score of 34 out of 80. The resulting FDEP Habitat Assessment score was an 89.

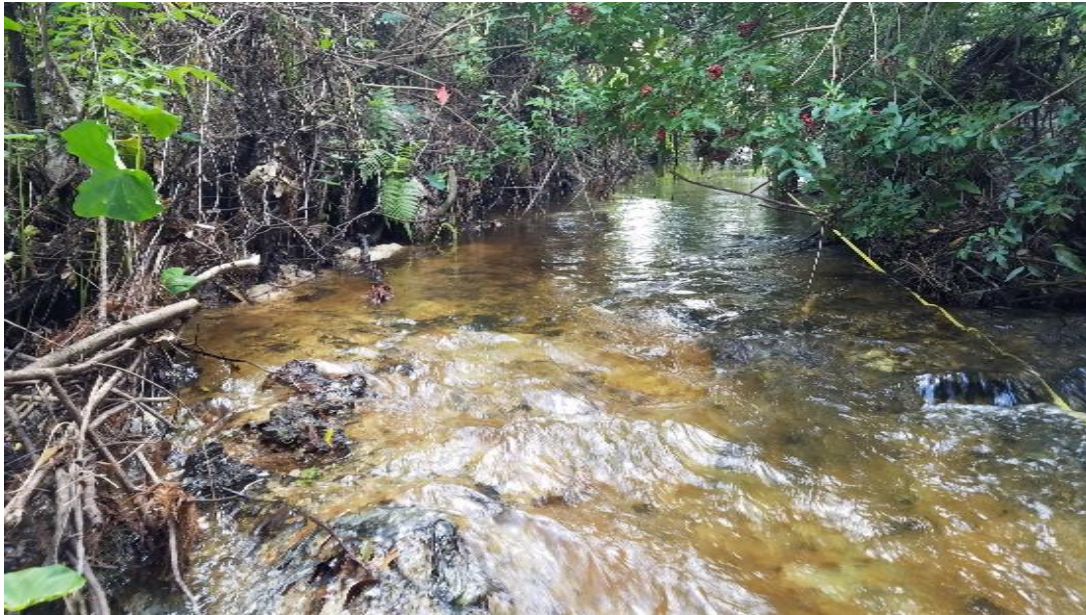
Stream Condition Index

The analysis of the SCI sample involves splitting the sample into 2 aliquots for analysis. The SCI metrics are then calculated on each separately. The final SCI score is an average of the two scores. The SCI score for Mango Drain was 45 out of a possible 100 points, corresponding with a “Healthy” designation, with the expected community of a healthy stream.
