Halls Branch

STREAM HABITAT ASSESSMENT, STREAM CONDITIONS INDEX, LINEAR
VEGETATION SURVEY, RAPID PERIPHYTON SURVEY AND WATER QUALITY

David Eilers, Bailey Cooper | USF Water Institute | February 10, 2020

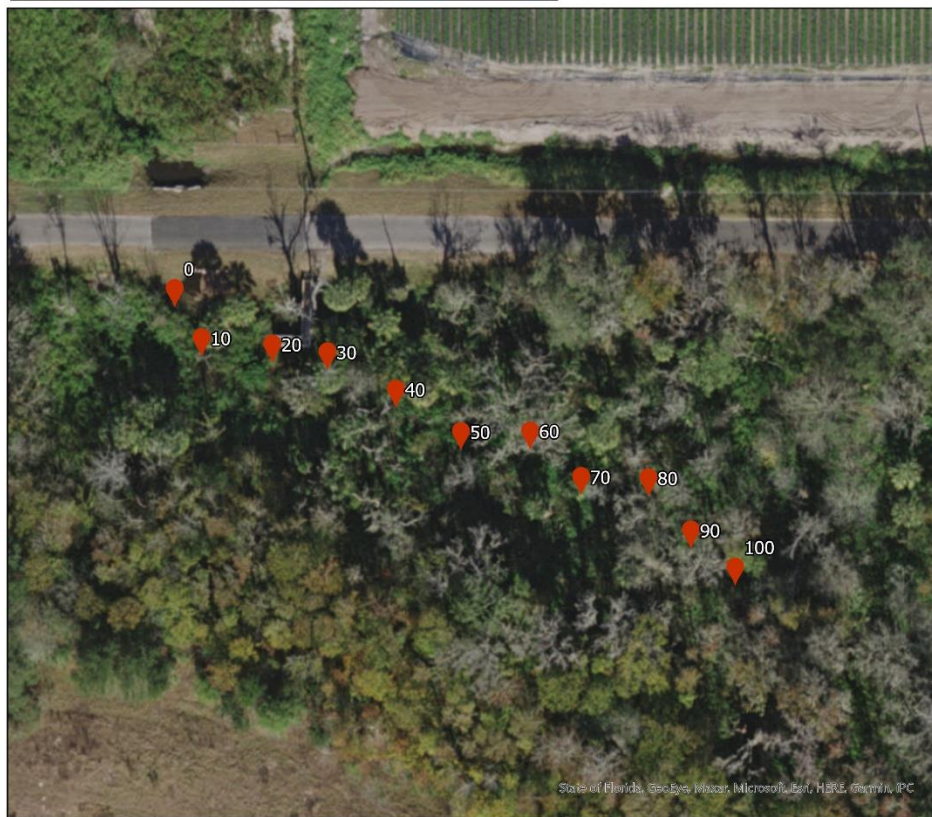
Figure 1 2020 Halls Branch Study Area Map

Halls Branch is located in south-eastern Hillsborough County. Its headwaters are located in an unnamed swamp between Highway 672 and Big Bend Road and the outfall of Little Bullfrog Creek is in Bullfrog Creek. The assessment of Little Bullfrog Creek was conducted on February 10, 2020. At the time of the assessment, the water levels were normal for the end of the dry season. The Halls Branch WBID covers 2.47 square miles and is dominated by agricultural (71.9%) and natural (26.7%) and land uses. The resulting calculated landscape development intensity index score was 5.55.

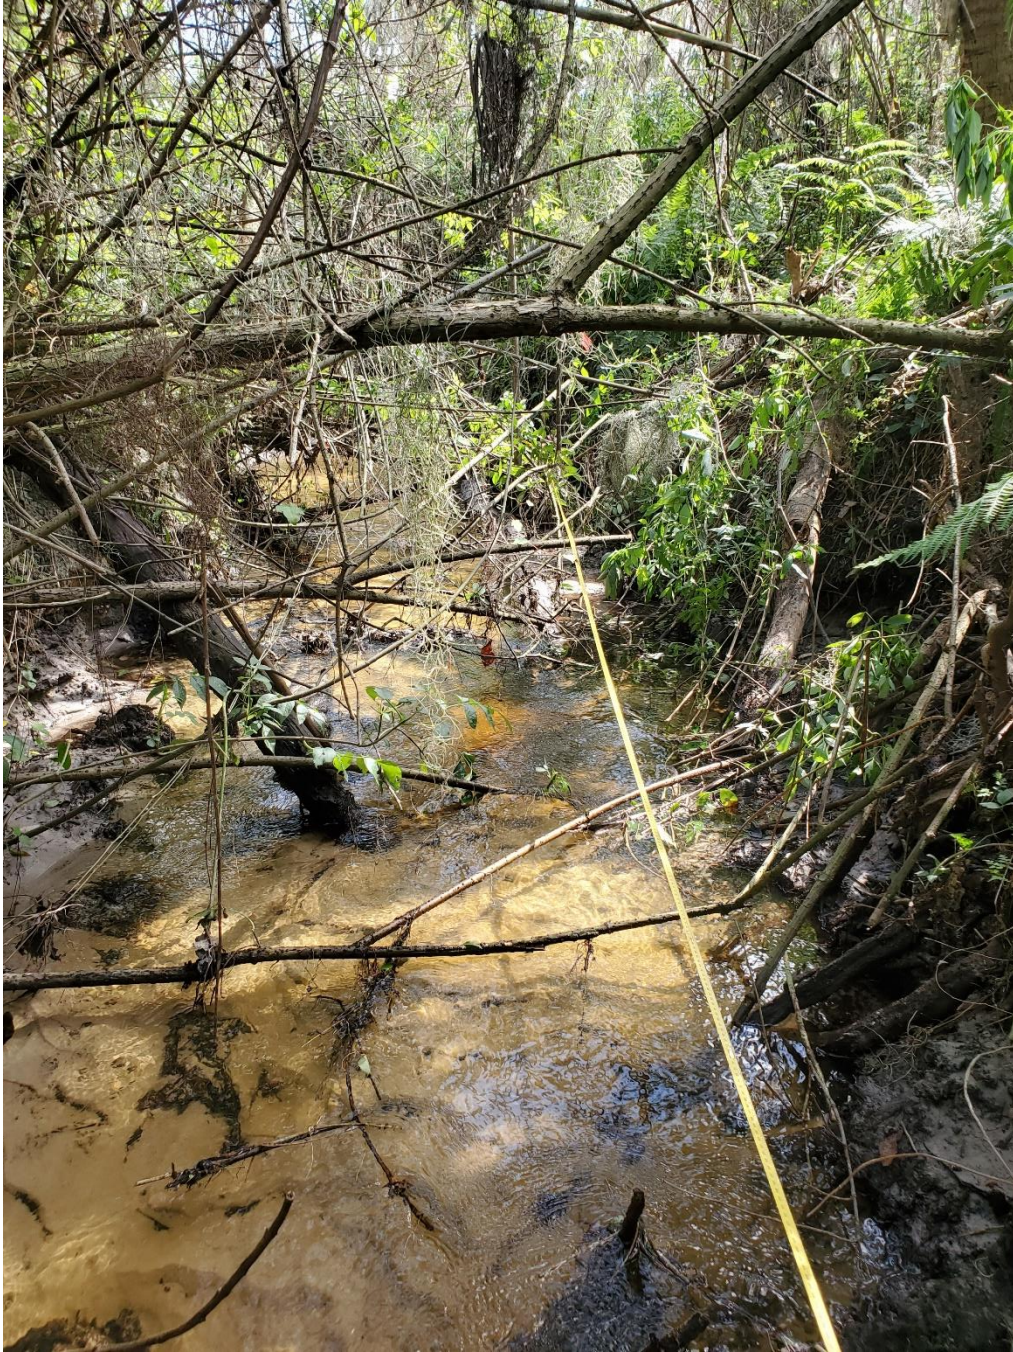
Figure 2 Overview photograph of the Halls Branch Sample Site

The region of Halls Branch where the assessment was conducted is in a natural buffer surrounded by agricultural land. The region was moderately shaded with a mean canopy cover measurement of 64.1%. Halls Branch averaged 0.1 meters in depth, approximately 1.9 meters wide with a flow of 0.36 m/s.

The primary habitat components of the FDEP Habitat Assessment focus on in-water habitat. The primary habitat components score in the optimal category for Water Velocity. Habitat Smothering (many of the productive habitats were affected by sand smothering) scored in the marginal category. Substrate Diversity (Presence of one major productive habitat (snags)) and Substrate Availability (3.7% of stream are productive habitats) were scored as poor. Minor habitats included fine roots, leaf packs/mats, sand and silt deposits. The total score for the primary habitat components was a 33 out of 80.

The secondary habitat components of the FDEP Habitat Assessment focus on the surrounding features of the stream. The secondary habitat components scored in the optimal category for Artificial Channelization and Riparian Buffer Zone Width – Right Bank. Bank Stability with many raw, eroded areas and Riparian Zone Vegetation Quality and scored in the suboptimal category due to collapsing, steep banks and several non-native invasive species. The riparian buffer zone surrounding the stream was 8 meters on the left bank scoring as marginal. The vegetation in the stream itself was a mixture of native and non-native species. Aquatic vegetation was abundant in only the 0-10 meter section of the assessment. The secondary habitat components received a score of 58 out of 80. The resulting FDEP Habitat Assessment score was a 91.

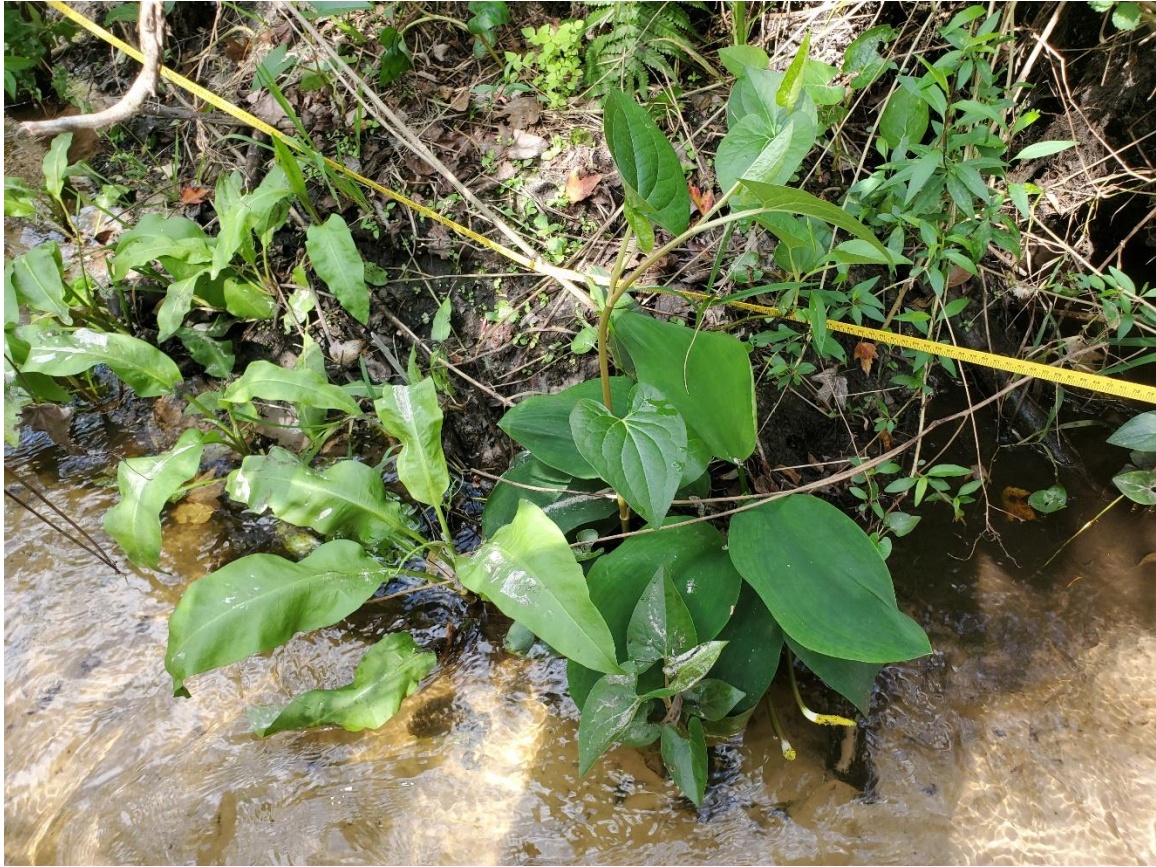
Figure 3 A mixture of species were observed along Halls Branch

The FDEP Linear Vegetation Survey encountered less than 2 square meters of rooted aquatic vegetation in the 100m study area. 10 herbaceous species were observed in Halls Branch including *Urochloa mutica*, *Ludwigia peruviana* and *Commelina diffusa* which are non-native invasive species and *Orontium aquaticum* which is a sensitive species. Only *Urochloa mutica* was abundant and dominant in the 0-10 meter assessment region.
