# Hurrah Creek

STREAM HABITAT ASSESSMENT, STREAM CONDITIONS INDEX, LINEAR  
VEGETATION SURVEY, RAPID PERIPHYTON SURVEY AND WATER QUALITY

David Eilers, William Dudley, Alyssa Schultz | USF Water Institute | February 19, 2020

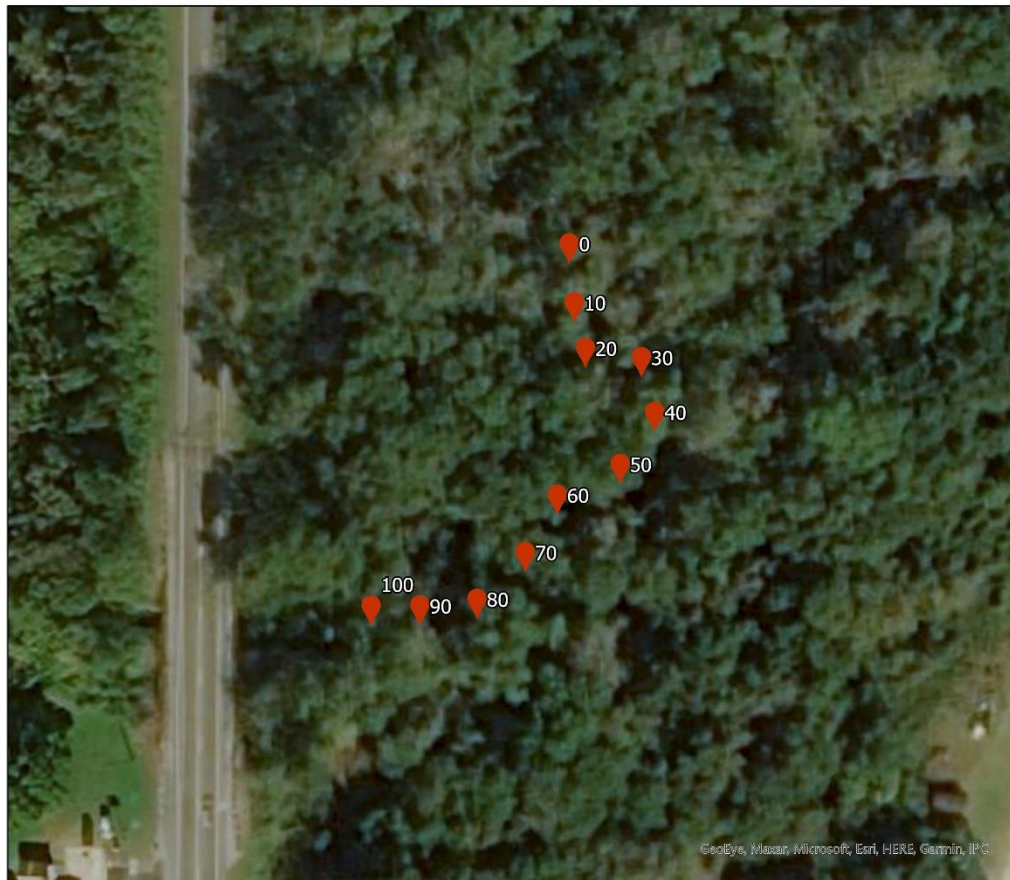
Figure 1 2020 Hurrah Creek Study Area Map

### Hurrah Creek WBID 1711

Mouth - South prong Alafia River  
Area - 5,152 Acres (6.22 Sq Miles)  
Landscape Development  
Intensity - 5.41  
Stream Habitat Assessment - 115  
Rapid Peiphyton Survey -  
% ranked 4-6 - 0%  
Linear Vegetation Survey -  $< 2m^2$   
% FLPPC - 29.41%  
Average CoC - 2.50  
Stream Condition Index - 72

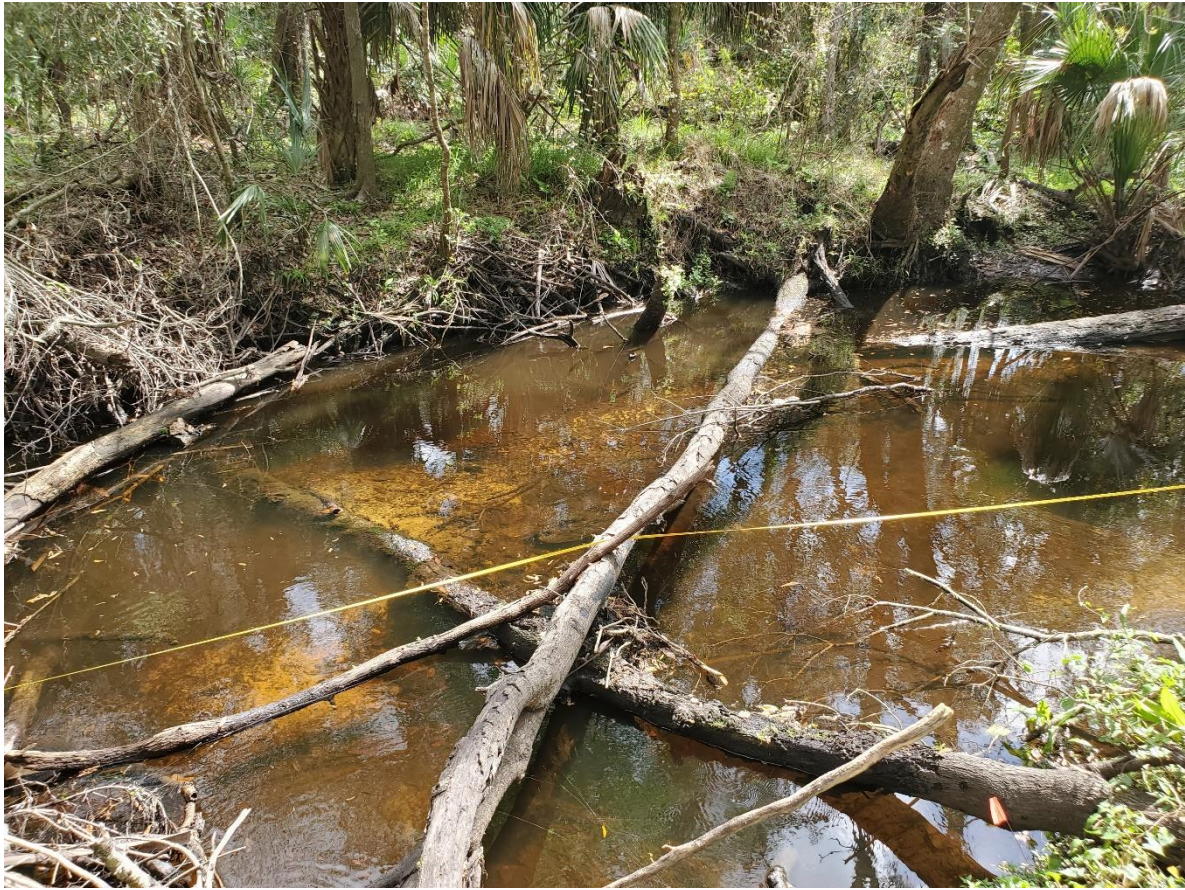
*Figure 2 Overview photograph of the Hurrah Creek Sample Site*

The region of Hurrah Creek where the assessment was conducted is in a natural corridor with extractive activities nearby. The region was moderately shaded with a mean canopy cover measurement of 72.5%. Hurrah Creek averaged 0.5 meters in depth, approximately 4.35 meters wide with a flow of 0.25 m/s.

The primary habitat components of the FDEP Habitat Assessment focus on in-water habitat. The primary habitat components score in the suboptimal category for Habitat Smothering (adequate number of stable pools with some habitats being affected by sand and silt) and Water Velocity. Substrate Availability (5.7% of stream are productive habitats) and Substrate Diversity (Presence of two major productive habitats (snags, roots)) were scored as marginal. Minor habitats included leaf packs/mats, aquatic macrophytes, sand and silt deposits. The total score for the primary habitat components was a 44 out of 80.

The secondary habitat components of the FDEP Habitat Assessment focus on the surrounding features of the stream. The secondary habitat components scored in the optimal category for Artificial Channelization, Bank Stability and Riparian Buffer Zone Width having well developed sinuosity with few raw eroded areas of bank and a vegetative buffer greater than 18 meters on both banks. Riparian Zone Vegetation Quality scored in the suboptimal category due to several non-native invasive species and native species indicative of disturbance in the surrounding buffer zone. The vegetation in the stream itself was sparse with less than 2 square meters of surface area in the study area of predominantly native species with 3 non-native invasive species out of 15 total species. The secondary habitat components received a score of 71 out of 80. The resulting FDEP Habitat Assessment score was a 115.

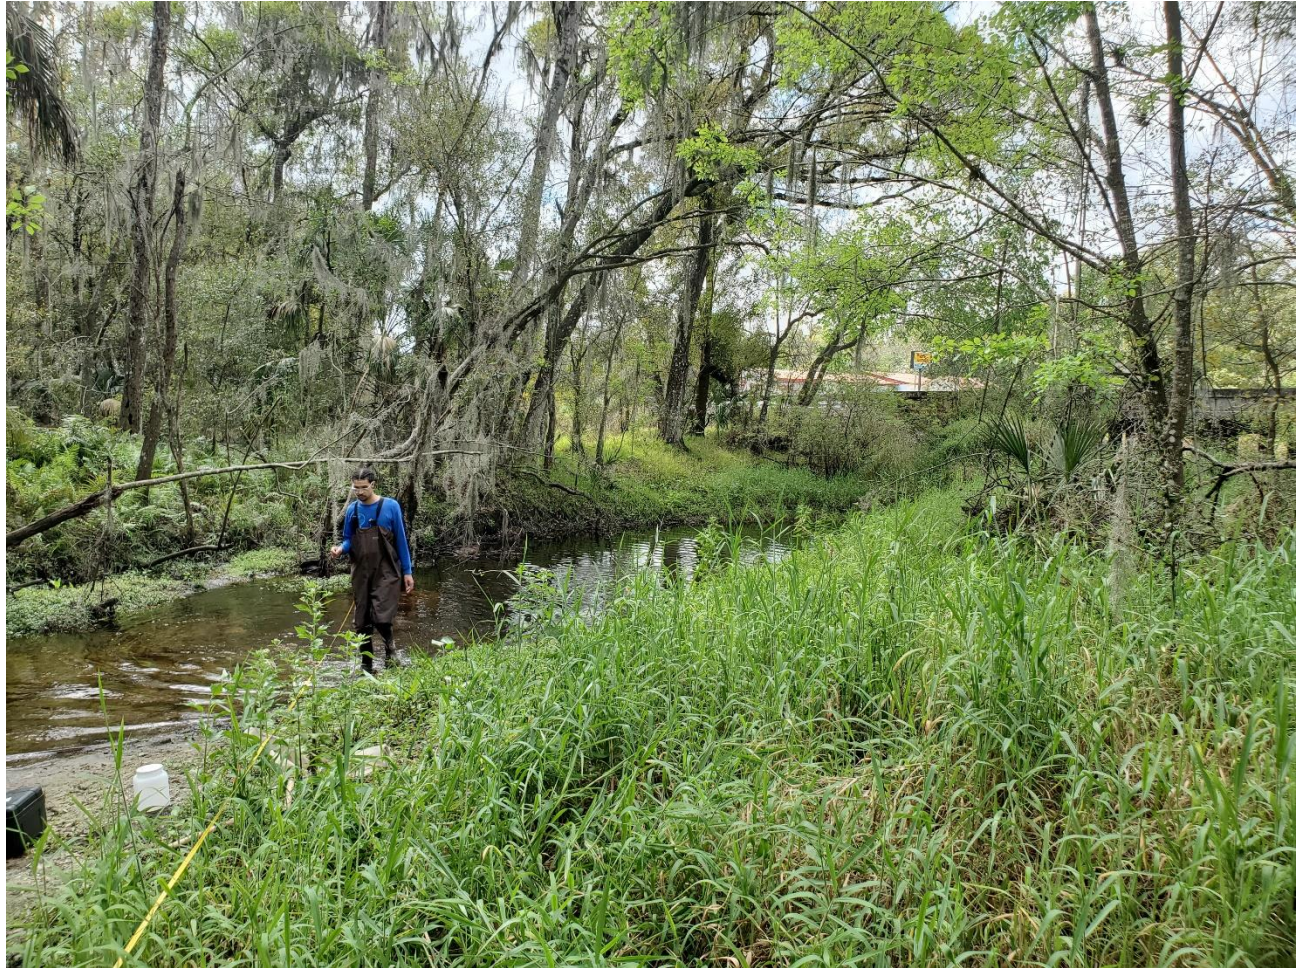
*Figure 3 The 80-100 meter section of the study area in Hurrah Creek.*

The FDEP Linear Vegetation Survey encountered less than 2 square meters of herbaceous aquatic vegetation among 15 species in Hurrah Creek. *Hygrophila polysperma*, *Alternanthera philoxeroides* and *Urochloa mutica* are non-native invasive species. Only *Hygrophila* was abundant in small sections of the assessment region. Although the coverage was less than 2 square meters (the threshold for incorporating LVS results) the resulting metrics would have been a Percent FLEPPC of 29.41% and an Average Coefficient of Conservatism of 2.50. The Percent FLEPPC metric is above the threshold and indicates disturbance to the vegetative community.
