# Lake Williams

LAKE HABITAT ASSESSMENT, LAKE VEGETATION INDEX, SUBMERGED  
VEGETATION SURVEY AND WATER QUALITY

David Eilers, Ray Dominguez | USF Water Institute | May 28, 2020

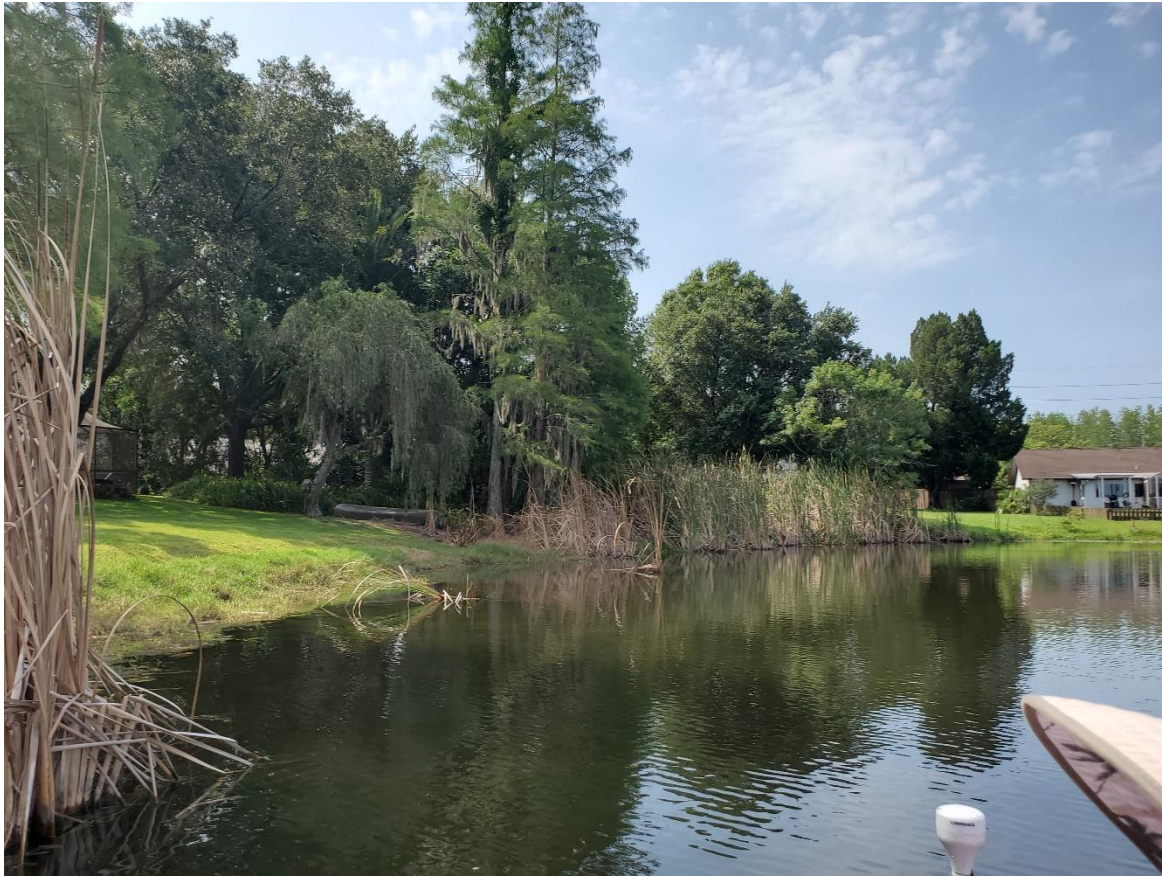
Figure 3 Overview photograph of Lake Williams showing typical shoreline in the residential section of the lake.

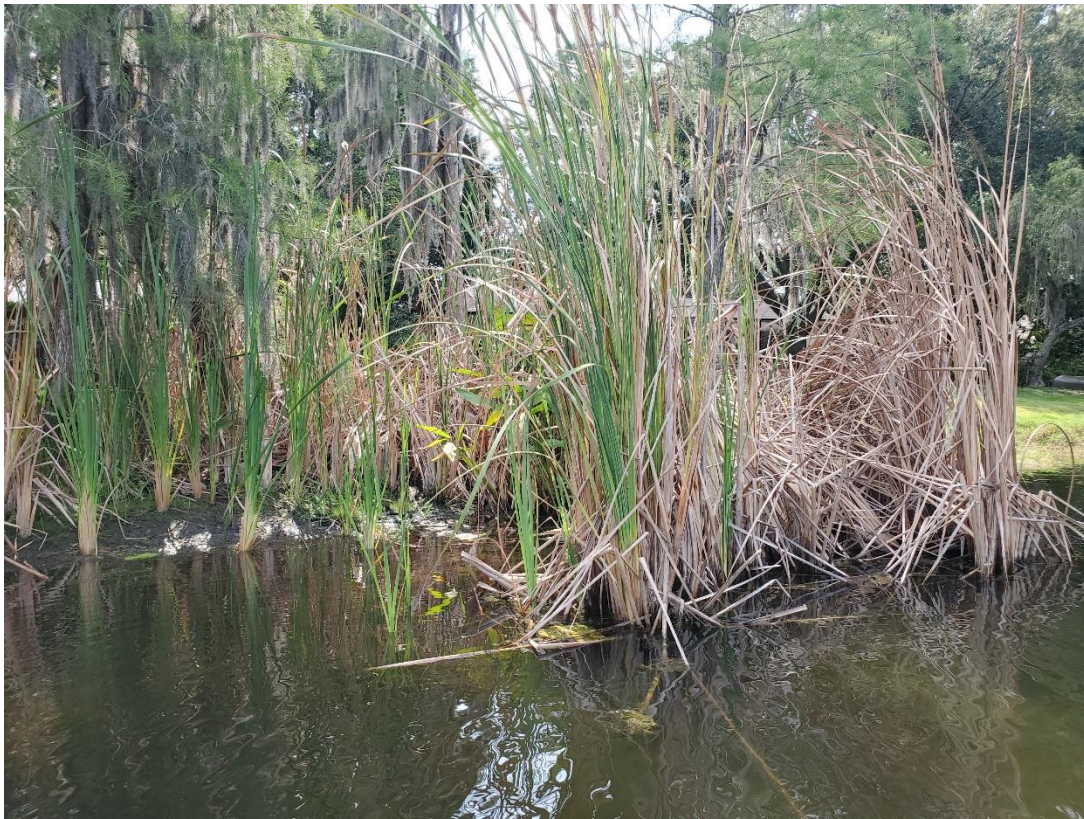
*Figure 4 Typha, Cattails, along a vegetated section of Lake Williams shoreline.*

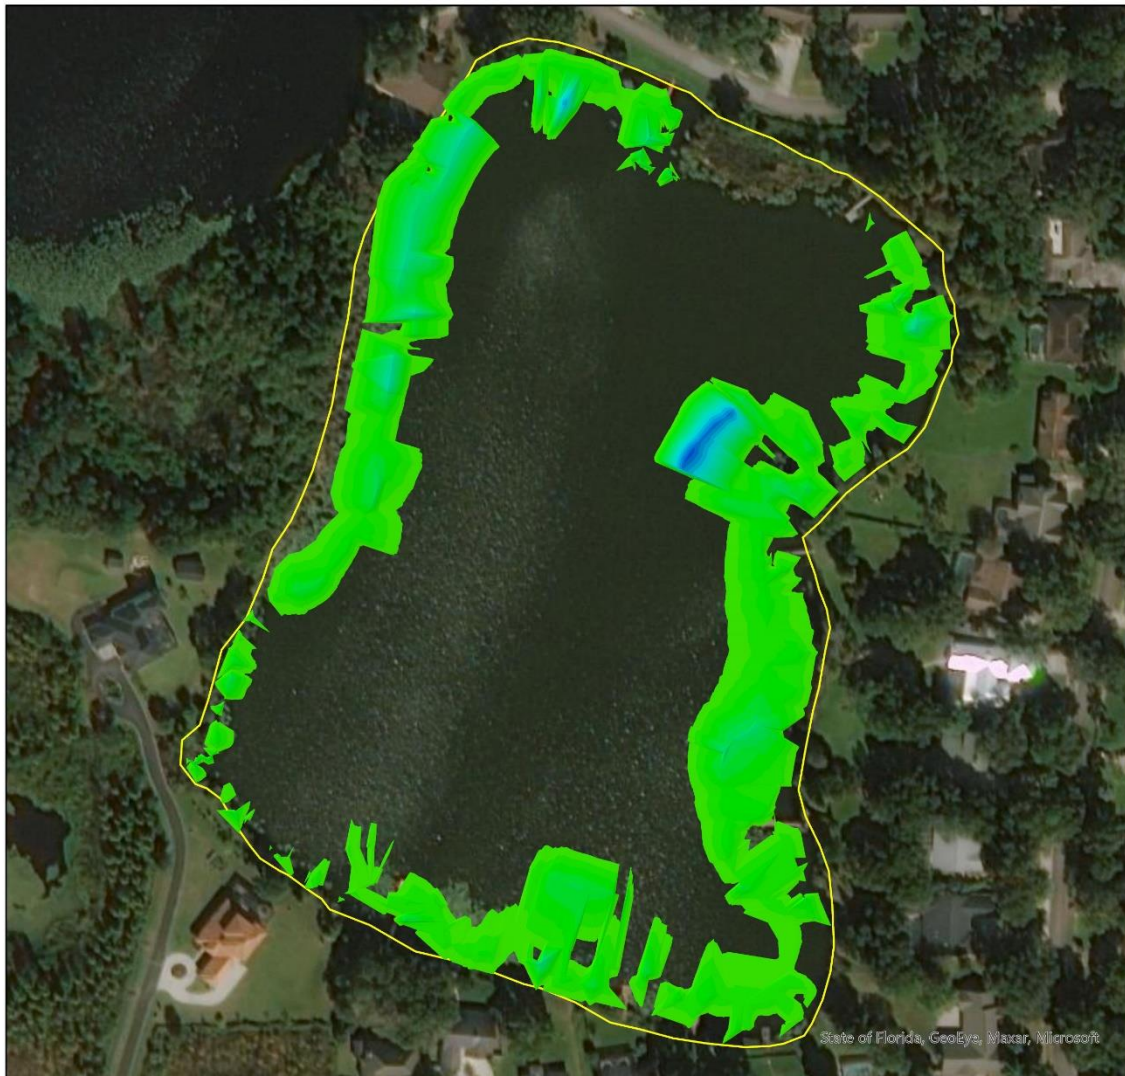
Figure 5 Lake Williams Submerged Aquatic Vegetation Assessment Results

The Lake Vegetation Index identified 33 species of wetland vegetation growing in the four selected sections along Lake Williams. The majority of these species (26) are native species. The remaining 7 species (*Panicum repens*, *Alternanthera philoxeroides*, *Eichhornia crassipes*, *Oxyaryum cubense*, *Schinus terebinthifolius*, *Sapium sebiferum* and *Ludwigia peruviana*) are non- native and invasive to this region. The vegetation community along Lake Williams is dominated by a variety of emergent species including *Panicum repens* and *Typha*. The water's surface in Lake Williams was dominated by *Nuphar* with some *Eichhornia crassipes*. A total of 7 species of submerged aquatic vegetation were observed, *Utricularia gibba*, *Utricularia radiata*, *Nitella*, *Potamogeteon diversifolius*, *Chara*, *Eleocharis baldwinii* and *Najas guadalupensis* with *Chara* being the dominant species. Submerged vegetation was abundant in the lake due to the moderate water visibility. By analyzing the collected sonar chart, submerged aquatic vegetation potentially covered approximately 29.76% of the surface area of Lake Williams. This submerged vegetation inhabits an estimated 1.83% of the water volume in Lake Williams. Figure 5 shows the results of the SAV analysis indicating the location and percent of the water column inhabited by SAV.

## SAV STATISTICS:

Area 228,153 square ft; 5.2 Acres;

(29.8% of Lake Surface Area)

Mean SAV Height 0.5 ft;

Volume 110,474 Cubic ft, (826,410 gallons);

(1.83 % of Lakes Volume)

The system also shows some impairment in the vegetation communities according to the Lake Vegetation Index with low overall species (33), moderate occurrences of non-native, invasive species and few sensitive plant species with an overall LVI score of 42. The assessment also revealed the submerged aquatic vegetation community comprising 7 species occupying 29.76% of the surface area and 1.83% of the volume of Lake Williams.
