Little Alafia River below Medard Reservoir

STREAM HABITAT ASSESSMENT, STREAM CONDITIONS INDEX, LINEAR VEGETATION SURVEY, RAPID PERIPHYTON SURVEY AND WATER QUALITY

David Eilers, William Dudley | USF Water Institute | January 29, 2020

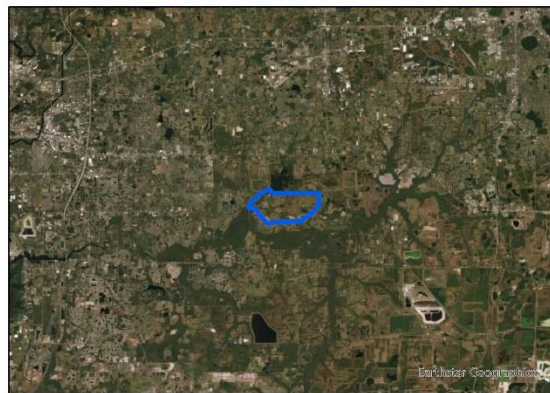
Little Alafia River below Medard Reservoir WBID 1592

Mouth - Alafia River North Prong
Area - 3,016 Acres (5.12 Sq Miles)
Landscape Development
Intensity - 5.02
Stream Habitat Assessment - 85
Rapid Periphyton Survey -
% ranked 4-6 - 0%
Linear Vegetation Survey - < 2m²
% FLPPC - 100%
Average CoC - 0.202
Stream Condition Index - 57

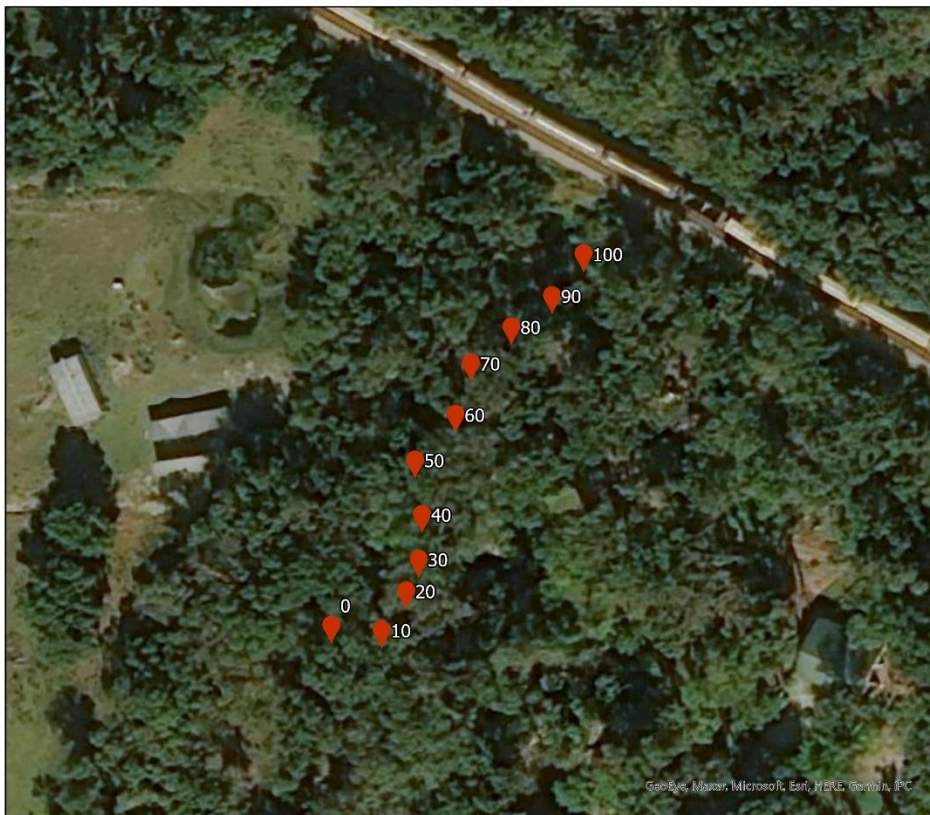
Figure 1 2020 Little Alafia River below Medard Reservoir Study Area Map

Little Alafia River below Medard Reservoir is located in eastern Hillsborough County. Its headwaters is the outfall of the Medard Reservoir in Plant City and the outfall of Little Alafia River is in Turkey Creek. The assessment of Little Alafia River was conducted on January 29, 2020. At the time of the assessment, the water levels were low, normal for the end of the dry season. The Little Alafia River below Medard Reservoir WBID covers 5.12 square miles and is dominated by pasture (26.3%), reclaimed (22.60%), residential (15.6%) and agricultural (11.8%) land uses. The resulting calculated landscape development intensity index score was 5.02.

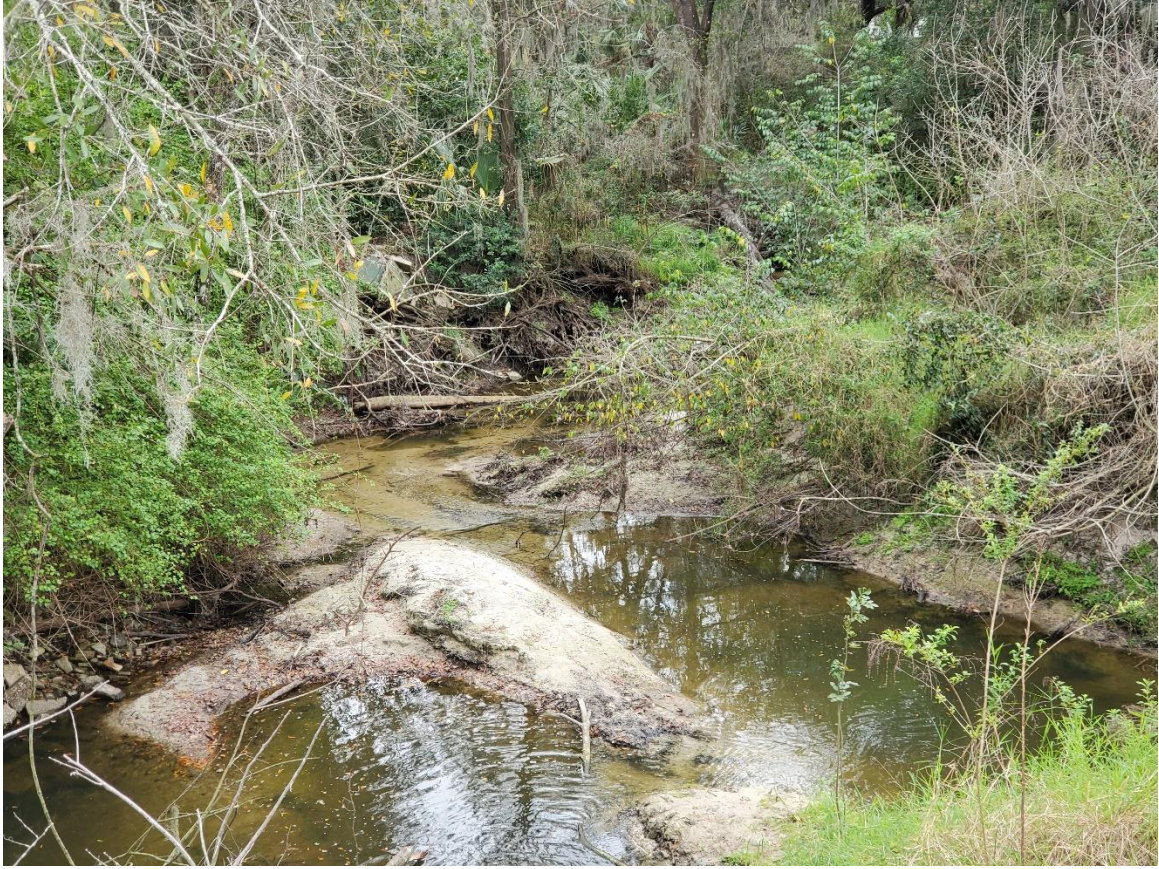
Figure 2 Overview photograph of the Little Alafia River below Medard Reservoir Sample Site

The region of Little Alafia River below Medard Reservoir where the assessment was conducted is in an agricultural and residential area. The region was moderately shaded with a mean canopy cover measurement of 66%. Little Alafia River below Medard Reservoir averaged 0.2 meters in depth, approximately 4.65 meters wide with a flow of 0.16 m/s.

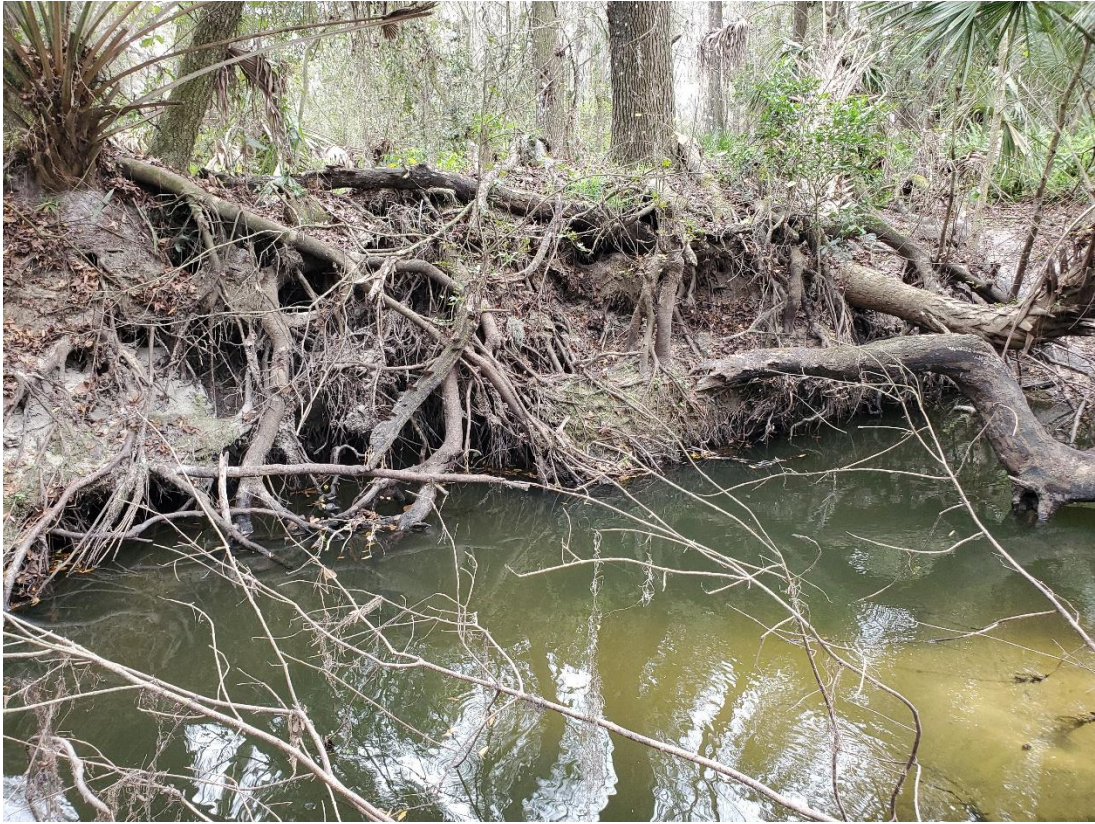
Figure 3 Eroded banks along Little Alafia River.

The secondary habitat components of the FDEP Habitat Assessment focus on the surrounding features of the stream. The secondary habitat components scored in the optimal category for Artificial Channelization and Riparian Buffer Zone Width for the left bank. Bank Stability with many raw, eroded areas and Riparian Zone Vegetation Quality for the left bank and scored in the suboptimal category due to collapsing, steep banks and several non-native invasive species. Riparian buffer zone width and vegetation quality for the right bank were marginal. The riparian buffer zone surrounding the stream was greater than 18 meters on the left bank, with areas of the right bank having clearings for RV's, and consisted of a mixture of native and invasive species indicative of disturbance. The vegetation in the stream itself was dominated by non-native species with 6 non-native invasive species out of 6 total species. The secondary habitat components received a score of 54 out of 80. The resulting FDEP Habitat Assessment score was an 85.
