Pretty Lake

LAKE HABITAT ASSESSMENT, LAKE VEGETATION INDEX, SUBMERGED
VEGETATION SURVEY AND WATER QUALITY

David Eilers, Natalie Abdo | USF Water Institute | May 18, 2020

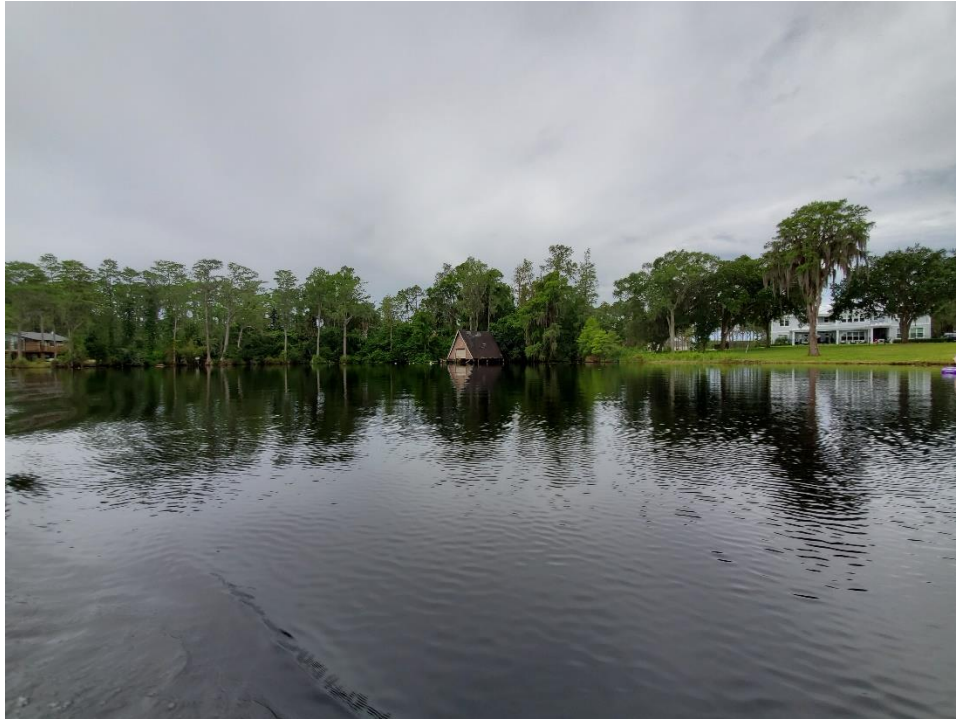
Figure 3 Overview photograph of Pretty Lake showing the typical shoreline vegetation communities and development.

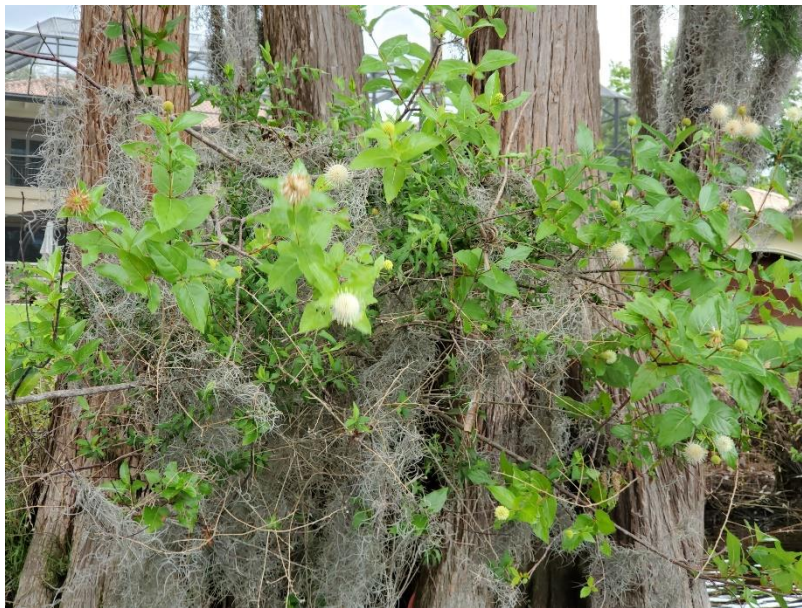
The lake assessment for Pretty Lake was conducted on May 18, 2020. The water in Pretty Lake is characterized as highly tannic with a mean color value of 96.2 PCU. The secchi disk depth was 2.7 feet in part due to the high tannins. The vegetation quality of the plants in and buffering Pretty Lake are predominantly native species with moderate growths of non-native nuisance species such as *Colocasia esculenta*, *Panicum repens* and *Melaleuca quinquenervia*. Some direct inputs of stormwater were noted through pipes and ditches to the lake, but most stormwater reaches the lake via sheet flow. The bottom substrate quality was dominated by sand with coarse particulate organic matter near shore and some accumulation of muck. Approximately 80.2% of the surrounding land has been developed for residential housing including several docks and seawalls. Some homeowners have maintained a vegetated buffer zone along the shoreline.

Figure 4 *Cephalanthus occidentalis* (Common Buttonbush) and *Taxodium* (Cypress) along a residential section of Pretty Lake shoreline.
