Rock Lake

LAKE HABITAT ASSESSMENT, LAKE VEGETATION INDEX, SUBMERGED
VEGETATION SURVEY AND WATER QUALITY

David Eilers, Natalie Abdo | USF Water Institute | May 13, 2020

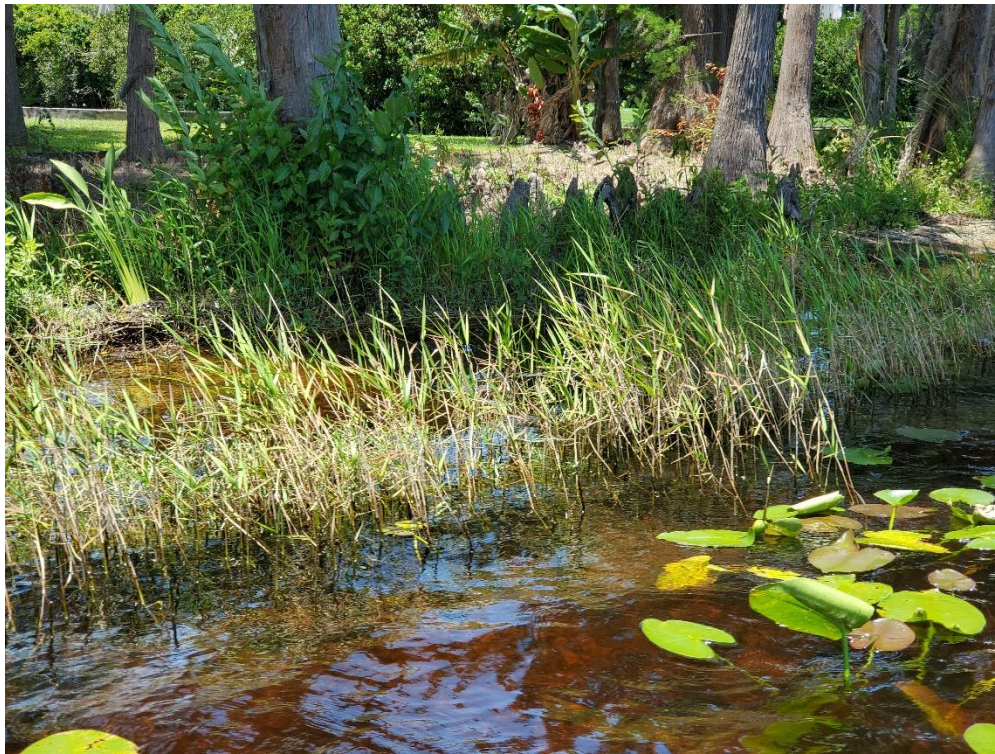
Figure 3 *Panicum hemitomon*, *Maidencane*, was a commonly occurring emergent grass in Rock Lake

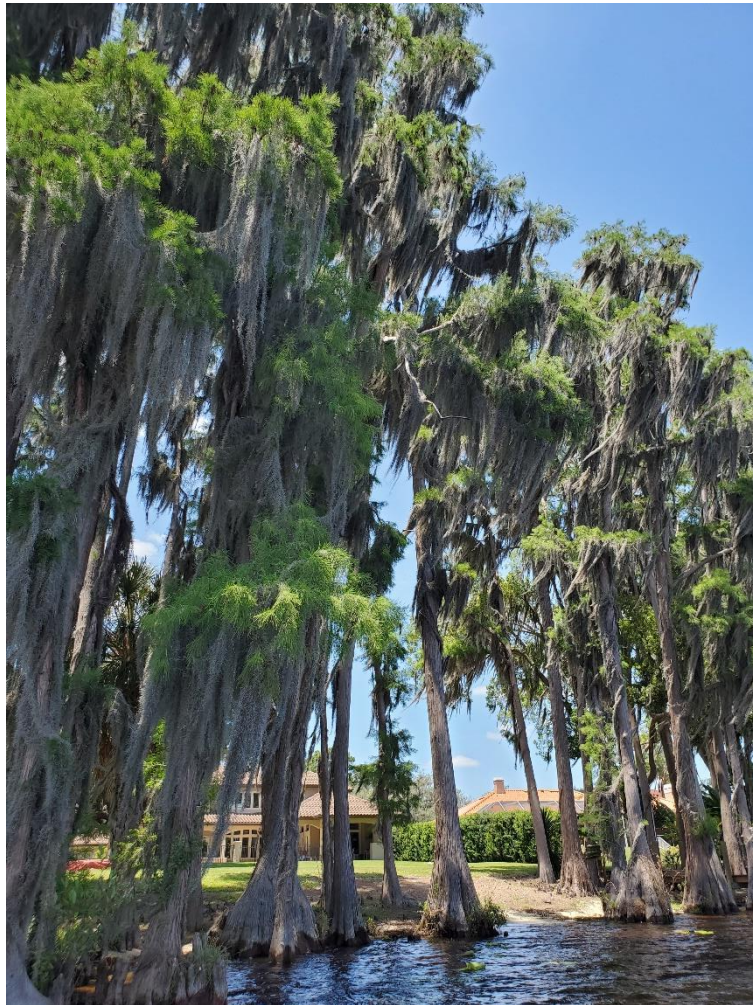
Figure 4 *Taxodium*, Cypress Tree, is common along the shoreline of Rock Lake and was co-dominant in the 4 regions of the Lake Vegetation Index Assessment.

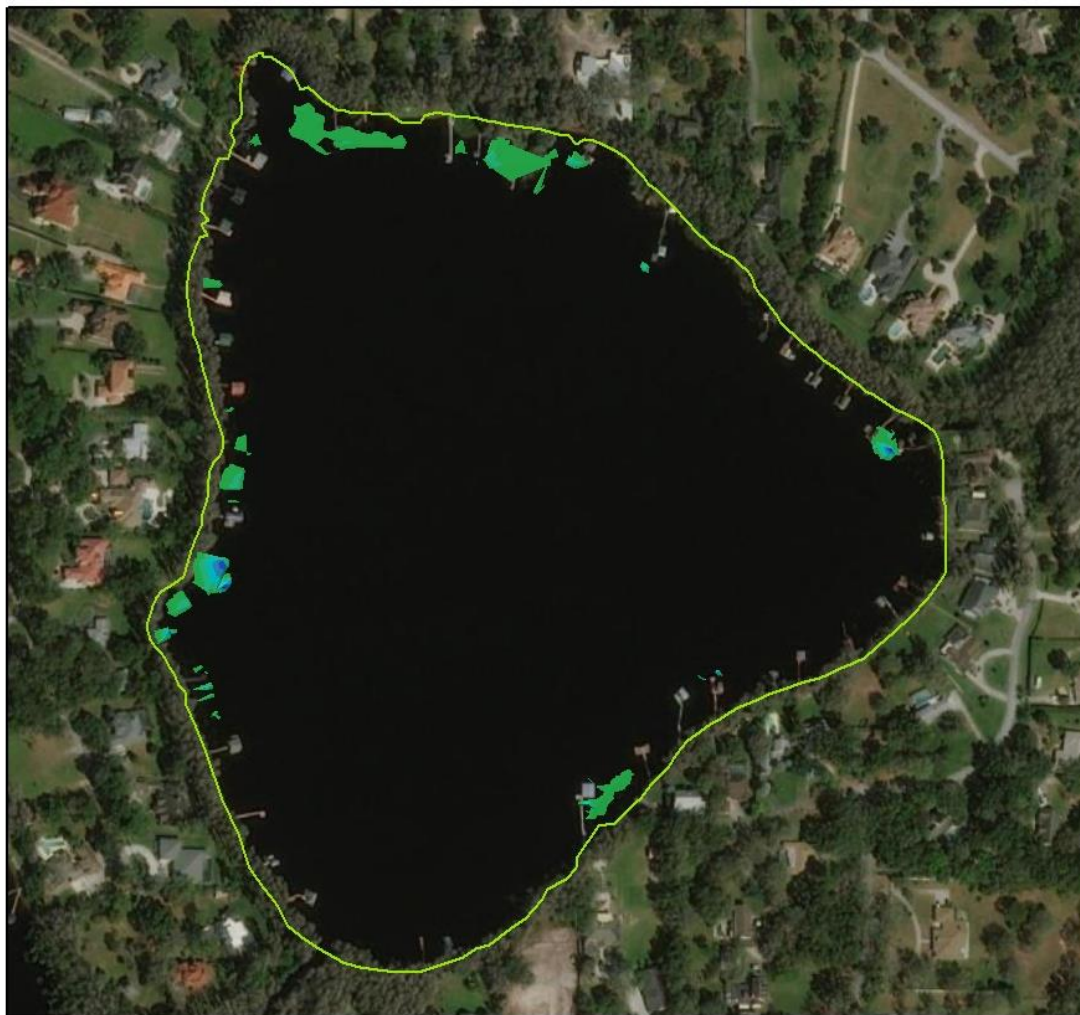
Figure 5 Rock Lake Submerged Aquatic Vegetation Assessment Results

The Lake Vegetation Index identified 40 species of wetland vegetation growing in the four selected sections along Rock Lake. The majority of these species (32) are native species. The remaining 8 species (*Panicum repens*, *Alternanthera philoxeroides*, *Eichhornia crassipes*, *Nymphoides cristata*, *Schinus terebinthifolius*, *Sapium sebiferum*, *Melaleuca quinquenervia* and *Ludwigia peruviana*) are non- native and invasive to this region. The vegetation community along Rock Lake is dominated by a variety of emergent species including *Taxodium*, *Acer rubrum* and *Cephalanthus occidentalis*. The water's surface in Rock Lake was dominated by *Nuphar*. A single species of submerged aquatic vegetation (*Eleocharis*) was identified in Rock Lake. Submerged vegetation was limited in the lake due to the low water visibility and tanins blocking available light. By analyzing the collected sonar chart, submerged aquatic vegetation potentially covered approximately 2.0% of the surface area of Rock Lake. This submerged vegetation inhabits an estimated 0.05% of the water volume in Rock Lake. Figure 5 shows the results of the SAV analysis indicating the location and percent of the water column inhabited by SAV.

Height of Submerged Vegetation

Survey Date: May 13, 2020
Water level was 42.88 ft NAVD 88 at the time of the assessment. Submerged Aquatic Vegetation was analyzed from collected sonar data. The height of the SAV where present is shown in 0.25 foot increments.

Area 50,111 square ft; 1.2 Acres;
(2.0% of Lake Surface Area)
Mean SAV Height < 0.2 ft;
Volume 8,677 Cubic ft, (64,907 gallons);
(0.05 % of Lakes Volume)
