Rocky Creek Lower Segment

STREAM HABITAT ASSESSMENT, STREAM CONDITIONS INDEX, LINEAR
VEGETATION SURVEY, RAPID PERIPHYTON SURVEY AND WATER QUALITY

David Eilers, Bailey Cooper & Alyssa Schultz | USF Water Institute | January 14, 2020

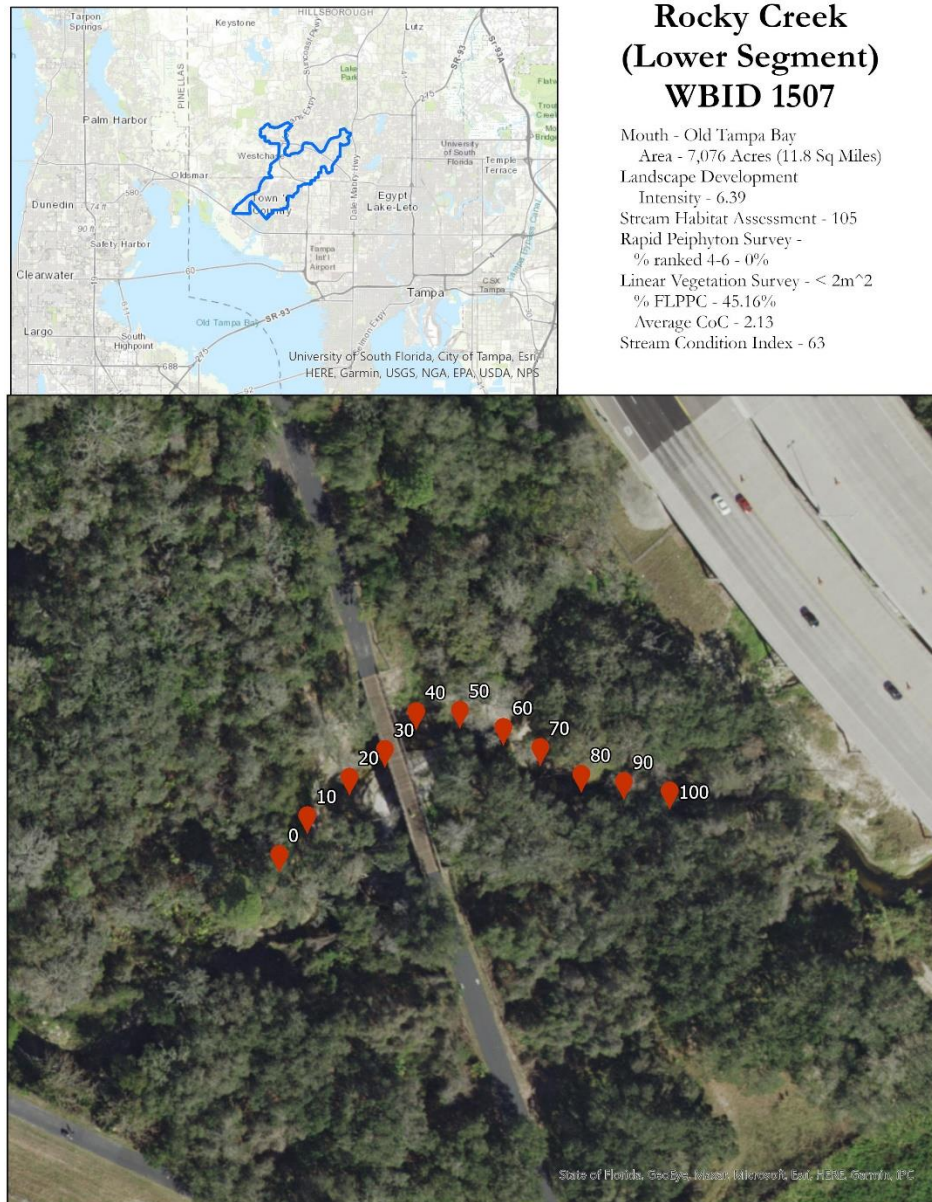
Figure 1 2020 Lower Rocky Creek Study Area Map

Rocky Creek lower segment is located in northwestern Hillsborough County. Its headwaters are located in Lake Carlton and the outfall of Rocky Creek is in Old Tampa Bay. The assessment of Rocky Creek was conducted on January 14, 2019 near Wilsky Rd. At the time of the assessment, the water levels were normal for the end of the dry season. The lower Rocky Creek WBID covers 11.8 square miles and is dominated by residential (52.0%) and natural (19.8%) land uses. The resulting calculated landscape development intensity index score was 6.39.

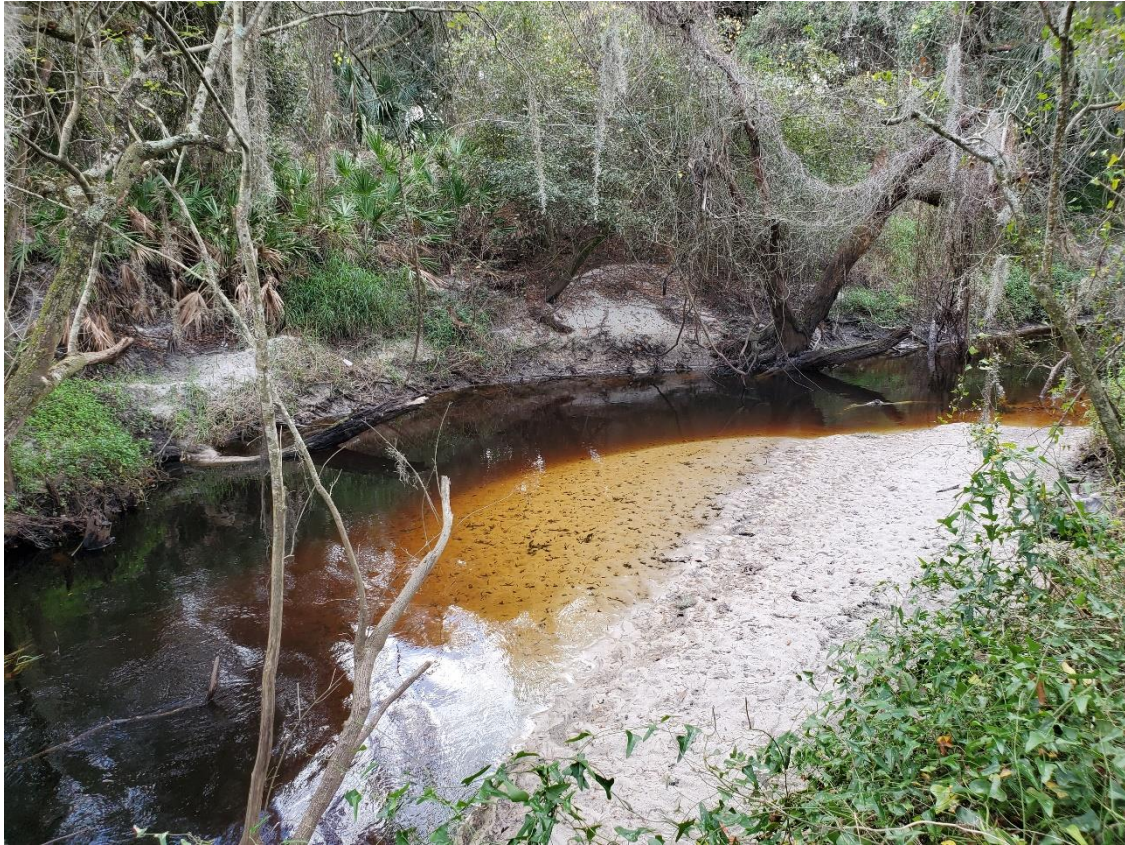
Figure 2 Overview photograph of the Lower Rocky Creek Sample Site

The region of Rocky Creek where the assessment was conducted is in a natural easement among a highly developed residential area. The region was moderately shaded with a mean canopy cover measurement of 47.5%. Rocky Creek averaged 0.4 meters in depth, approximately 6.8 meters wide with a flow of 0.36 m/s.

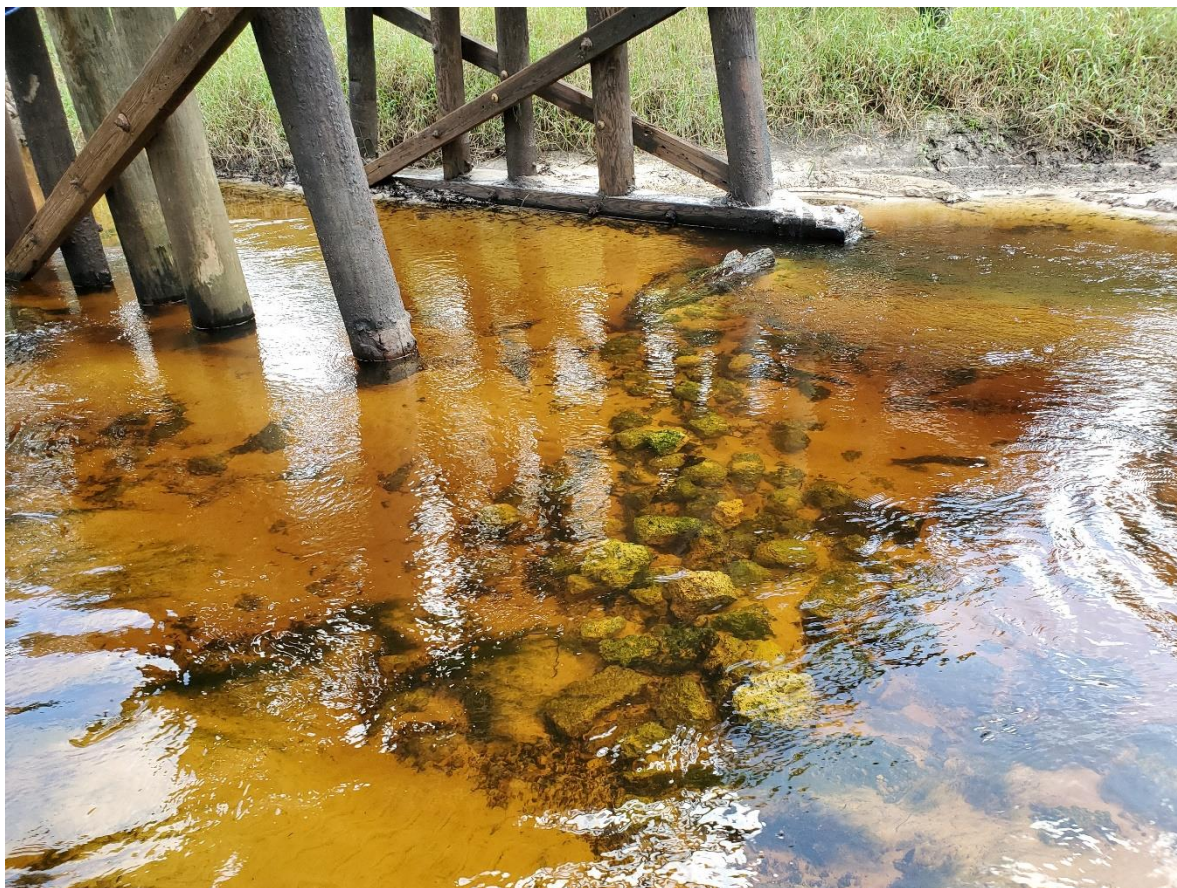
Figure 3 Rock habitat along Rocky Creek.

The primary habitat components of the FDEP Habitat Assessment focus on in-water habitat. The primary habitat components score in the optimal category for Water Velocity. Habitat Smothering (sufficient stable pools with some of the productive habitats affected by sand smothering) scored in the suboptimal range. Substrate Diversity (Presence of two major productive habitats (snags, rocks)) was scored as marginal. Substrate Availability (3.1% of stream are productive habitats) was scored as poor. Minor habitats included roots, leaf packs/mats, macrophytes, sand and silt deposits. The total score for the primary habitat components was a 44 out of 80.
