Delaney Creek at Maydell

STREAM HABITAT ASSESSMENT, STREAM CONDITIONS INDEX, LINEAR
VEGETATION SURVEY, RAPID PERIPHYTON SURVEY AND WATER QUALITY

David Eilers, Seth Curtin, Liliana Sikes, Elizabeth Brauer | USF Water Institute | April 8, 2021

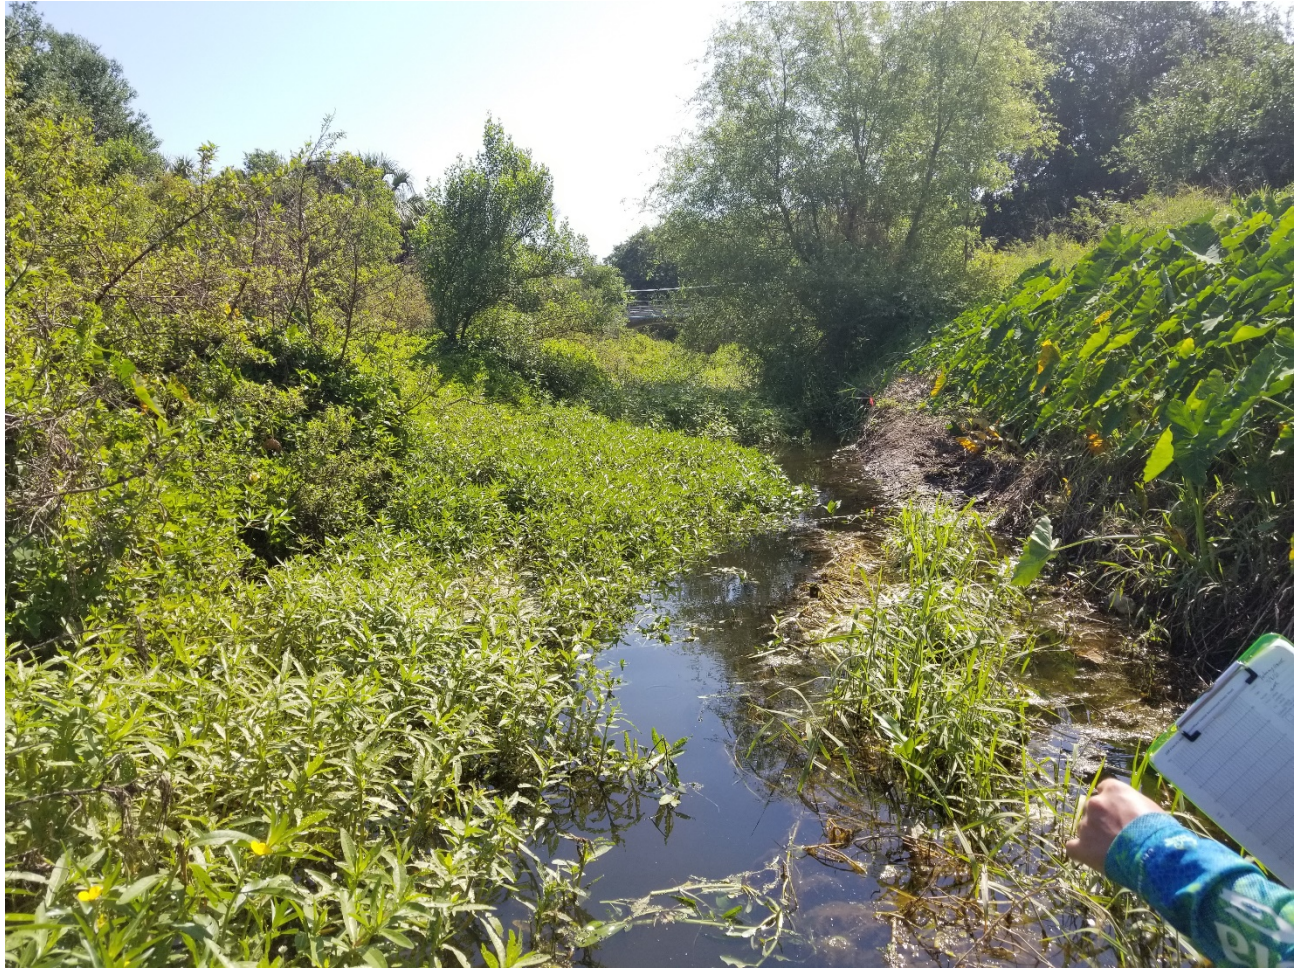
Figure 2 Overview photograph of the Delaney Creek Sample Site showing the typical habitat features

The region of Delaney Creek where the assessment was conducted is in an easement downstream from the Maydell Avenue Bridge. The region was open with a mean canopy cover measurement of 23.8%. Delaney Creek averaged 0.3 meters in depth, approximately 3.2 meters wide with a flow of 0.15 m/s.

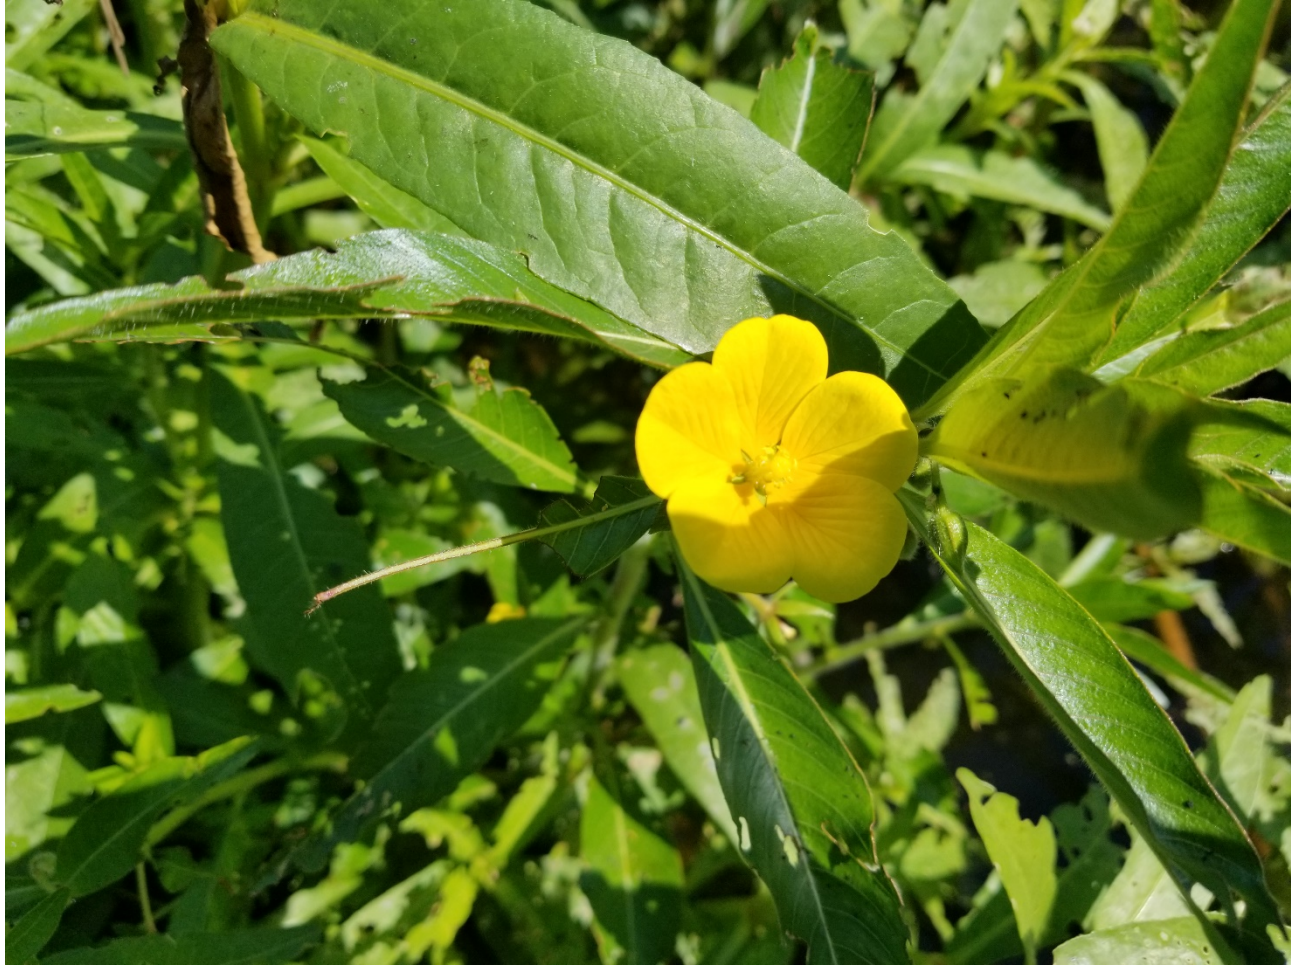
The FDEP Linear Vegetation Survey encountered abundant herbaceous species rooted in Delaney Creek at the time of the assessment. The vegetation in the creek was dominated by *Alternanthera philoxeroides*, *Ludwigia grandiflora* and *Polygonum glabrum* (*Pesicaria glabra*) .

Figure 3 Ludwigia grandiflora was a dominant species in Delaney Creek.
