# Hillsborough River

STREAM HABITAT ASSESSMENT, STREAM CONDITIONS INDEX, LINEAR  
VEGETATION SURVEY, RAPID PERIPHYTON SURVEY AND WATER QUALITY

David Eilers, Lauren Kier, Megan Dunne | USF Water Institute | May 12, 2021

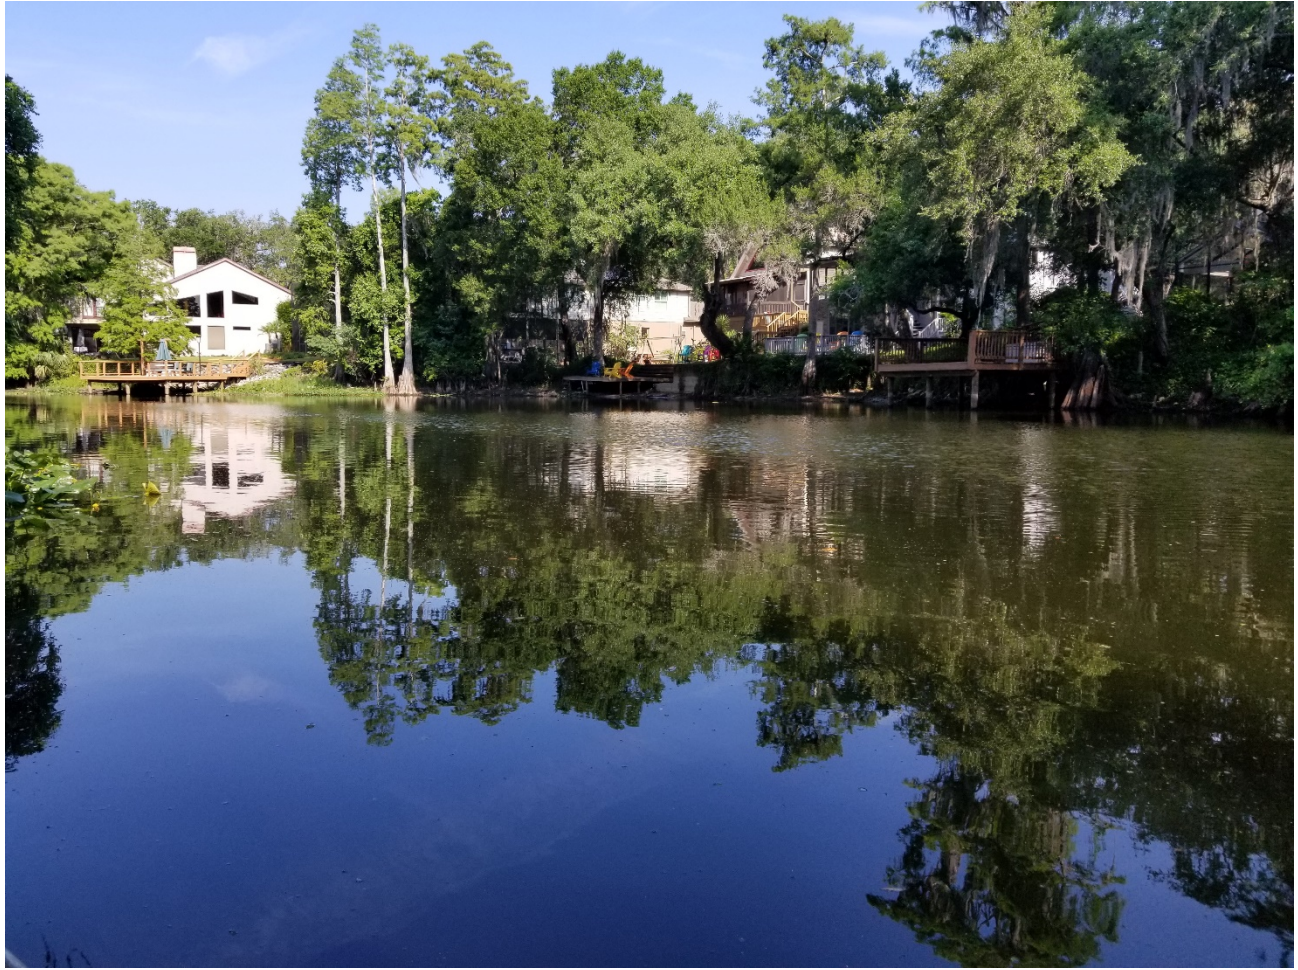
*Figure 2 Overview photograph of the Hillsborough River Sample Site showing the typical habitat features*

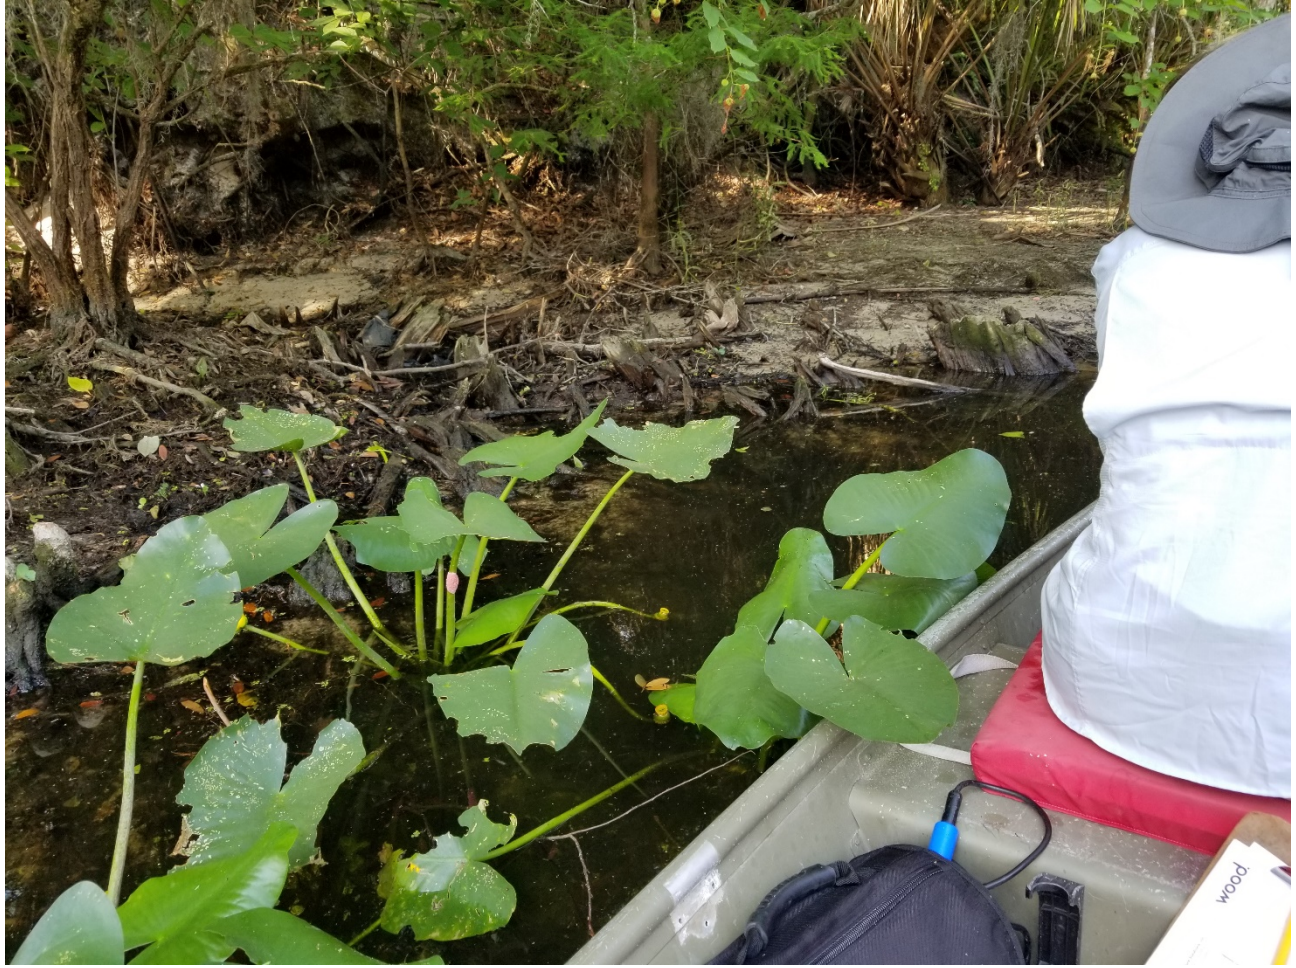
The FDEP Linear Vegetation Survey encountered greater than 2 m<sup>2</sup> of herbaceous species rooted in Hillsborough River at the time of the assessment. The vegetation in Hillsborough River was dominated by *Nuphar luteum*. Several non-native invasive species were also observed. The resulting metrics for Mean Coefficient of Conservatism was 1.37 and % FLEPPC was 41.5%, both exceeding FDEP criteria indicating an imbalance of flora.

*Figure 3 Nuphar luteum was common in the Hillsborough River sample site*
