# Hollomans Branch

STREAM HABITAT ASSESSMENT, STREAM CONDITIONS INDEX, LINEAR VEGETATION SURVEY, RAPID PERIPHYTON SURVEY AND WATER QUALITY

David Eilers, Megan Dunne, Lauren Kier | USF Water Institute | April 21, 2021

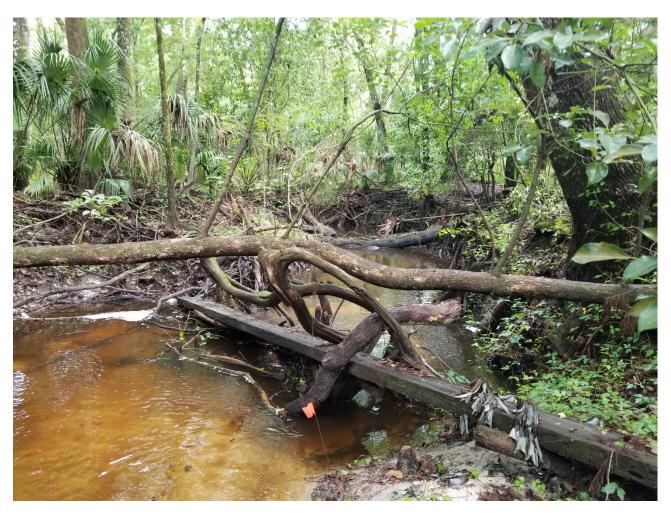
Figure 2 Overview photograph of the Hollomans Branch Sample Site showing the typical habitat features

The region of Hollomans Branch where the assessment was conducted is in a natural region downstream from the US Highway 301 Bridge. The region was heavily shaded with a mean canopy cover measurement of 92.4%. Hollomans Branch averaged 0.26 meters in depth, approximately 3.47 meters wide with a flow of 0.32 m/s.

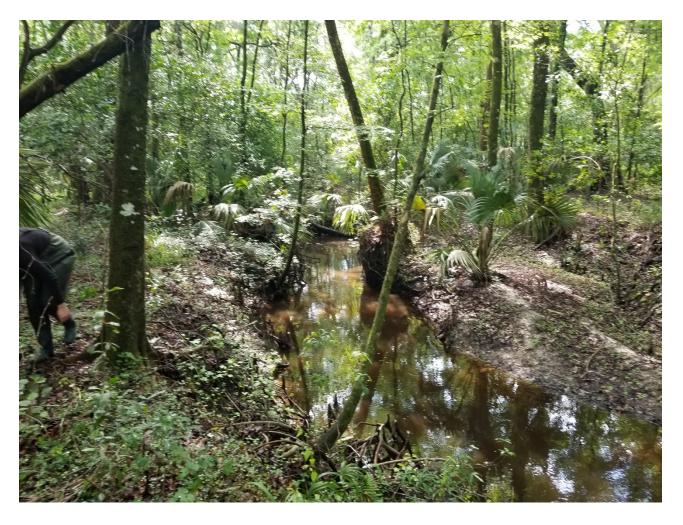
Figure 3 Snags were the most abundant major productive habitat in Hollomans Branch.
