Juanita Lake

LAKE HABITAT ASSESSMENT, LAKE VEGETATION INDEX, SUBMERGED
VEGETATION SURVEY AND WATER QUALITY

David Eilers | USF Water Institute | June 3, 2021

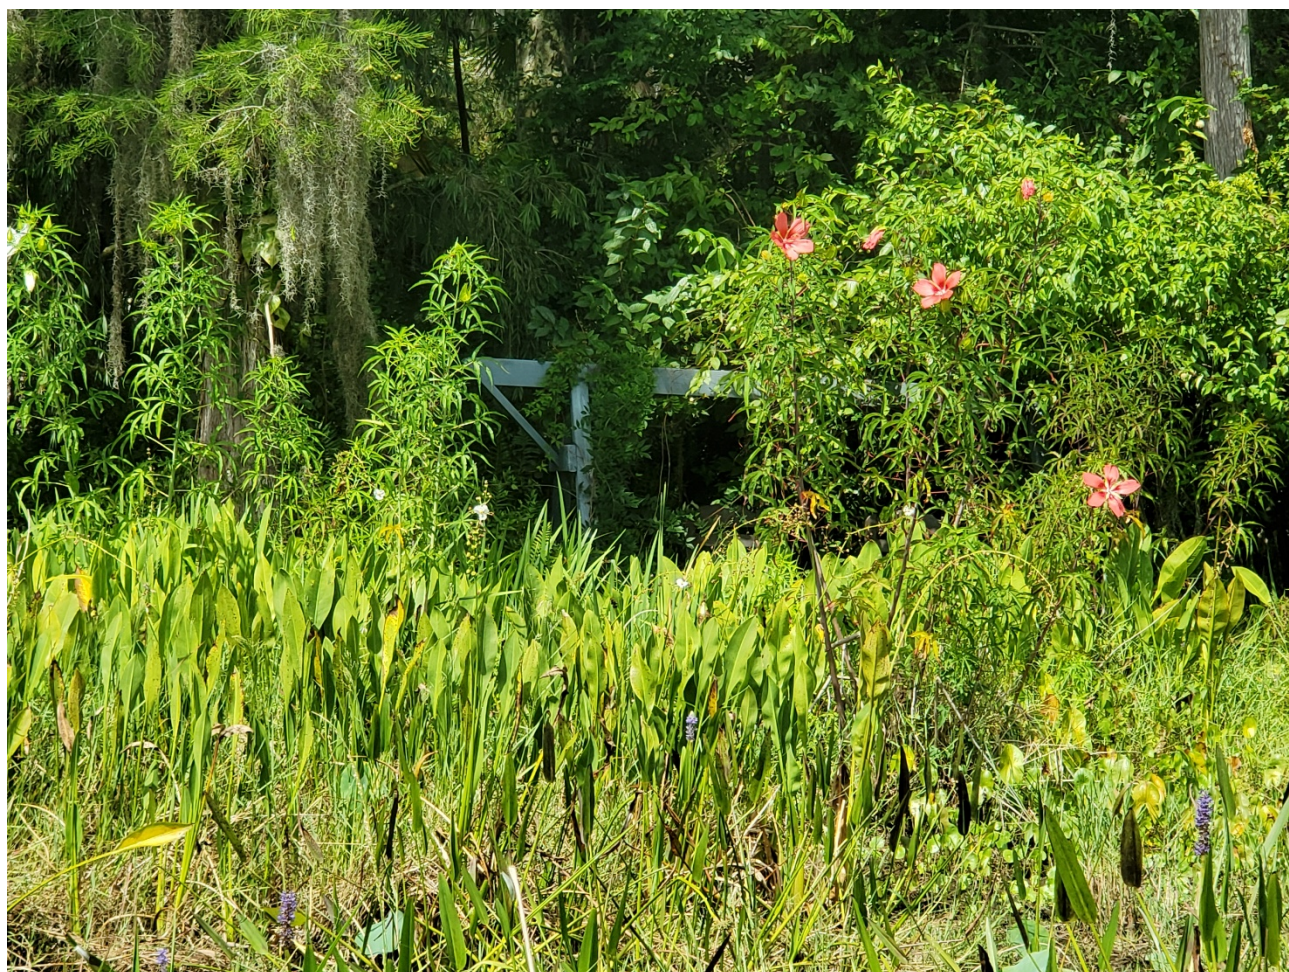
Figure 4 Emergent vegetation community along a residential property where the homeowner had preserved and restored native species of emergent vegetation.

The lake assessment for Juanita Lake was conducted on June 3, 2021. The water in Juanita Lake was characterized as tannic with a color value of 40 PCU. The secchi disk depth was 1.6 meters in part due to the tannins and low turbidity. The vegetation quality of the plants in and buffering Juanita Lake are predominantly native species with minor growths of non-native nuisance species such as *Panicum repens* and *Ludwigia peruviana*. Stormwater reaches the lake via sheet flow from surrounding residential and natural land cover. The bottom substrate quality was dominated by sand. The residential properties along the shorelines of Juanita Lake varied greatly in how they maintained the emergent vegetation community. Several properties had been predominately cleared of vegetation or replaced the emergent vegetation with sand to create a “beach”. Other properties had exerted significant effort towards the planting of native emergent plants creating areas rich in diversity.
