Lake Virginia

LAKE HABITAT ASSESSMENT, LAKE VEGETATION IDEX, SUBMERGED
VEGETATION SURVEY AND WATER QUALITY

David Eilers | USF Water Institute | May 20, 2021

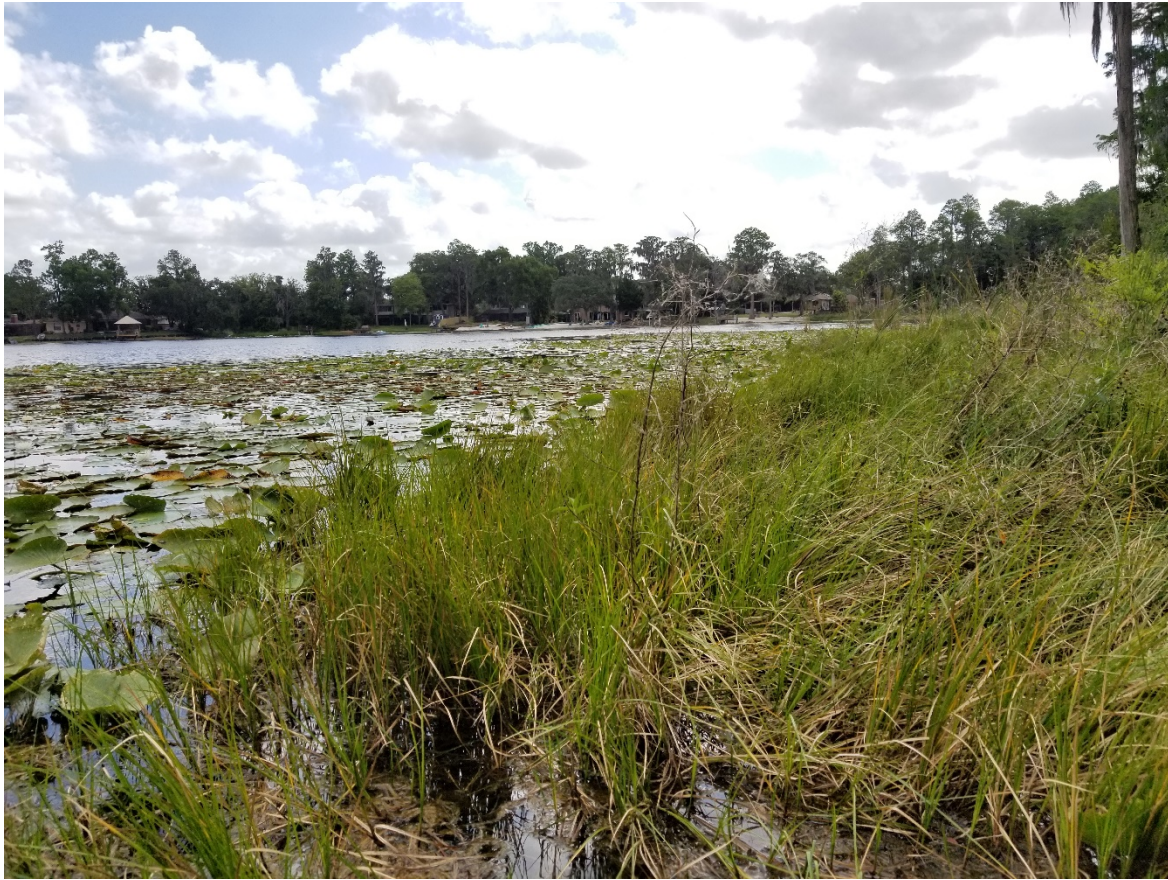
Figure 3 Overview photograph of Lake Virginia showing typical shoreline vegetation

The lake assessment for Lake Virginia was conducted on May 20, 2021. The water in Lake Virginia was characterized as colored with a color value of 50 PCU. The secchi disk depth was 1.52 meters in part due to the tannins and turbidity. The vegetation quality of the plants in and buffering Lake Virginia are predominantly native species with minor growths of non-native nuisance species such as *Limnophila sessiliflora*, *Panicum repens* and *Lugwigia peruviana*. Stormwater reaches the lake via sheet flow from surrounding land cover. The bottom substrate quality was dominated by sand with coarse particulate organic matter near shore. The Lake Virginia shoreline features a mixture of residential properties and natural buffers. Along these natural buffers, diversity was elevated. Along the residential properties the emergent vegetation community was greatly reduced.

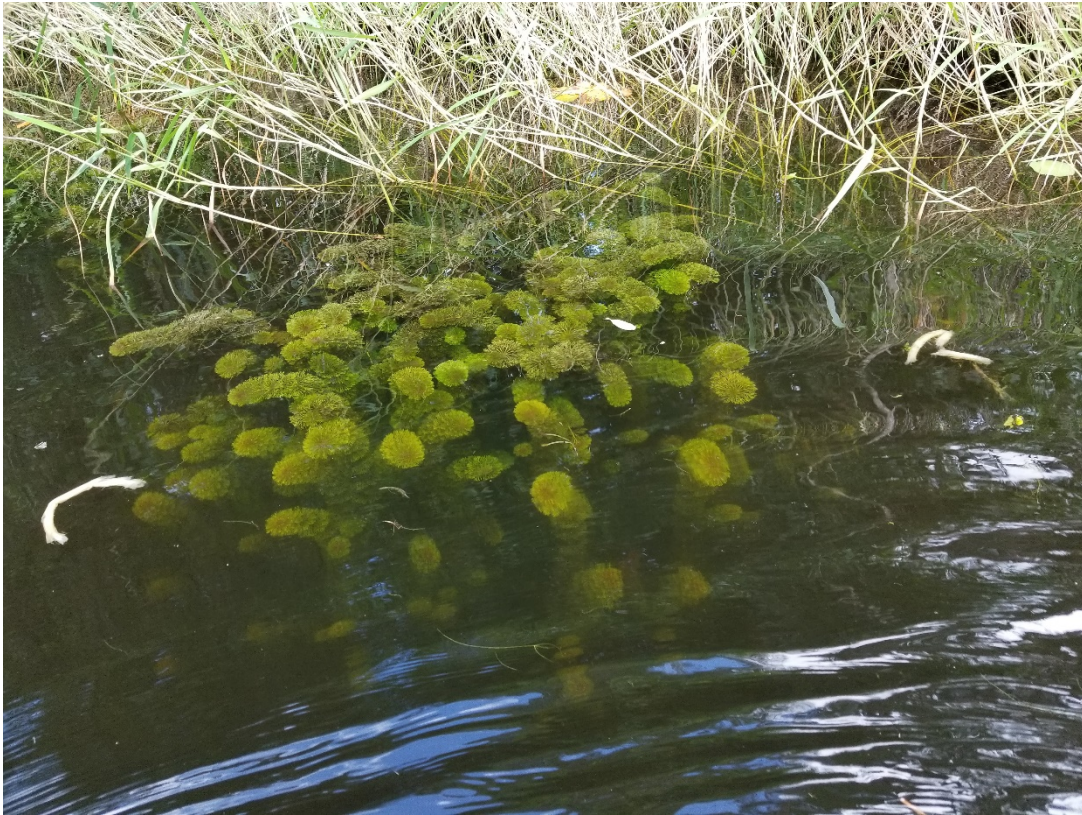
Figure 4 Limnophila sessiliflora was seen occasionally on Lake Virginia
