Valrico Lake

LAKE HABITAT ASSESSMENT, LAKE VEGETATION INDEX, SUBMERGED
VEGETATION SURVEY AND WATER QUALITY

David Eilers | USF Water Institute | May 19, 2021

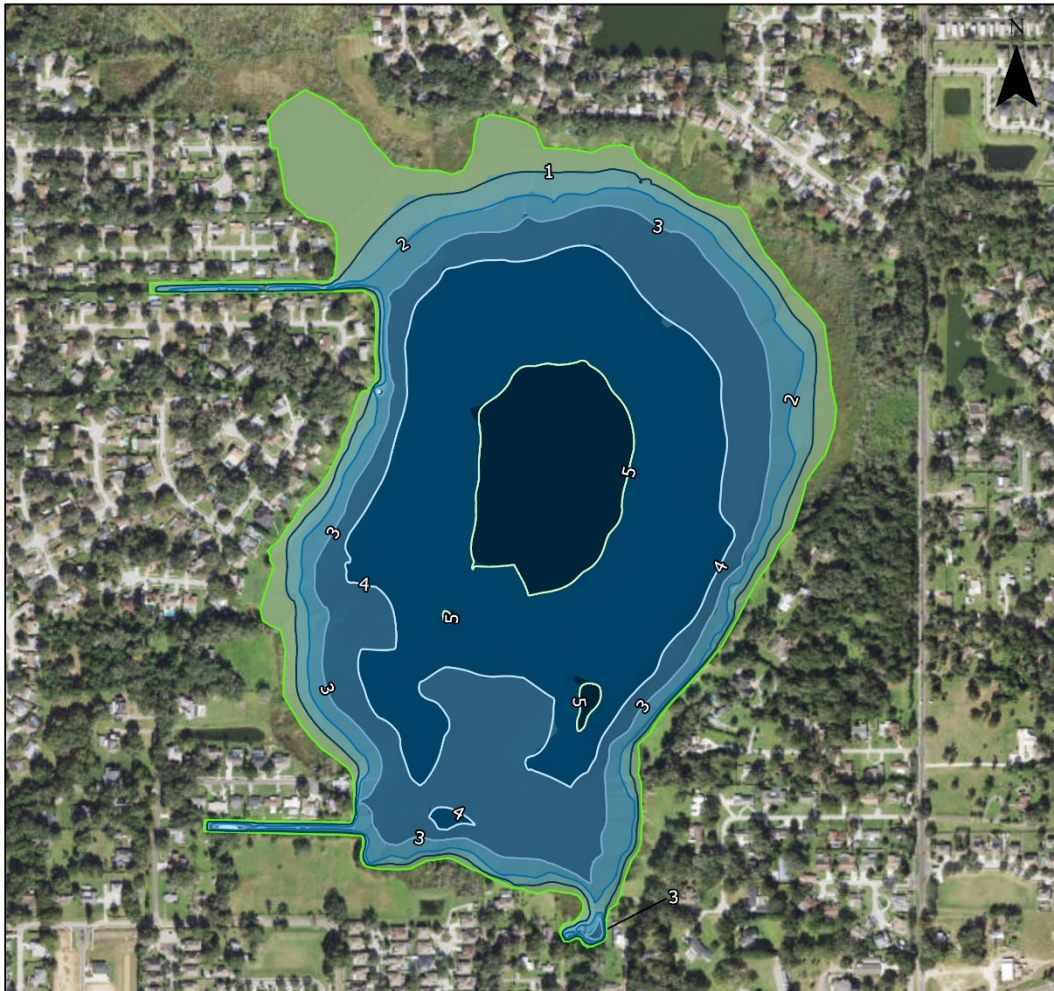
Figure 2: 2021 1-Foot Bathymetric Contour Map for Valrico Lake

At the time of the assessment, Valrico Lake was experiencing normal water levels (43.76 feet above sea level NAVD 88) resulting in a 143.6 acre water body. Valrico Lake at the time of the assessment had a mean water depth of 3.5 feet and a maximum observed depth of 5.61 feet. The volume at this time was approximately 164,767,284 gallons. Figure 2 shows the resulting bathymetric contour map for Valrico Lake from data collected on May 19, 2021. The collected data has been overlain the 2020 Hillsborough County aerials.

LAKE MORPHOLOGY:
 Perimeter 15,150 ft;
 Area 143.6 Acres;
 Mean Depth 3.5 ft;
 Volume 505.7 Acre-ft, (164,767,284 gallons);
 Deepest point 5.61 ft

EXPLANATION:
 Survey Date: May 19, 2021
 Water level was 43.76 ft NAVD 88
 at the time of the assessment.
 Contours are expressed in absolute depth
 below this level.

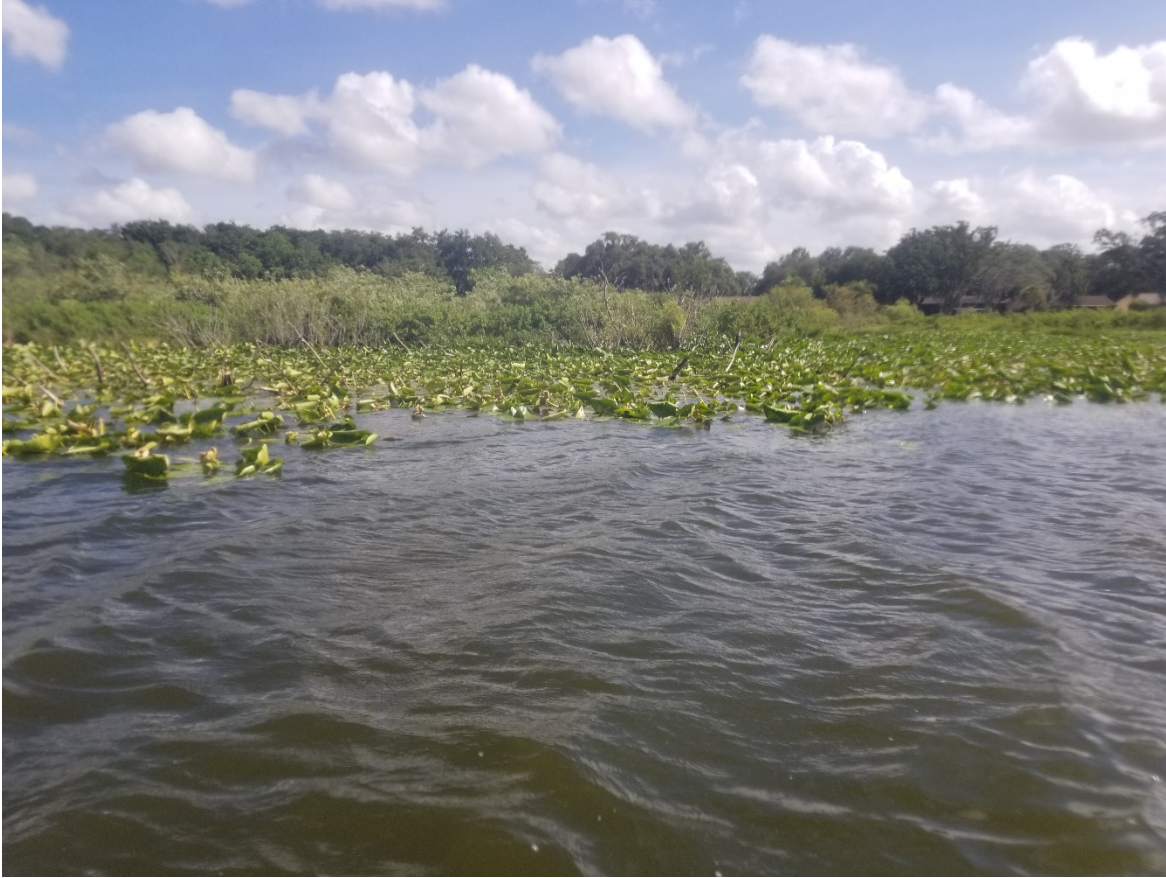
Figure 3 Overview photograph of Valrico Lake showing typical shoreline vegetation

The lake assessment for Valrico Lake was conducted on May 19, 2021. The water in Valrico Lake was characterized as colored with a color value of 60 PCU. The secchi disk depth was 0.73 meters in part due to the high tannins and turbidity. The vegetation quality of the plants in and buffering Valrico Lake are predominantly native species with significant growths of non-native nuisance species such as *Eichhornia crassipes*, *Panicum repens* and *Oxycaryum cubense*. Stormwater reaches the lake via sheet flow from the surrounding residential and natural land cover. The bottom substrate quality was dominated by sand/silt with coarse particulate organic matter near shore. The largest factor influencing the emergent vegetation community is the alteration of shorelines by homeowners.

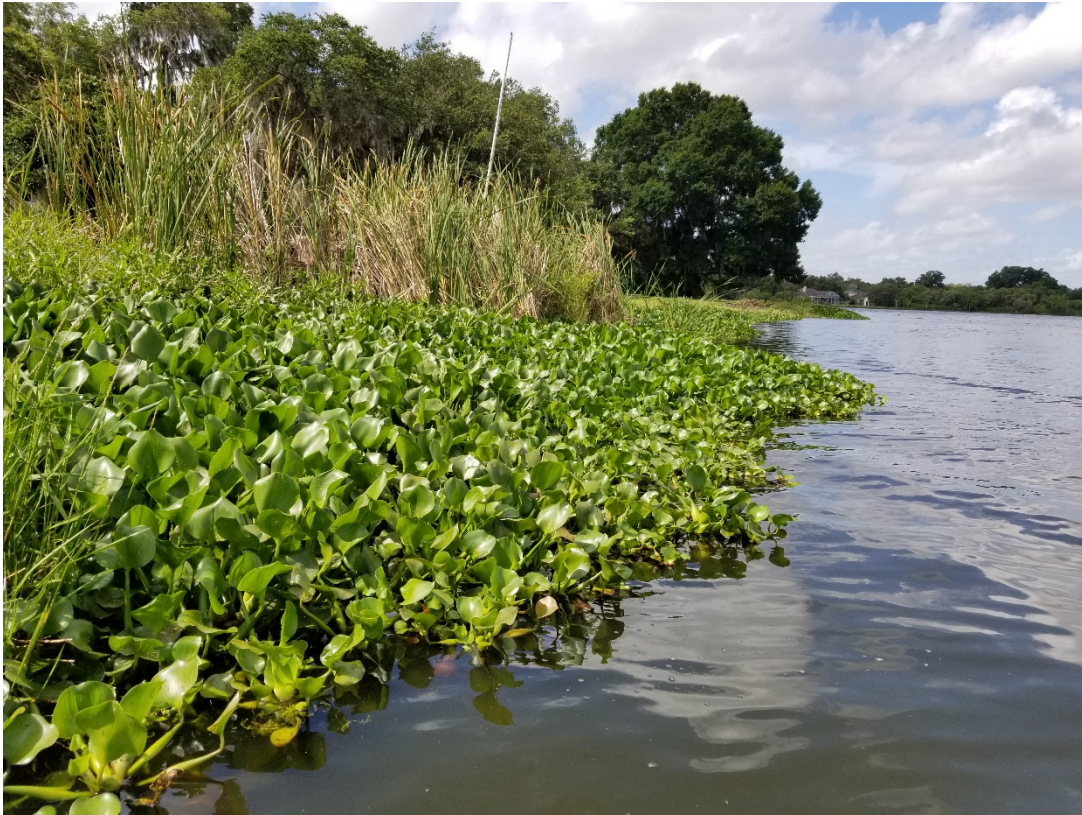
Figure 4 Eichhornia crassipes was a common floating leaved vegetation in Valrico Lake during the assessment.

The calculated LVI score for Valrico Lake was 12, below the impairment threshold of 43 indicating that the vegetation community is "Impaired". Figure 6 shows the map of Valrico Lake detailing the LVI regions used for the assessment (Regions 1, 4, 7, 10). Table 2 details the species list results of the Lake Vegetation Index. Table 3 details the scoring result for the Lake Vegetation Index. The main issues causing the impairment were the abundance of invasive species (29.5%), including *Eichhornia crassipes* which was dominant or codominant in all four regions of the LVI.

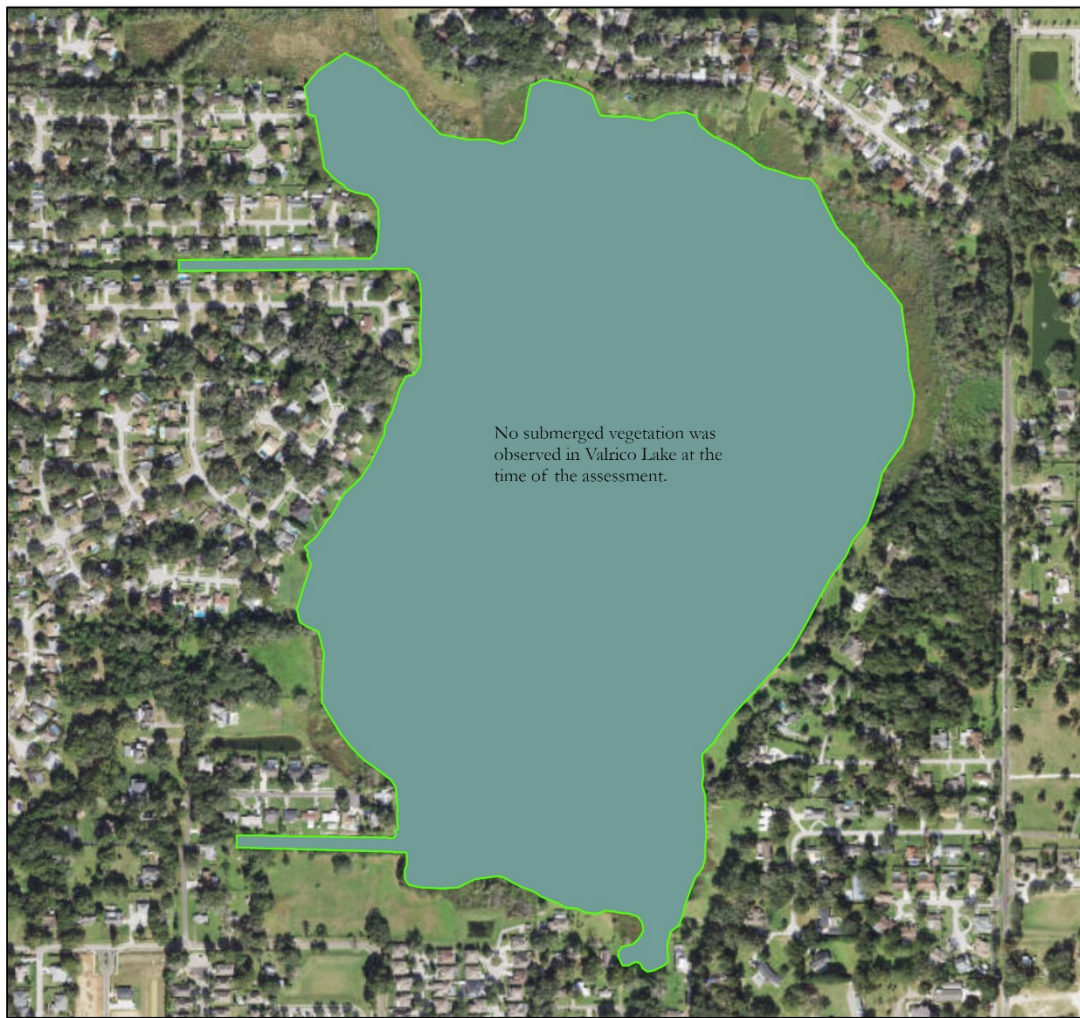
Figure 5 Valrico Lake Submerged Aquatic Vegetation Assessment Results

The Lake Vegetation Index identified 44 species of wetland vegetation growing in the four selected sections along Valrico Lake. The majority of these species (31) are native species. The remaining 13 species (*shown in bold in Table 2*) are non- native and invasive to this region. The vegetation community along Valrico Lake is dominated by a variety of emergent species including *Oxycaryum cubense*, *Panicum repens* and *Ludwigia peruviana*. The water's surface in Valrico Lake was dominated by *Nuphar* and *Eichhornia crassipes*. A total of one species of submerged aquatic vegetation was observed, *Utricularia gibba* is a native species that does not root into substrates and is commonly seen tangled in floating leaved and emergent vegetation. Submerged vegetation was sparse in Valrico Lake in part due to reduced available light and bottom substrates. Due to the unrooted nature, this species is not typically seen in sonar chart data. By analyzing the collected sonar chart, submerged aquatic vegetation potentially covered approximately 0% of the surface area of Valrico Lake. This submerged vegetation inhabits an estimated 0% of the water volume in Valrico Lake. Figure 5 shows the results of the SAV analysis indicating the location and height of SAV.

Survey Date: May 19, 2021
 Water level was 43.76 ft NAVD 88 at the time of the assessment.
 Submerged Aquatic Vegetation was analyzed from collected sonar data.
 The height of the SAV where present is shown in 0.2 foot increments.

Area 0 square ft; 0 Acres;
 (0% of Lake Surface Area)
 Mean SAV Height 0.0 ft;
 Volume 0 Cubic ft, (0 gallons);
 (0% of Lakes Volume)
