# LAKE ASSESSMENT REPORT FOR LAKE THONOTOSASSA IN HILLSBOROUGH COUNTY, FLORIDA

Date Assessed: June, 10, 2008

Assessed by: Grant Harley and David Eilers

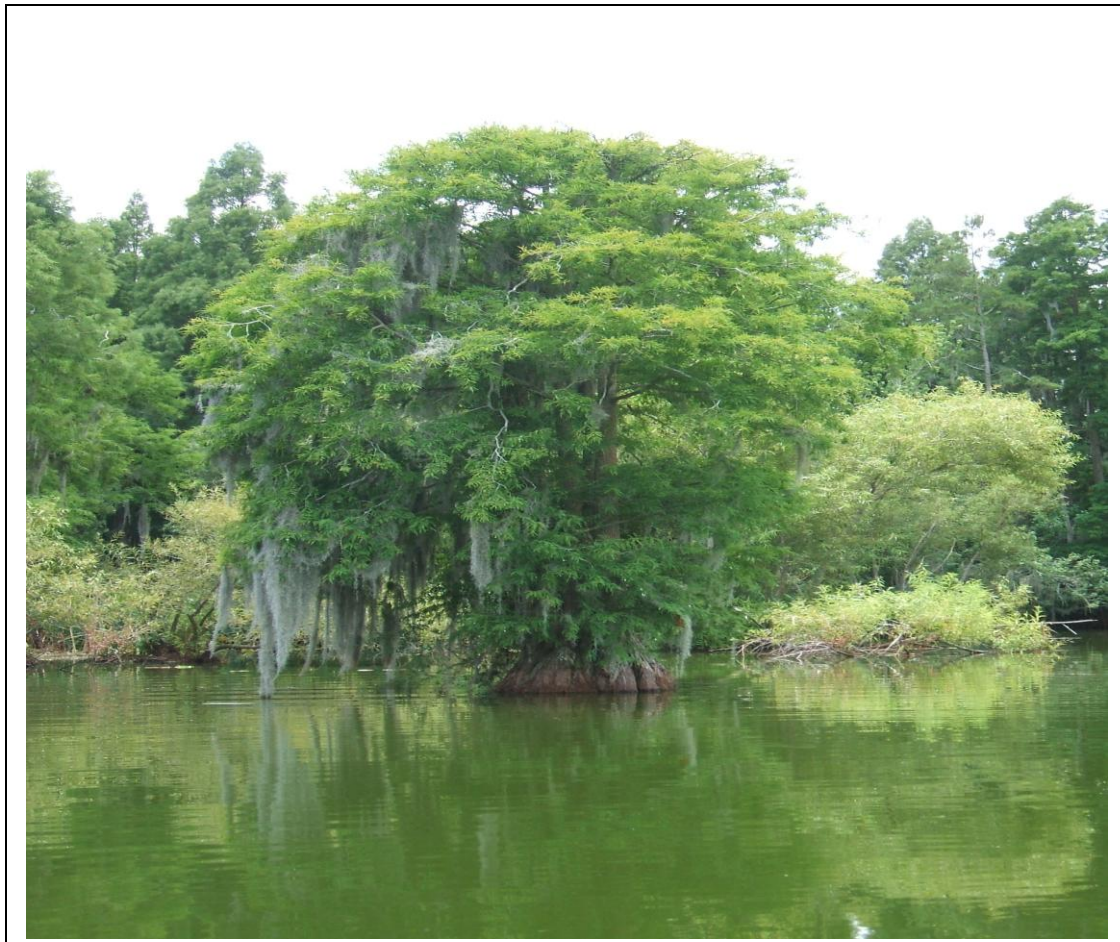
**Figure 1.** Photo of Lake Thonotosassa, taken June 10, 2008.

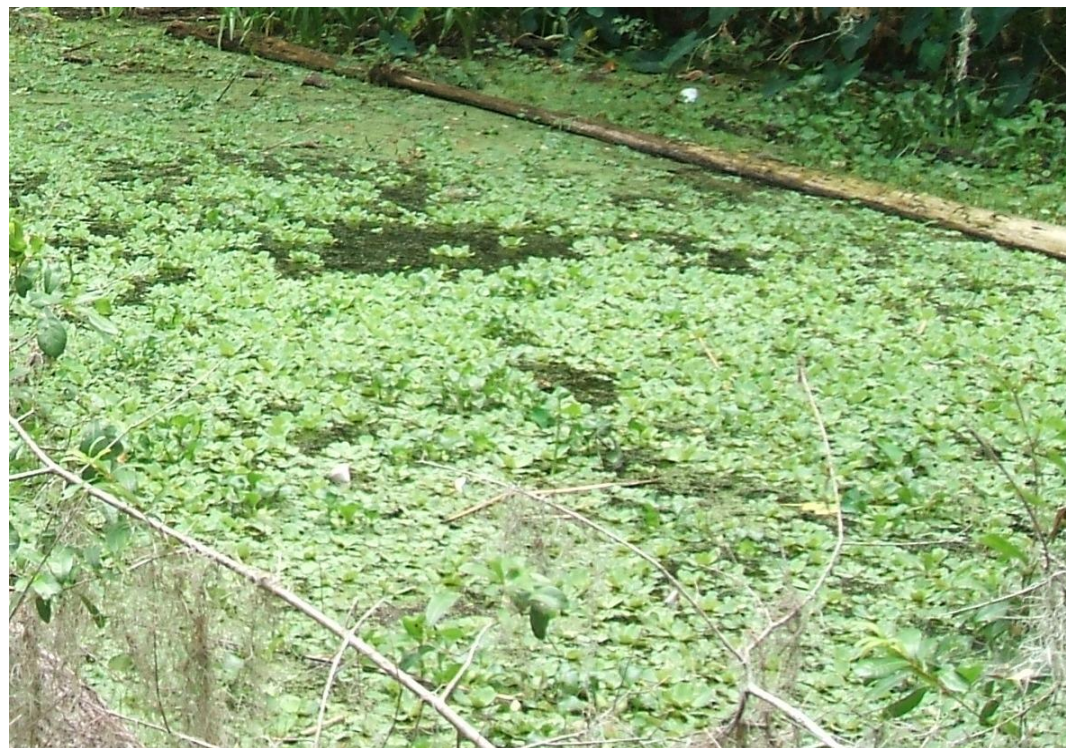
**Figure 4.** Water Lettuce, *Pistia stratioides*, Giant Duckweed, *Spirodela polyrhiza*, Common Duckweed, *Lemna* spp., Water Fern, *Salvinia minima*, and Carolina Mosquito Fern, *Azolla caroliniana*, infesting a stagnant back water of Lake Thonotosassa.

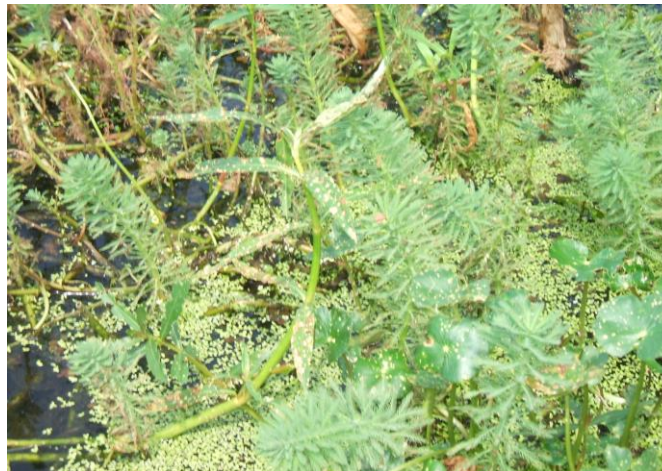
**Figure 6.** Photograph of Photograph of Parrot Feather, *Myriophyllum aquaticum*, on Lake Thonotosassa, Parrot Feather is a non-native plant found on Florida lakes.

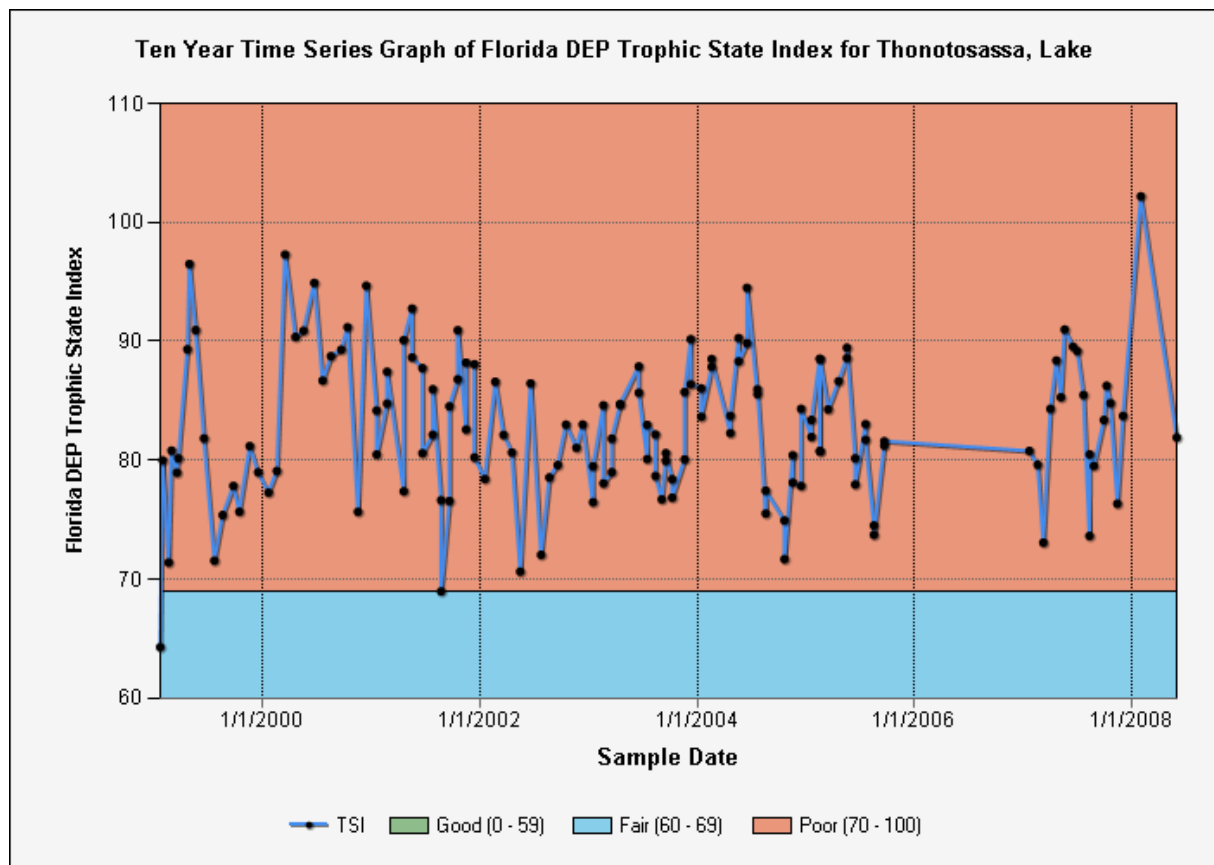
**Figure 7. Recent Trophic State Index (TSI) graph from Hillsborough Watershed Atlas. For the latest data go to:**

**Note:** The graph above includes benchmarks for using verbal descriptors of "good", "fair" and "poor". The verbal descriptors for these benchmarks are based on an early determination by stakeholders of the generally acceptable and understood terms for describing the state of lakes. The same benchmarks are used for nutrient graphs (Nitrogen and Phosphorus), chlorophyll graphs and trophic state index (TSI) graphs. The TSI is a calculated index of lake condition based on nutrient and chlorophyll (a) concentrations (please see "Learn more about Trophic State Index"). The benchmarks are established based on the TSI range that relates to a specific descriptor. The source for the TSI concentration relationships is the Florida Water Quality Assessment, 1996, 305(b) (Table 2-8).

As part of the lake assessment the physical water quality and chemical water chemistry of a lake are measured. These data only indicate a snap shot of the lakes water quality; however they are useful when compared to the trend data available from LAKEWATCH or other sources. Table 9 contains the summary water quality data and index values and adjusted values calculated from these data. The total phosphorus (TP), total nitrogen (TN) and chlorophyll (a) water chemistry sample data are the results of chemical analysis of samples taken during the assessment and analyzed by the Hillsborough County Environmental Protection Commission laboratory. These data compare reasonably well with the mean data from the LAKEWATCH data set for the lake. The trophic state index (TSI) calculated from the sample data (76.82) is within the values shown in the figure above.
