Bear Branch Stream Assessment

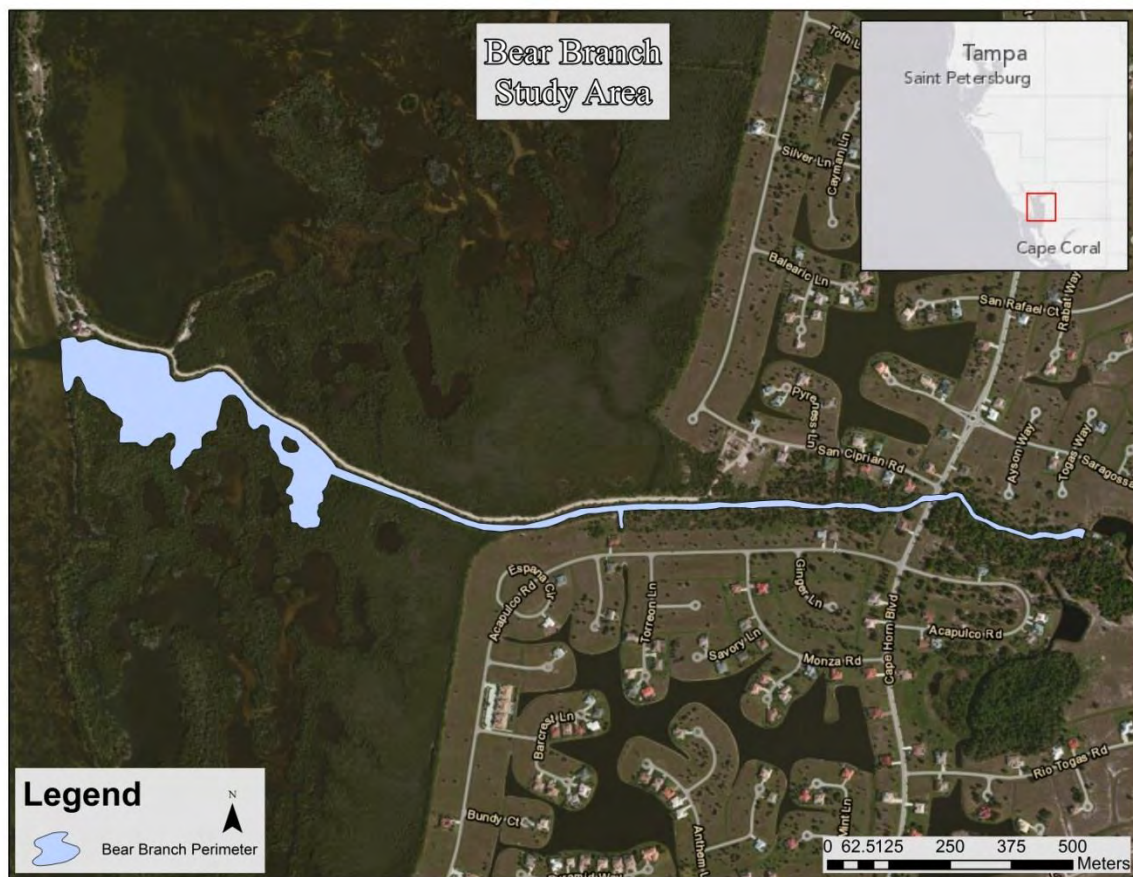
Figure 78. Overview of the Bear Branch Study Area

Bear Branch is located in the Charlotte Harbor Watershed in southern Charlotte County with its head waters in and unnamed canal at the end of Harborside Blvd and its mouth in Charlotte Harbor as shown in Figure 78. Bear Branch is also known as Key Point Canal which is located within a relatively unimpaired watershed. The downstream portion of Bear Branch is surrounded by mangroves. The upstream portion of Bear Branch is surrounded by a combination of open land and low density residential property. Bear Branch's watershed has a LDI value of 2.7 and the area immediately surrounding the creek with a buffer LDI value of 2.1.

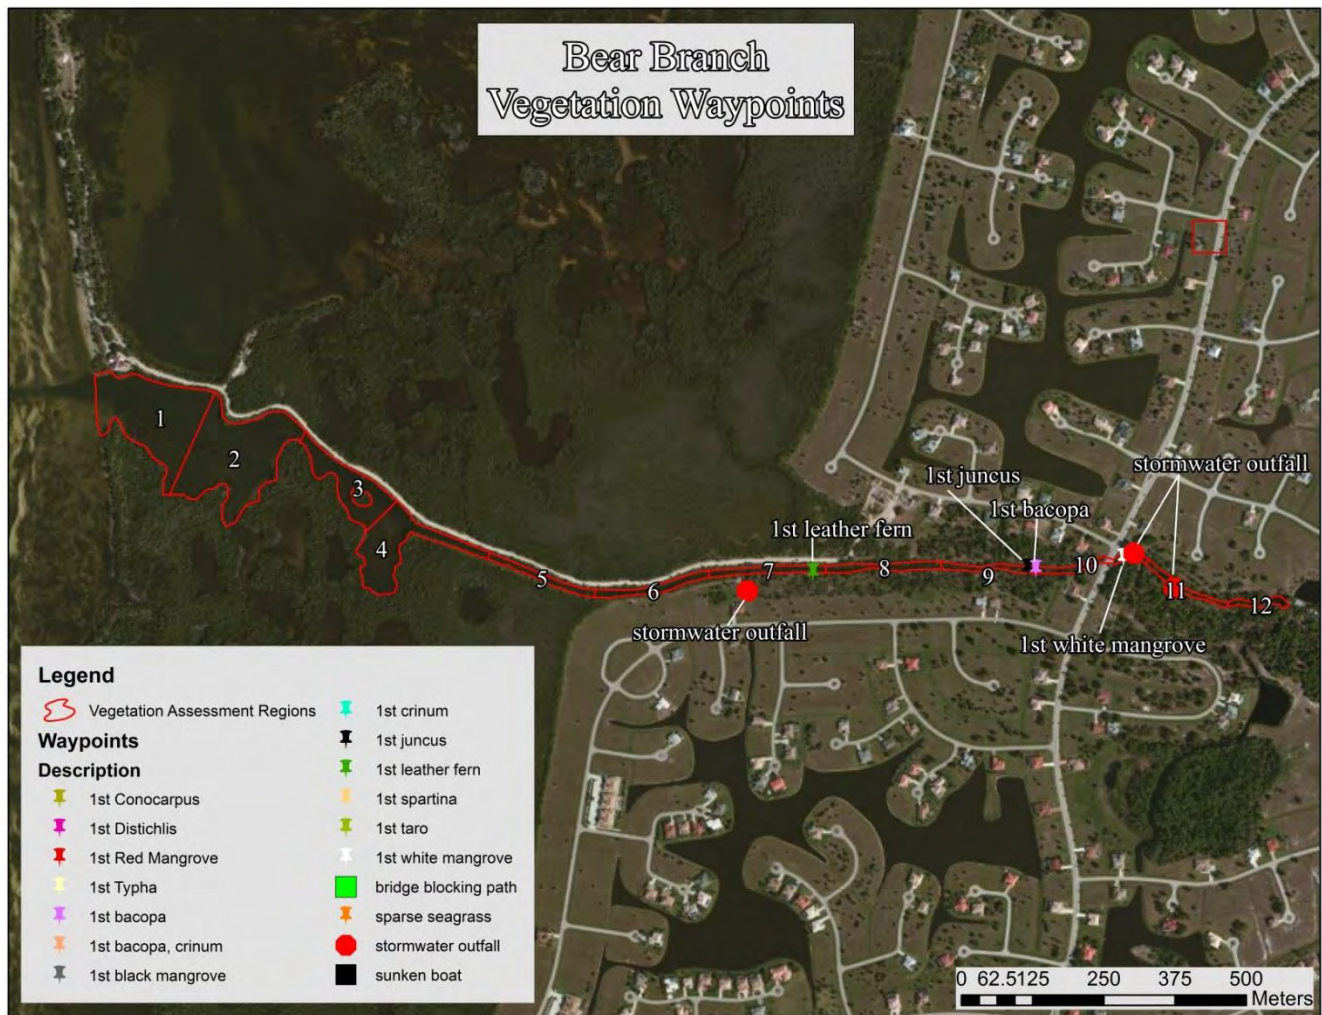
Figure 80. Bear Branch Vegetation Waypoints

Figure 80 shows the vegetation transition zone of Bear Branch indicating the most upstream White Mangrove (*Laguncularia racemosa*) as well as the most downstream Leather Fern (*Acrostichum danaeifolium*), Waterhyssop (*Bacopa monnieri*), and Needle Rush (*Juncus roemerianus*). The locations of stormwater outfalls are also indicated on the map. Based on the vegetation assessment data for Bear Branch, regions 1 through 7 would comprise the highest salinity and tidal influence zone, regions 8 through 10 would comprise the “mixing” zone and regions 11 and 12 would comprise the freshwater dominant zone. The vegetation assessment species list is shown in Table 19.

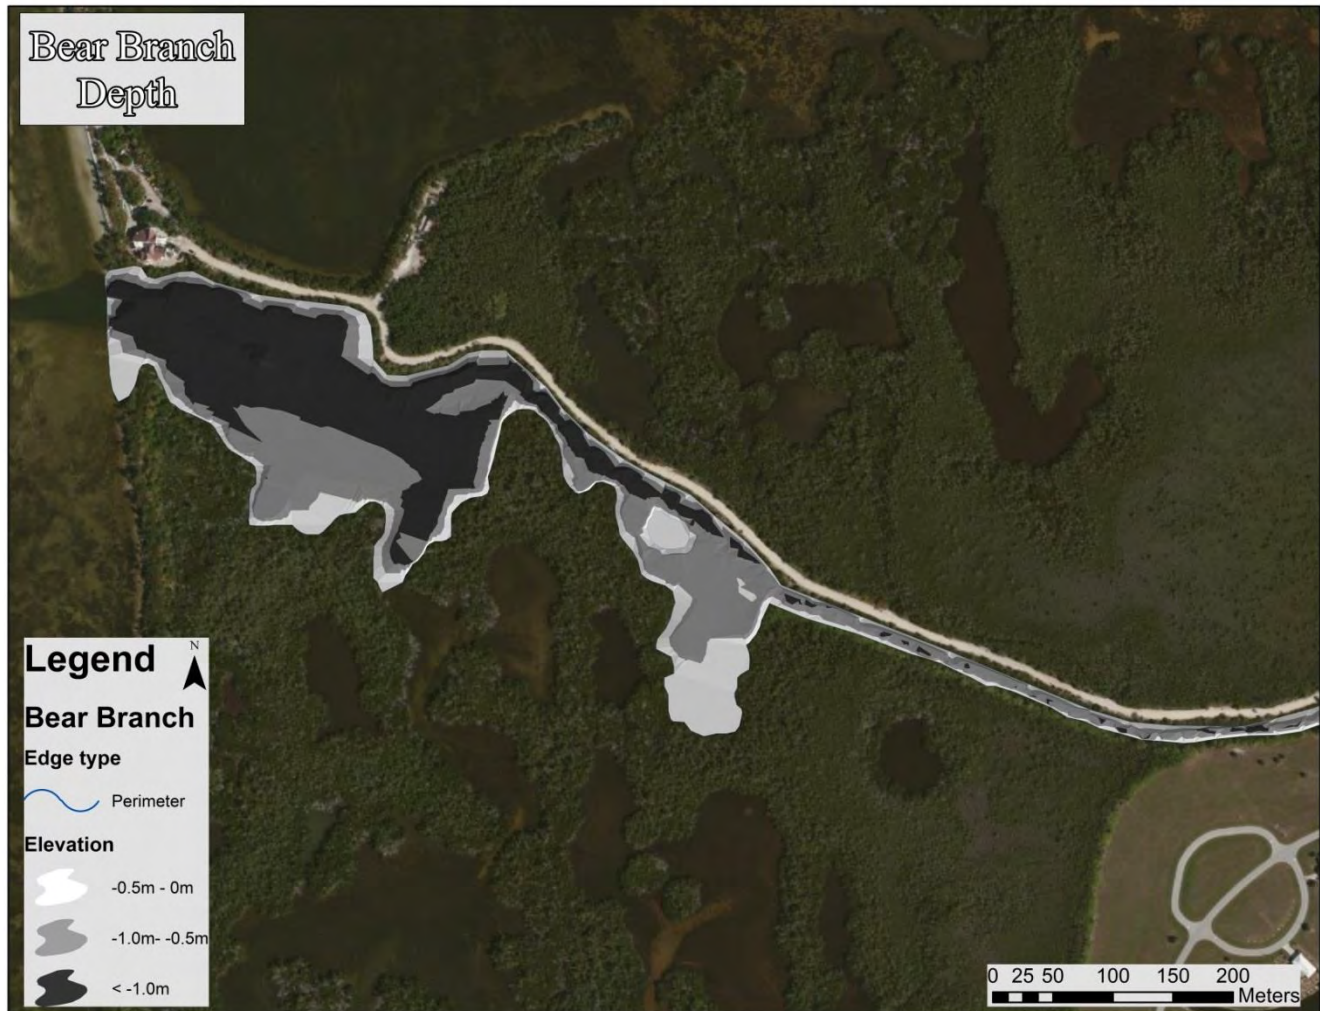
Figure 82. Bear Branch Bathymetric Stratum Map (1 of 2)

In the study area, Bear Branch had a mean depth of 3.28 feet and a maximum depth of 10.22 feet. A total of 21.19 acres of creek was mapped during the assessment. At the time of assessment, Bear Branch contained an estimated 18,600,604 gallons of water in the study area. Figure 82 and Figure 83 detail the bathymetric mapping for Bear Branch showing the three depth stratum.

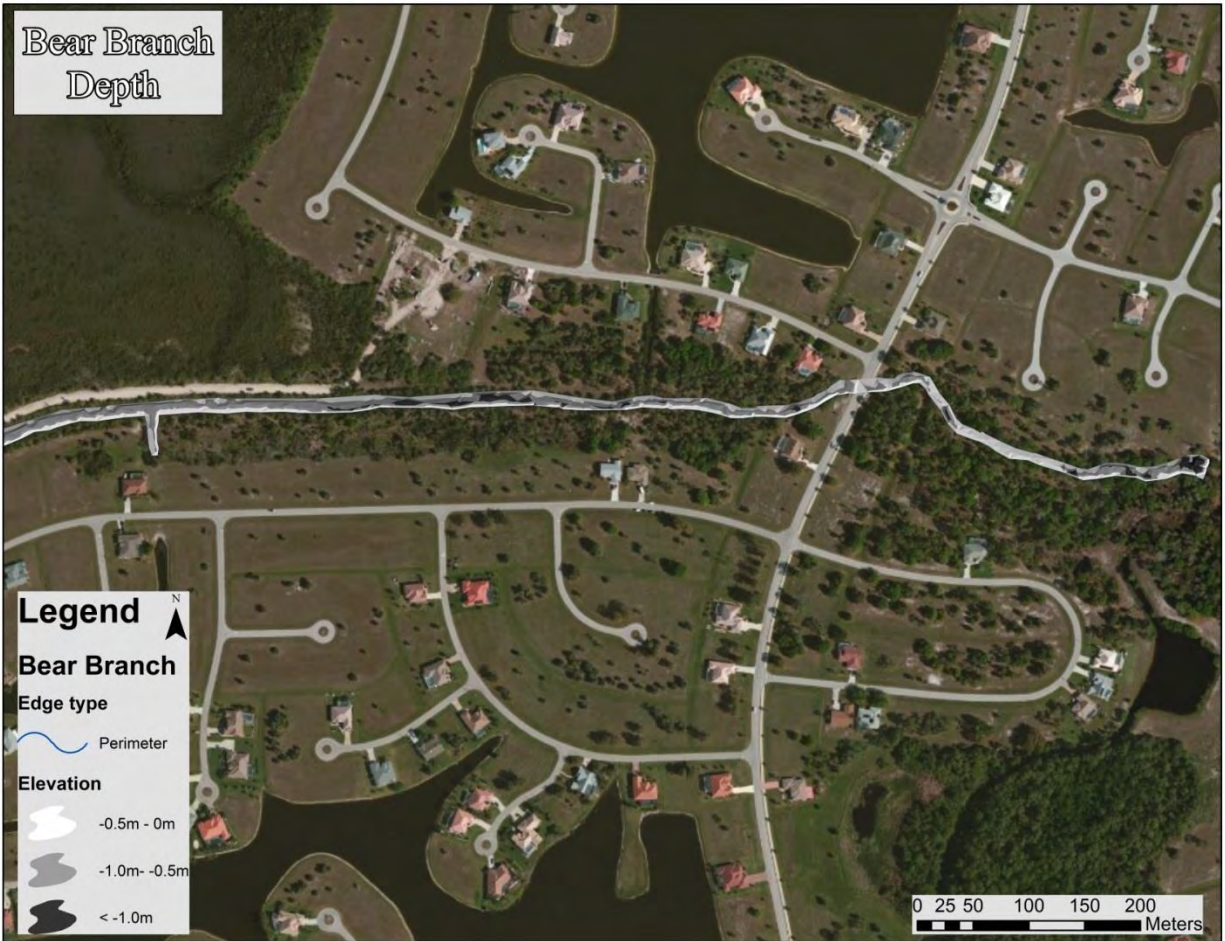
Figure 83. Bear Branch Bathymetric Stratum Map (2 of 2)
