# Lake Assessment Report for Lake Stemper in Hillsborough County, Florida

Date Assessed: July 13, 2010

# Lake Stemper

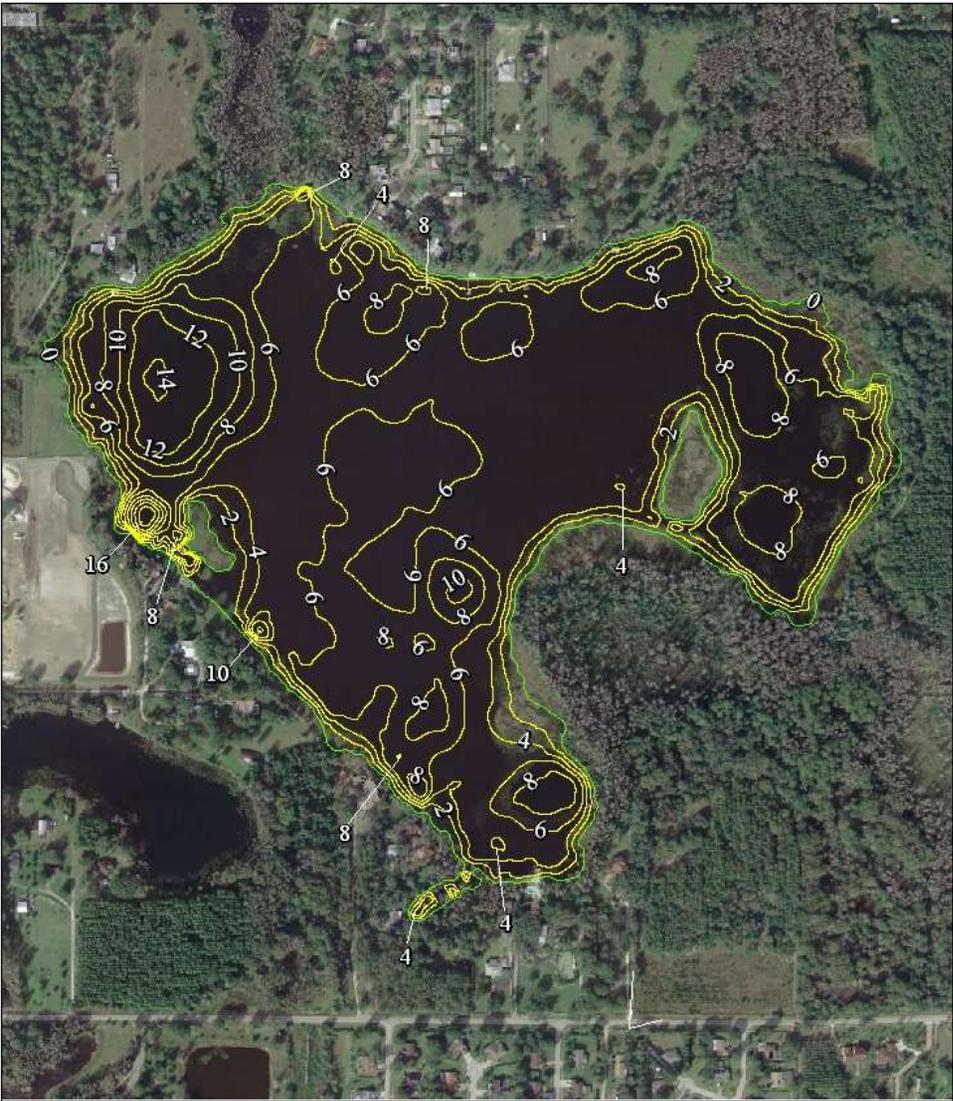
Figure 2. Bathymetry map for Lake Stemper using data collected by USF-FCCDR in 2010

Survey Date: July 13, 2010  
Reservoir water level was 61.06 ft above sea level at time of the assessment NGVD29.  
Contours are expressed in absolute depth below this level.

Perimeter 14,805.13 ft,  
Area 115.85 Acres  
Mean Depth 6.04 ft;  
Volume 672.61 Ac-ft, (219,169,964.7 gallons);  
Deepest point 17.68 ft

**Bathymetric Map**<sup>ii</sup>. Table 1 provides the lake's morphologic parameters in various units. The bottom of the lake was mapped using a Lowrance LCX 28C HD Wide Area Augmentation System (WAAS)<sup>iii</sup> enabled Global Positioning System (GPS) with fathometer (bottom sounder) to determine the boat's position, and bottom depth in a single measurement. The result is an estimate of the lake's area, mean and maximum depths, and volume and the creation of a bottom contour map (Figure 2). Besides pointing out the deeper fishing holes in the lake, the morphologic data derived from this part of the assessment can be valuable to overall management of the lake vegetation as well as providing flood storage data for flood models.

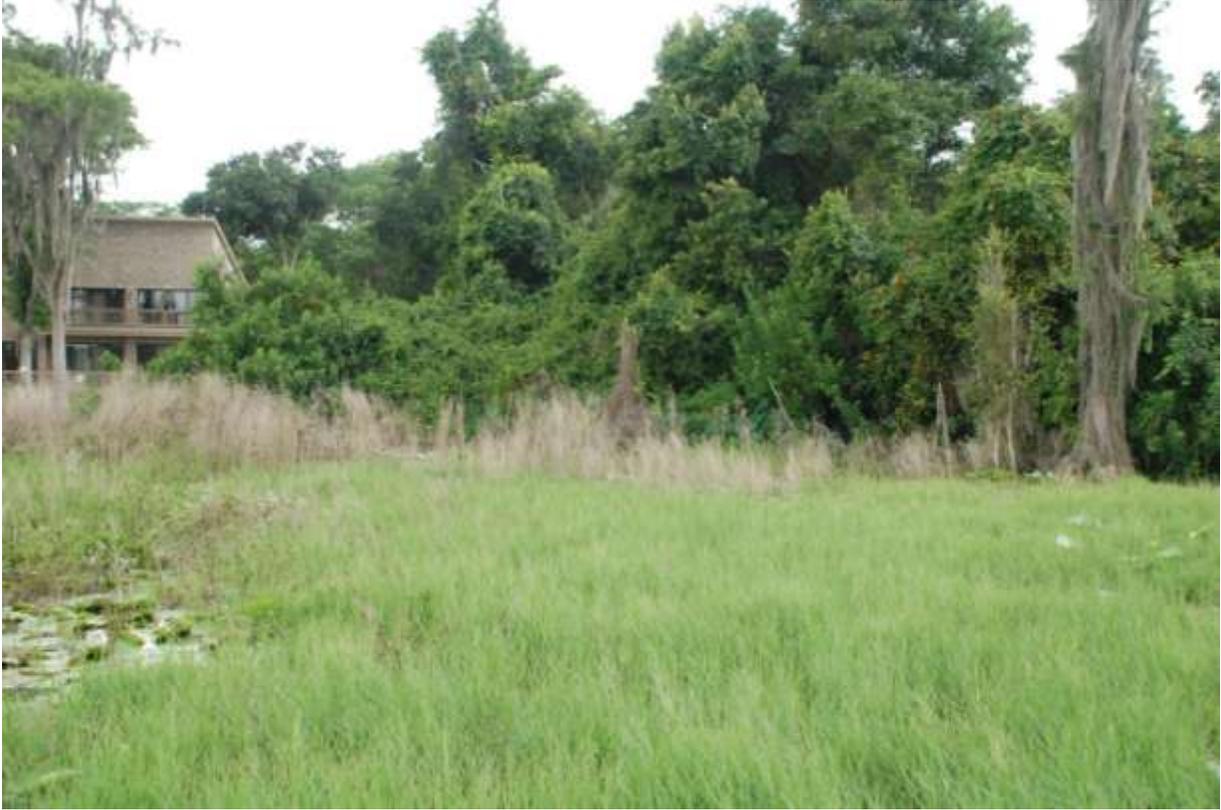
**Figure 5. *Panicum repens*, a non-native invasive species, on Lake Stemper**

Lake Stemper is a large area (115.45-acre) lake that would be considered in the [Eutrophic](#) category of lakes based on water chemistry. It has a plant diversity of 68 species relative to the total watershed plant diversity of 120 species with about 12.00 % percent of the open water areas containing submerged aquatic vegetation. Vegetation helps to maintain the nutrient balance in the lake as well as provide good fish habitat. The lake has many open water areas to support various types of recreation and has a good diversity of plant species. The primary pest plants in the lake include *Salvinia minima*, *Panicum repens*, *Casuarina equisetifolia*, *Ludwigia peruviana*.

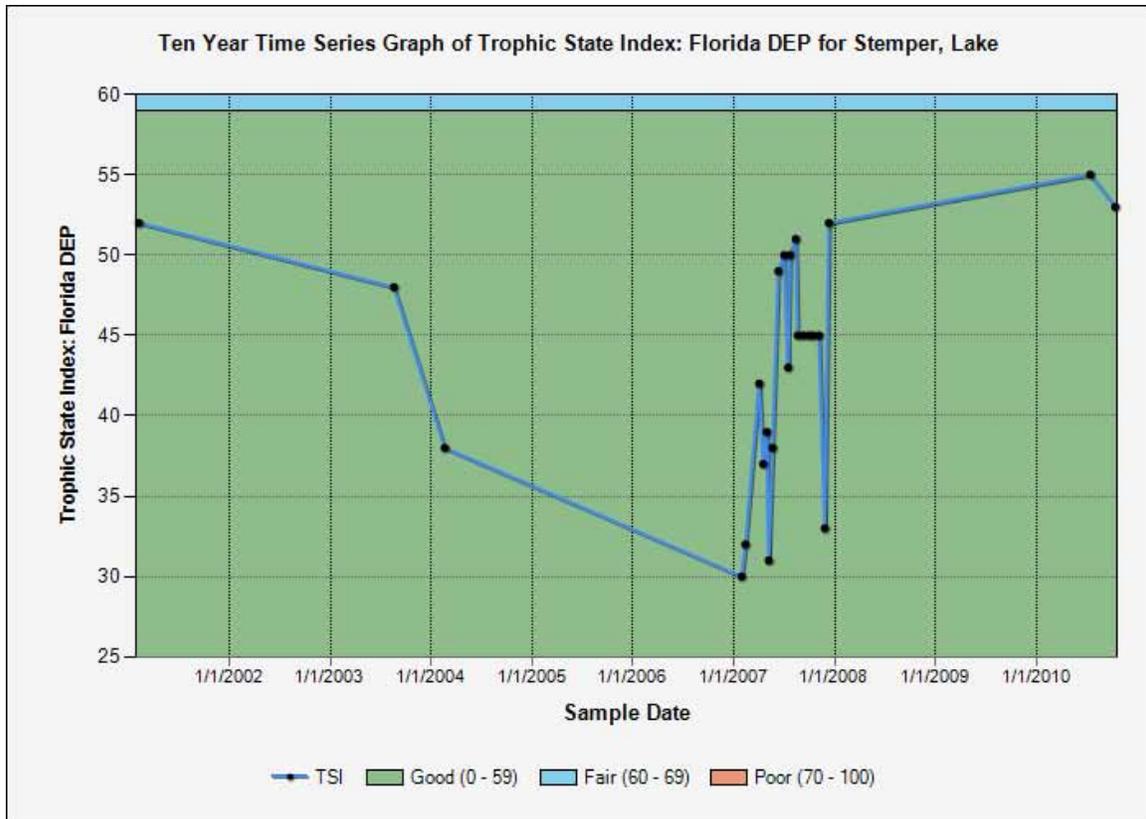
Figure 6. Recent Trophic State Index (TSI) graph for Lake Stemper<sup>vi</sup>

These data are displayed and analyzed on the Water Atlas as shown in Figure 6, Figure 7, and Figure 8 for Lake Stemper. The figures are graphs of: (1) the overall trophic state index (TSI)<sup>1</sup>, which is a method commonly used to characterize the productivity of a lake, and may be thought of as a lake's ability to support plant growth and a healthy food source for aquatic life; (2) the chlorophyll *a* concentration, which indicates the lake's algal concentration, and (3) the lake's Secchi Disk depth which is a measure of water visibility and depth of light penetration. These data are used to evaluate a lake's ecological health and to provide a method of ranking lakes and are indicators used by the US Environmental Protection Agency (USEPA) and the Florida Department of Environmental Protection (FDEP) to determine a lake's level of impairment. The chlorophyll *a* and Secchi Disk depth graphs include benchmarks which indicate the median values for the various parameters for a large number of Lakes in Florida expressed as percentiles.

Based on best available data, Lake Stemper has a color value determined as a platinum cobalt unit (pcu) value of 100 and is considered a Dark lake (has a mean color in pcu greater than 40). The FDEP and USEPA may classify a lake as impaired if the lake is a dark lake and has a TSI greater than 60, or is a clear lake (has a mean color in pcu less than or equal to 40) and has a TSI greater than 40. Lake Stemper has a TSI of 53 and does not meet the FDEP Impaired Waters Rule (IWR) criteria for impaired lakes. See also Table 7.

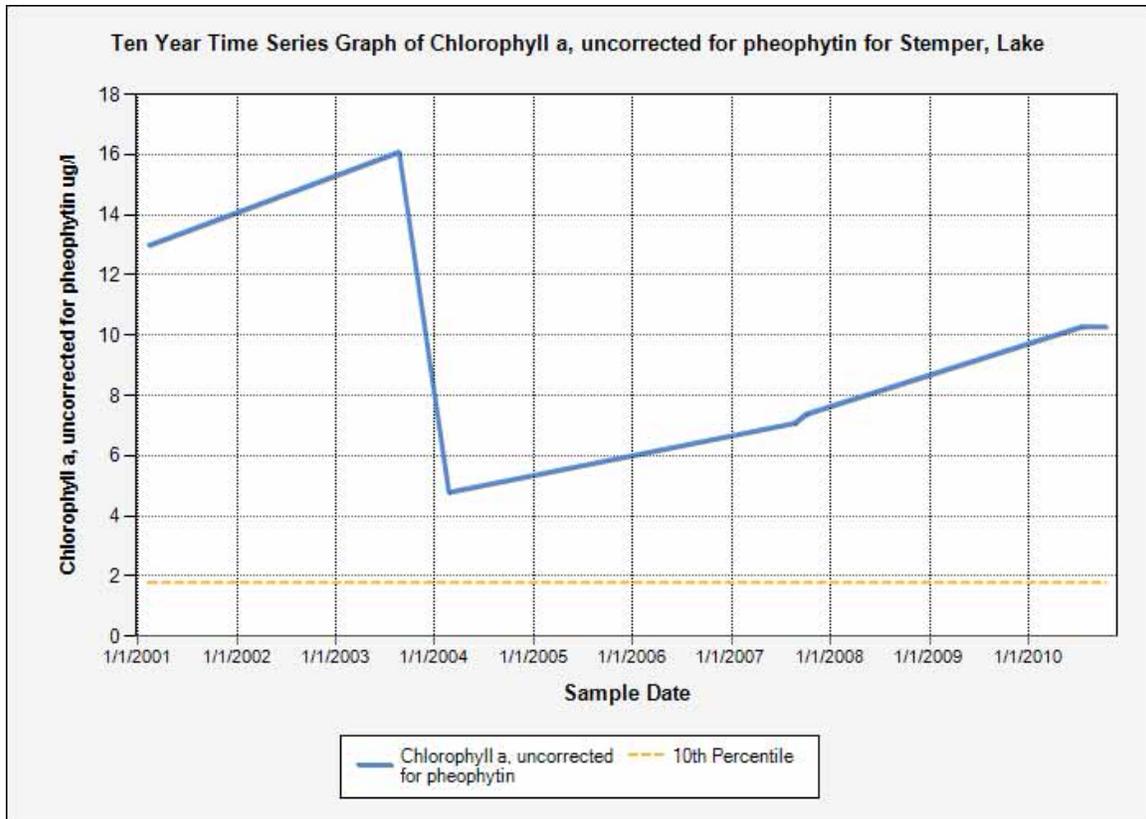
Figure 7. Recent Chlorophyll a graph for Lake Stemper<sup>vii</sup>

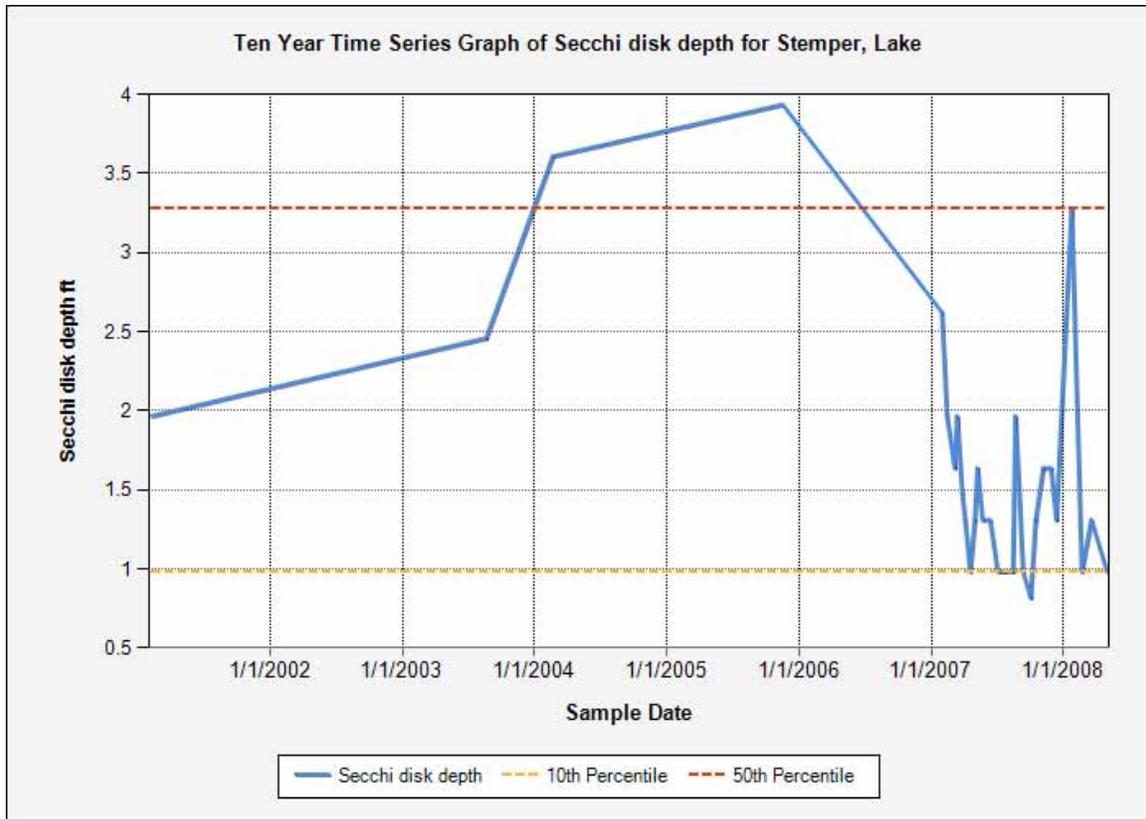
**Figure 8. Recent Secchi Disk graph for Lake Stemper<sup>viii</sup>**

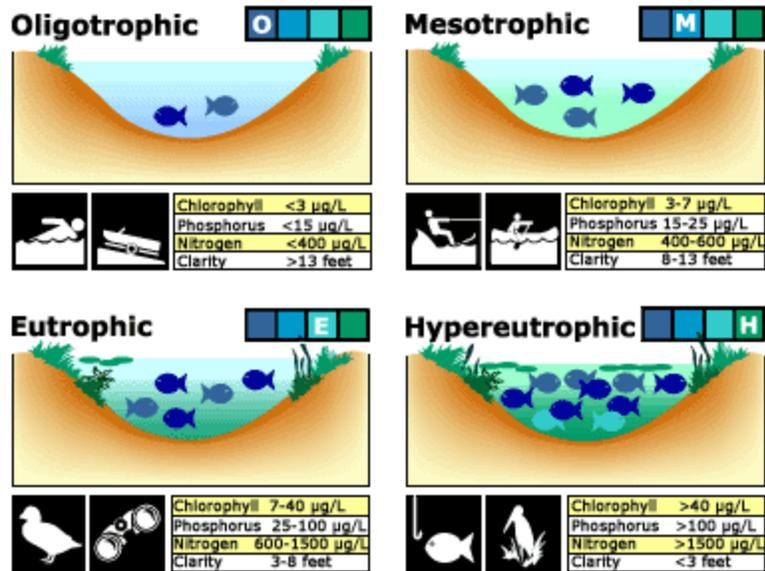
Figure 9. Tropic States

**Hypereutrophic** (HI-per-you-TROH-fik) where waterbodies have the highest level of biological productivity. The trophic state of a waterbody can also affect its use or perceived utility. Figure 9 illustrates this concept.

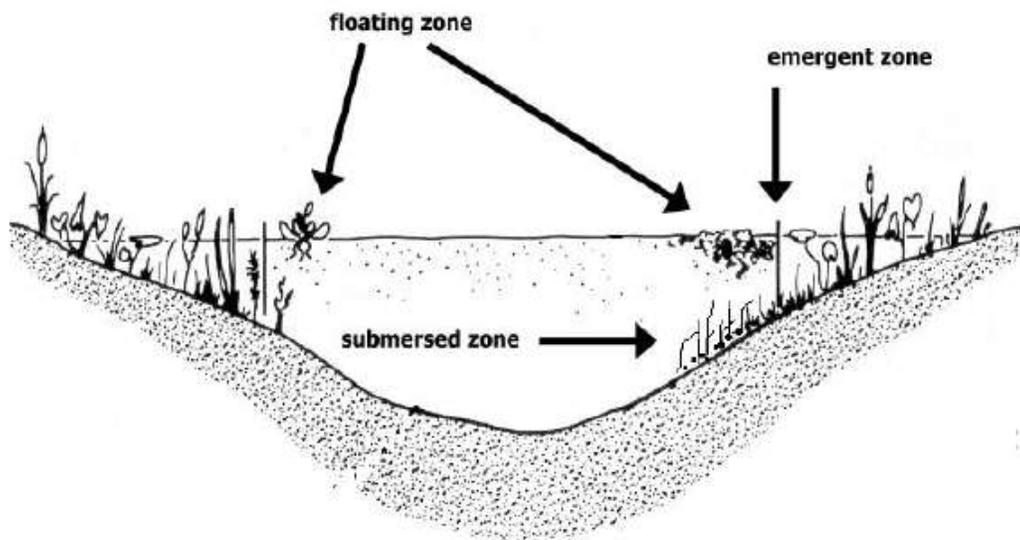
- The three primary aquatic vegetation zones are shown below:

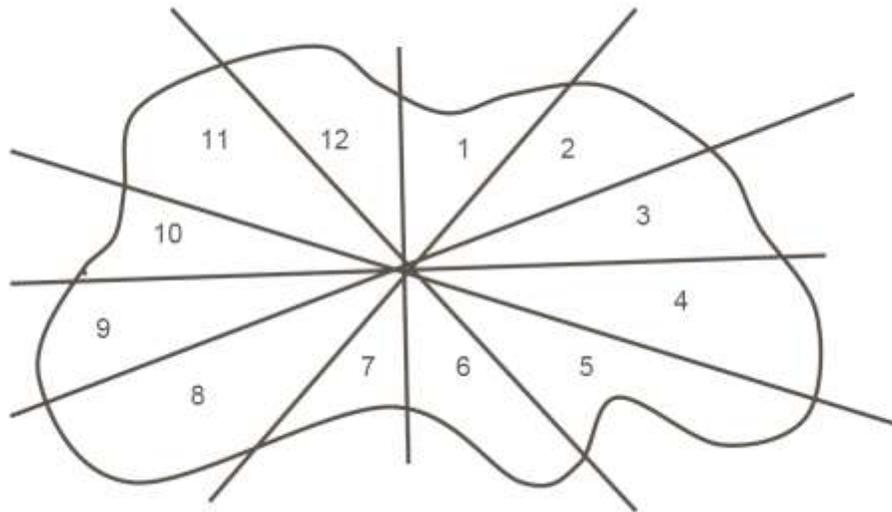
Diagram showing the method used to divide a typical lake into 12 sections for replicate sampling:
